Aviation Investigation Final Report

Location:	Thief River Falls, Minnesota	Accident Number:	CEN17FA361
Date & Time:	September 23, 2017, 07:42 Local	Registration:	N4777T
Aircraft:	Cessna TR182	Aircraft Damage:	Destroyed
Defining Event:	Loss of control in flight	Injuries:	3 Fatal
Flight Conducted Under:	Part 91: General aviation - Personal

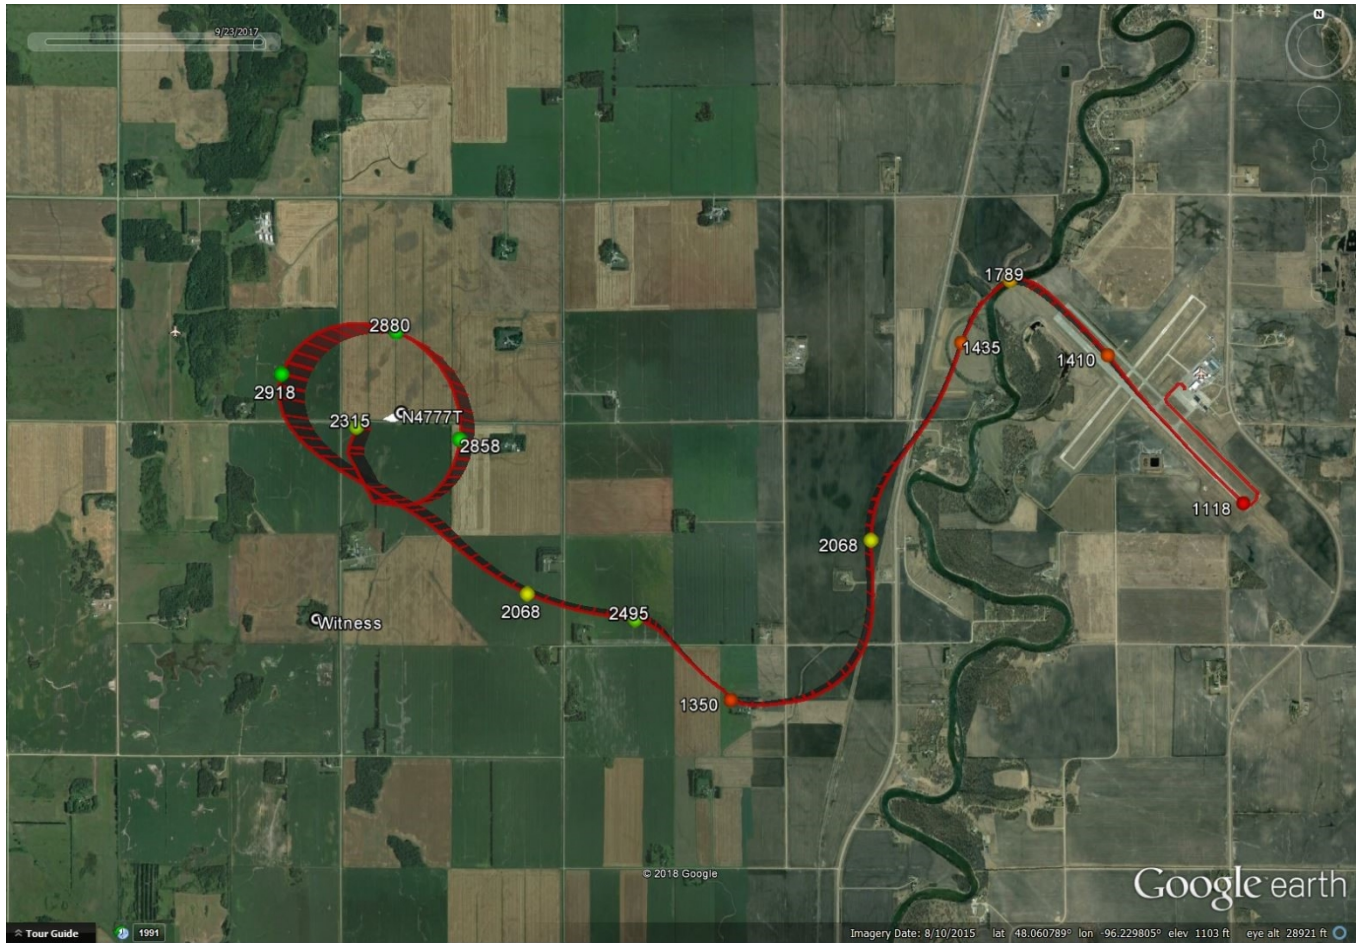
A Garmin handheld GPS was found in the wreckage and was sent to the NTSB recorders laboratory for download. The device contained data that corresponded to the accident flight. The airplane departed TVF then climbed and descended several times. About 2 minutes after takeoff, the airplane descended to 250 ft agl and then quickly climbed to 1,400 ft agl. The airplane then circled in the vicinity of the accident site in a right descending turn as seen in figure 1, which depicts the altitudes in mean sea level.

The final GPS point was about 280 yards west-southwest of the accident site on a true heading of about 20°.

Figure 1 – Accident flight GPS track

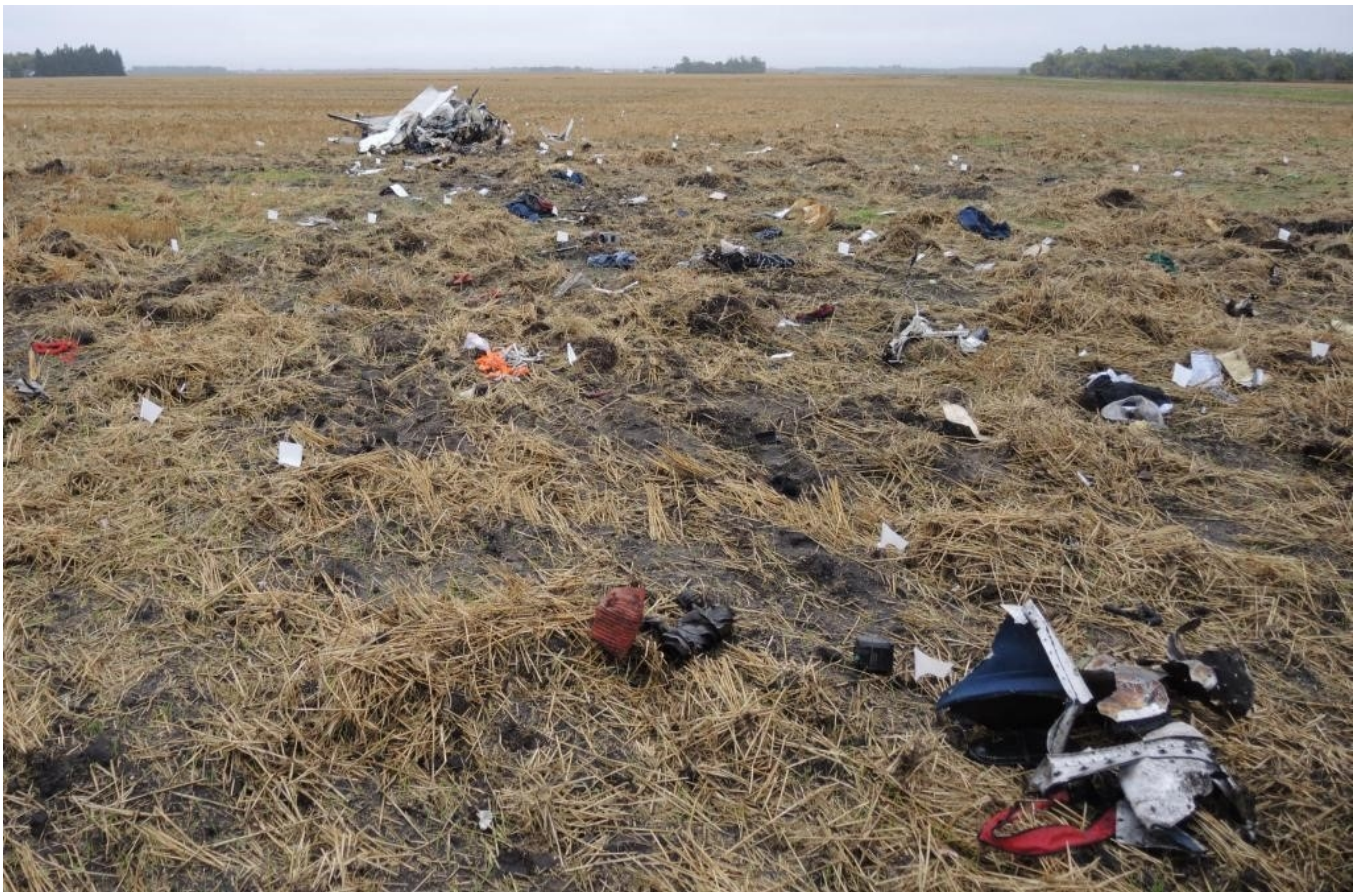
The accident site was located in a harvested wheat field next to a gravel road. The wreckage debris path began with a ground impact mark, which contained broken green glass from the right wing navigation light, and continued on a heading of 060° for about 230 yards. The airplane was highly fragmented, but all major components were found at the accident site (figure 2).

Figure 2 – Debris Path and Main Wreckage
