# Aviation Investigation Final Report

<b>Location:</b>	New York, New York	<b>Accident Number:</b>	DCA19LA134
<b>Date &amp; Time:</b>	April 10, 2019, 20:40 Local	<b>Registration:</b>	N114NN
<b>Aircraft:</b>	Airbus A321	<b>Aircraft Damage:</b>	Substantial
<b>Defining Event:</b>	Abnormal runway contact	<b>Injuries:</b>	110 None
<b>Flight Conducted Under:</b>	Part 121: Air carrier - Scheduled

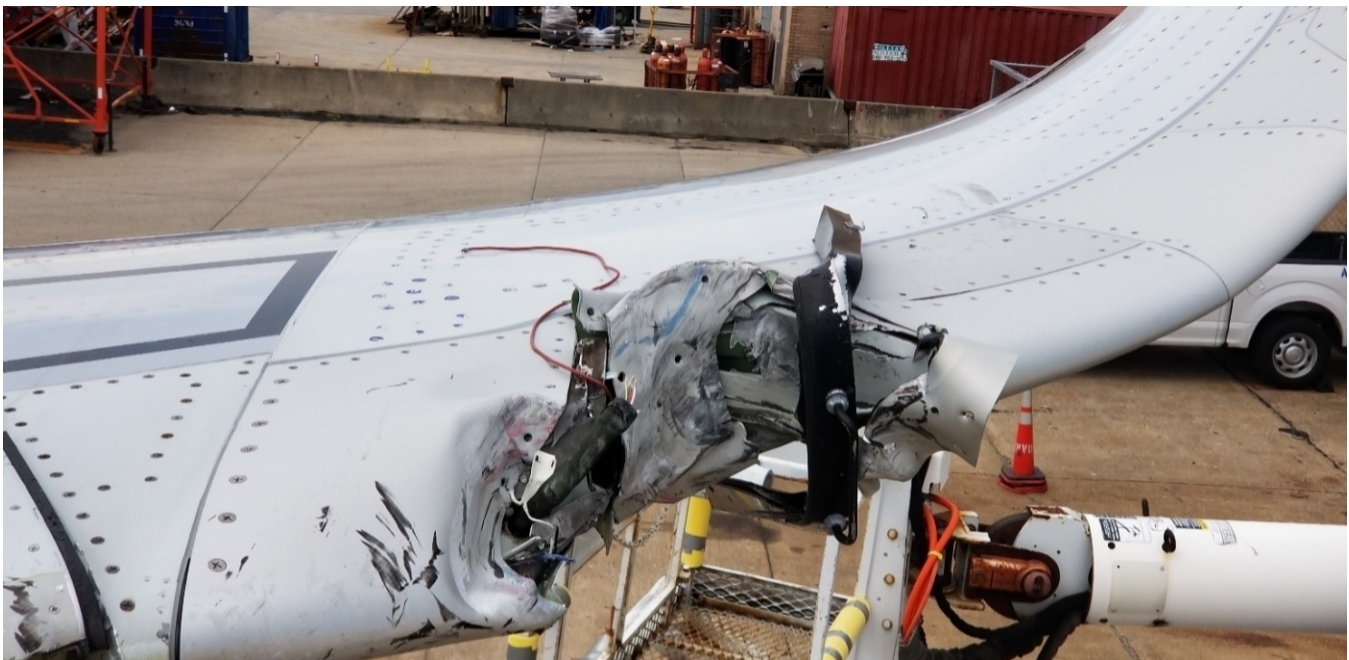
The large left roll angle immediately after liftoff resulted in the left wingtip striking the ground and a runway distance marker, part of which remained imbedded in the wingtip. Airbus engineering simulations performed as part of this investigation demonstrated that the several seconds of near-maximum left rudder generated a rolling moment after the gear had left the ground to impart the left roll rate that the DFDR recorded. No airplane flight control

American Airlines' examination of the airplane revealed that a portion of the marker support structure was lodged in the left wingtip (see figure 1). The left wing outboard slat, left aileron, left outboard flap, and underside of the left wingtip sharklet were damaged (see figure 2).

**Figure 1.** Left wingtip damage and portion of distance remaining marker support structure lodged in wingtip (Source: American Airlines).
