Aviation Investigation Final Report

Location:	Poolville, Texas	Accident Number:	CEN19FA004
Date & Time:	October 12, 2018, 16:08 Local	Registration:	N221MC
Aircraft:	Piper PA32RT	Aircraft Damage:	Destroyed
Defining Event:	Loss of control in flight	Injuries:	2 Fatal
Flight Conducted Under:	Part 91: General aviation - Personal

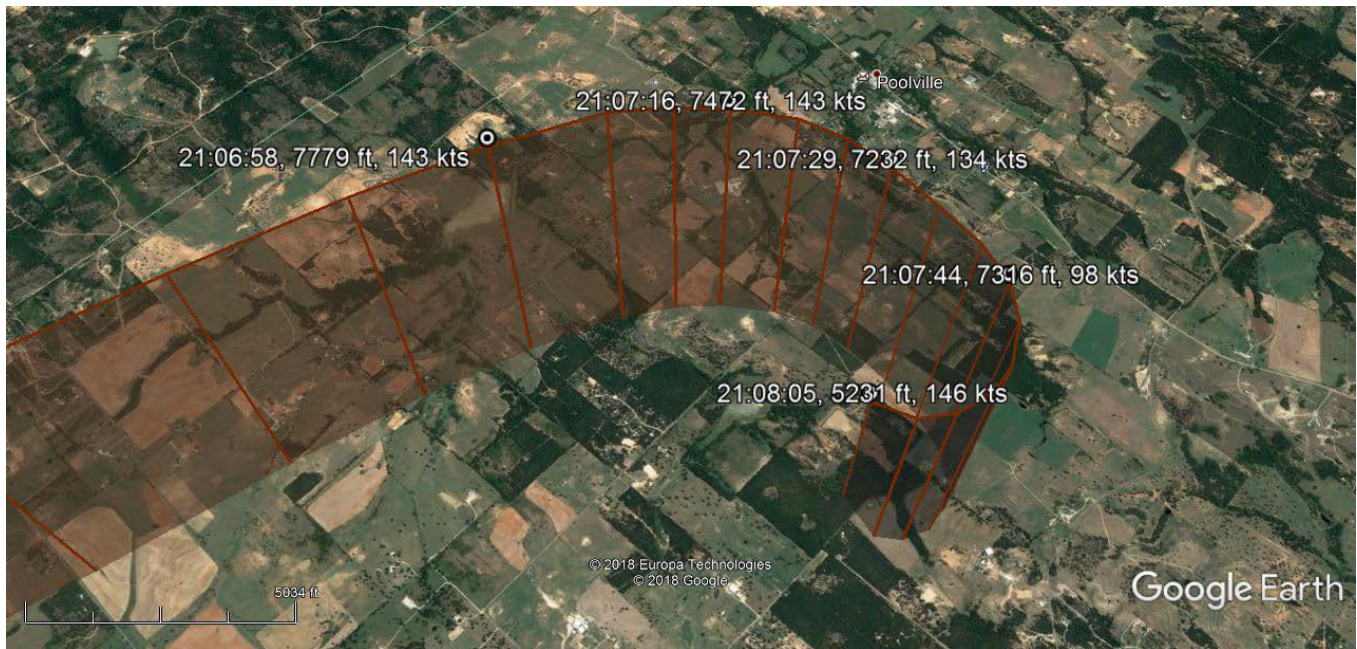
The pilot and passenger departed on the cross-county flight in visual meteorological conditions. Automatic dependent surveillance-broadcast (ADS-B) and GPS data indicated that, after takeoff, the airplane proceeded east and that, for most of the flight, flew at altitudes that were between 8,500 and 9,500 ft mean sea level (msl). However, as the flight progressed, the weather conditions deteriorated. Toward the end of the flight, the airplane began descending from 9,000 ft msl at a descent rate of about 700 ft per minute. The airplane then entered a descending right turn with a decreasing radius before the ADS-B and GPS data ended. The radius of the turn was initially about 4,000 ft and decreased during the next minute to about 1,000 ft by the final 1 second of the data. As the airplane continued to turn, the descent rate increased; the average rate of descent of the airplane for the final 10 seconds of the recorded ADS-B data was about 12,900 ft per minute.

that the pilot experienced spatial disorientation during an encounter with IMC, which progressed into a graveyard spiral (as indicated by the tightening of the turn) and a subsequent loss of control.

Figure. GPS data showing the final portion of the accident flight.
