# Aviation Investigation Final Report

<b>Location:</b>	Uvalde, Texas	<b>Accident Number:</b>	CEN18LA213
<b>Date &amp; Time:</b>	June 7, 2018, 10:24 Local	<b>Registration:</b>	N3291X
<b>Aircraft:</b>	Beech F33A	<b>Aircraft Damage:</b>	Destroyed
<b>Defining Event:</b>	Loss of engine power (total)	<b>Injuries:</b>	1 Serious
<b>Flight Conducted Under:</b>	Part 91: General aviation - Personal

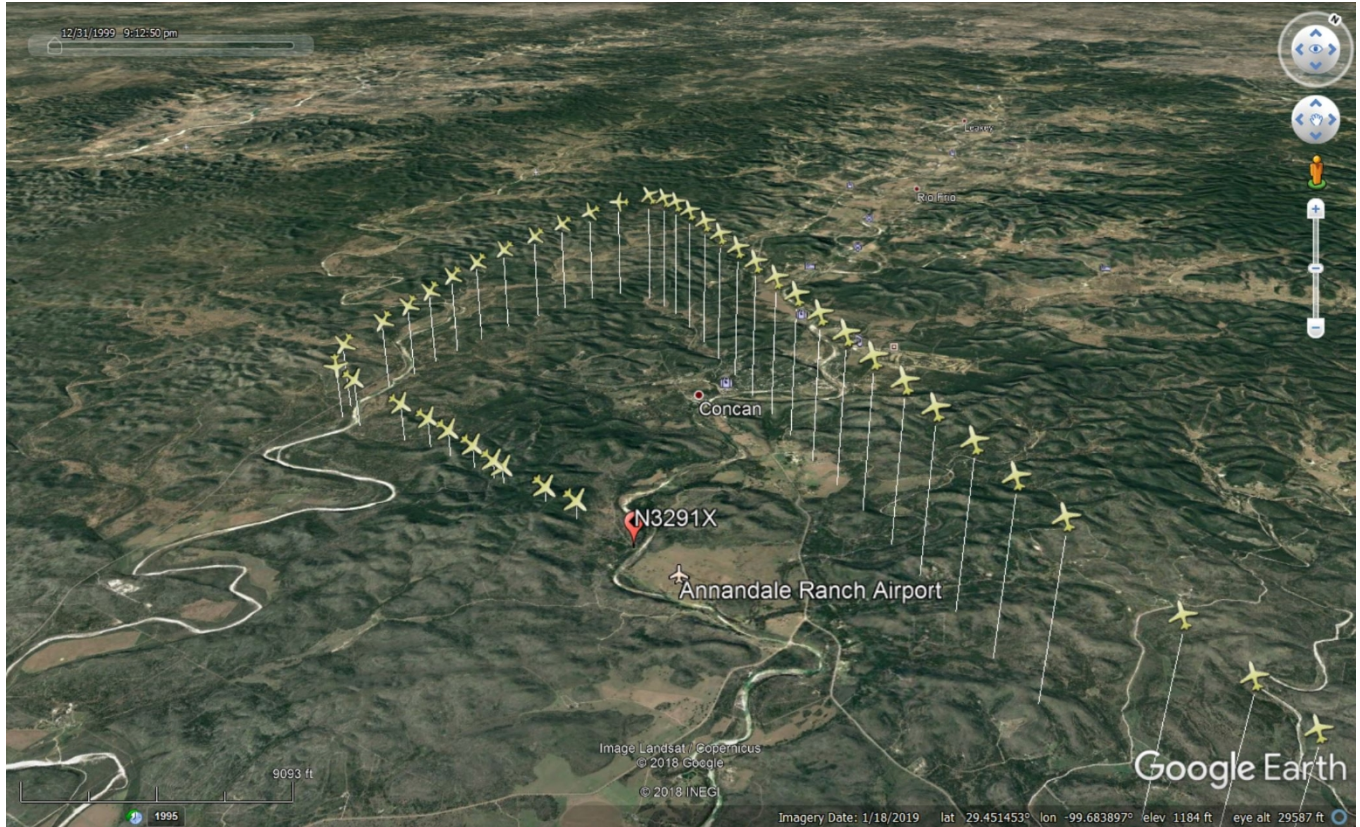
A review of the Federal Aviation Administration (FAA) air traffic control (ATC) data revealed that the airplane's recorded flight track began at 0937 about 5 nautical miles northwest of 8T6. The pilot was in contact with ATC and the airplane was in cruise flight about 8,500 ft msl and 110 nautical miles from 8T6 when the emergency was declared. At 1018 the airplane made a left descending turn toward 2XS7. The final radar return at 1023 showed the airplane about 2,300 ft msl (1,000 ft above ground level (agl)) on a 99° heading. Figure 1 shows the final radar track with the accident site and 2XS7 labeled.

Figure 1 – Radar track with the accident site and airport labeled

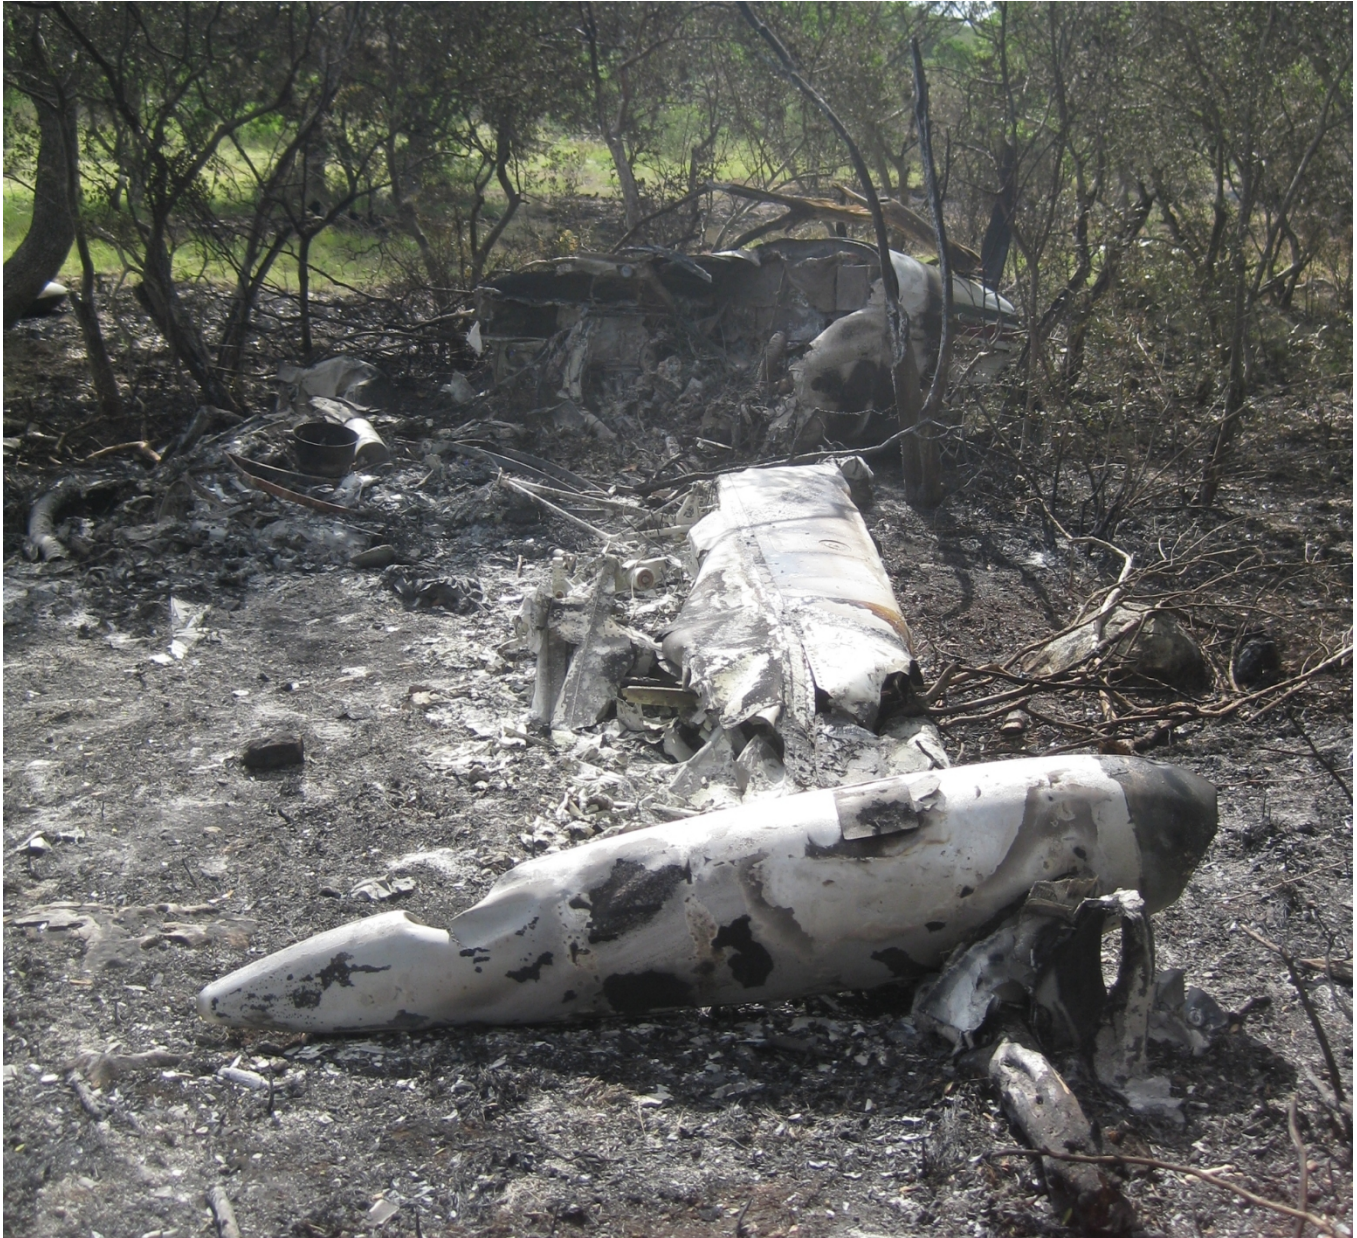
The responding FAA inspector stated that the airplane was found among trees on the west side of 2XS7 about 500 yards from the threshold of runway 8. The post-impact fire consumed a majority of the airplane. The wreckage debris path began with the left horizontal stabilizer and elevator that were sheared off, followed by the left wing, the left wing tip fuel tank, and nosewheel. The right wing, right wing tip fuel tank, fuselage, main landing gear, and engine/engine compartment remained together at the final resting position. The fuel tanks were breached and there was evidence of a large fire around the airplane as seen in Figure 2.

Figure 2 – Right side of the accident airplane with significant fire damage
