Aviation Investigation Final Report

Location:	Paso Robles, California	Accident Number:	WPR18LA101
Date & Time:	March 6, 2018, 22:26 Local	Registration:	N33807
Aircraft:	Piper PA28R	Aircraft Damage:	Substantial
Defining Event:	Loss of engine power (total)	Injuries:	2 None
Flight Conducted Under:	Part 91: General aviation - Instructional

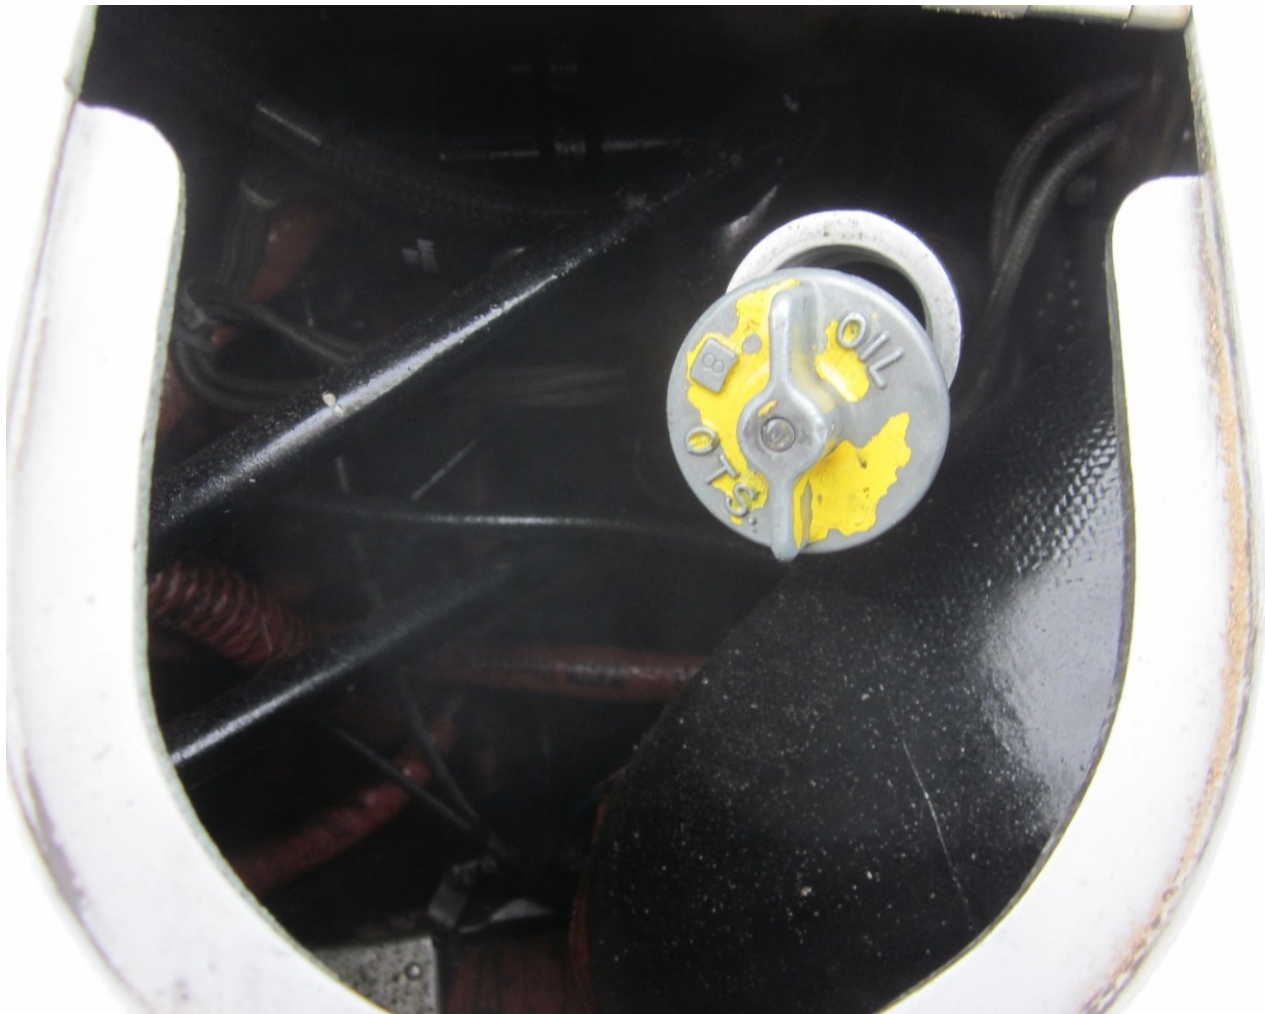
Examination revealed that the oil filler cap was not secured, and that the engine contained about 1 quart of oil. In addition, oil was splattered on the inside of the engine compartment. It is likely that the pilots failed to secure the oil filler cap during the preflight inspection, which resulted in the loss of engine oil inflight, eventual oil starvation, and the total loss of engine power.

The pilots' inadequate preflight inspection, which failed to ensure that the oil filler cap was secured and resulted in oil starvation and a total loss of engine power.

The following day, a Federal Aviation Administration inspector examined the wreckage and noted that the oil filler cap was not secured, and that the engine contained about 1 quart of oil. In addition, oil was splattered inside the engine compartment. (see Figure 1.)

Figure 1. Loose oil cap visible through the access panel on the engine cowling
