Aviation Investigation Final Report

Location:	Chariton, Iowa	Accident Number:	CEN16FA361
Date & Time:	September 7, 2016, 12:19 Local	Registration:	N465JM
Aircraft:	Piper PA 46-310P	Aircraft Damage:	Substantial
Defining Event:	Loss of control in flight	Injuries:	1 Fatal
Flight Conducted Under:	Part 91: General aviation - Personal

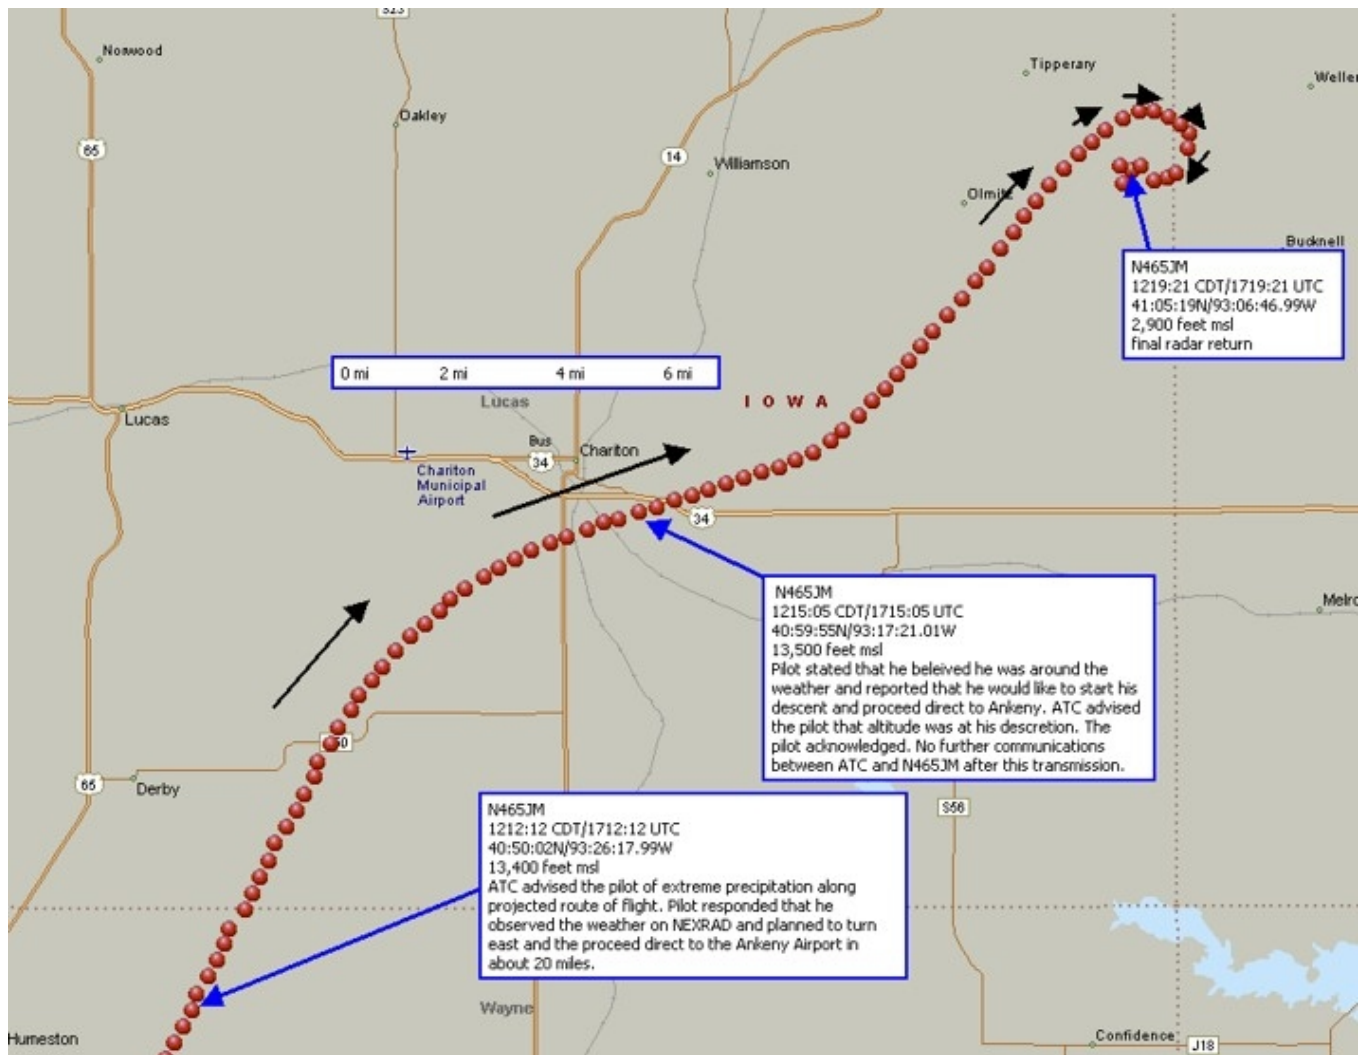
According to radar data and air traffic control communications information from the Federal Aviation Administration (FAA), the pilot was receiving visual flight rules (VFR) flight following from the Chicago Air Route Traffic Control Center (ARTCC) at a cruise altitude of 13,500 ft mean sea level (msl). The pilot had deviated around convective weather earlier in the flight and was proceeding direct to IKV. The controller issued a weather advisory to the pilot about areas of moderate to extreme precipitation along his route, and the pilot responded that he had weather information on the airplane's NEXRAD system. About 3 minutes later, the pilot reported to the controller that he was around the weather and requested to start a descent direct to IKV. The controller responded that the descent altitude was at the pilot's discretion, then instructed the pilot to contact Des Moines Air Traffic Control Tower. The controller received no response from the pilot, and subsequent attempts to contact him were unsuccessful. Radar data showed the airplane making a descending right turn before radar contact was lost (Figure 1). The last radar return showed the airplane about 2,900 ft msl.

Figure 1. The radar flight track of N465JM is indicated by red dots. The direction of flight is indicated by black arrows.

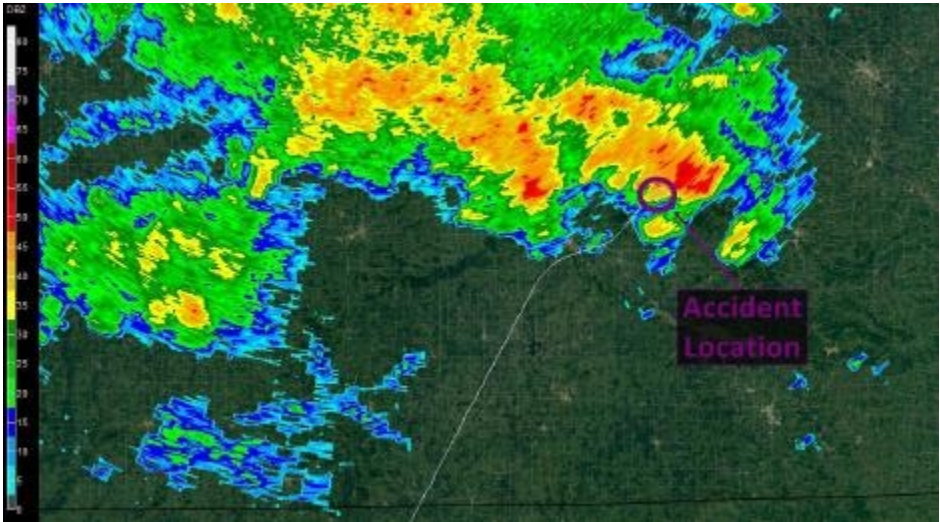
Given the pilot's discussions with ATC during the flight, the pilot was aware of and was trying to avoid convective weather along his route of flight. The airplane most likely would have encountered instrument meteorological conditions (IMC) during the last several minutes of flight. Figure 2 shows the airplane's flight path into storms. Additional details can be found in the weather study in the docket.

Figure 2. Level-II reflectivity product from a sweep initiated at 1223:06 CDT. Accident flight path through the accident time denoted by white line with accident location marked.

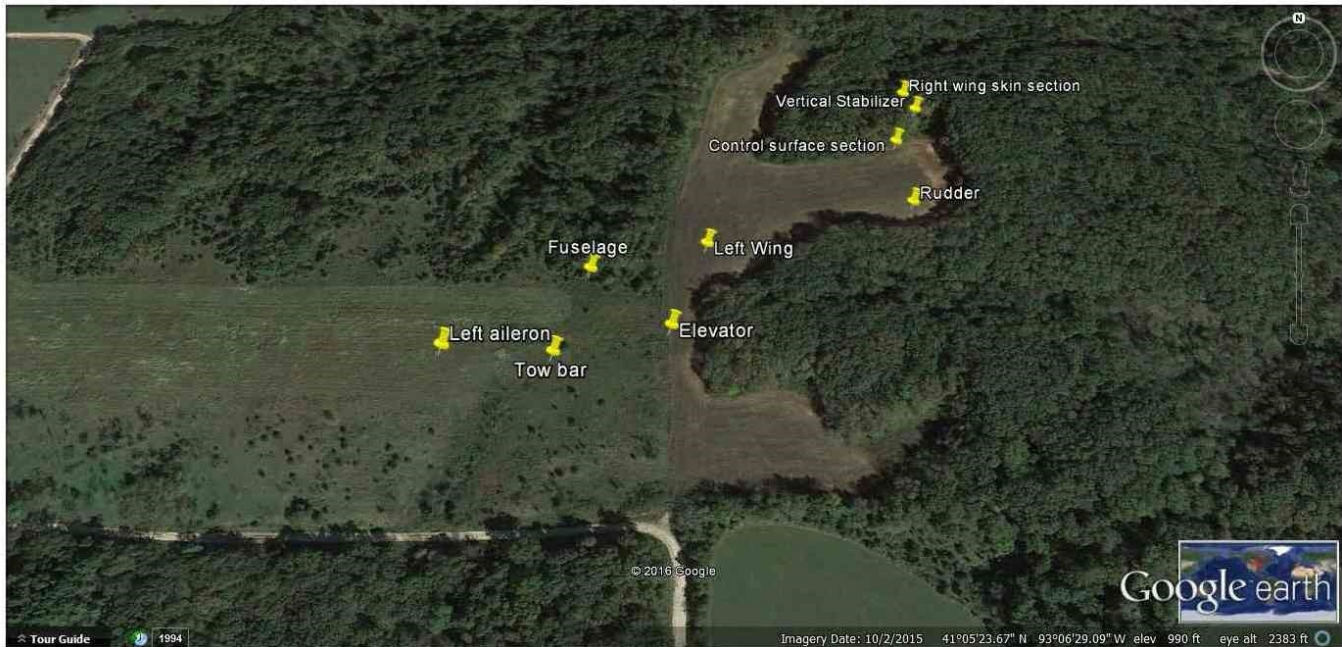
Figure 3. Wreckage Distribution

The airplane impacted a mature corn field, and components of the wings and empennage were scattered along a path about 1/4-mile long (see figure 3). The main wreckage (cabin and fuselage) came to rest along a stand of trees adjacent to the corn field. The distribution of the wreckage was consistent with an in-flight breakup.
