Aviation Investigation Final Report

Location:	Hydaburg, Alaska	Accident Number:	ANC18FA053
Date & Time:	July 10, 2018, 08:35 Local	Registration:	N3952B
Aircraft:	De Havilland DHC 3	Aircraft Damage:	Substantial
Defining Event:	Loss of visual reference	Injuries:	6 Serious, 4 Minor, 1 None
Flight Conducted Under:	Part 135: Air taxi & commuter - Non-scheduled

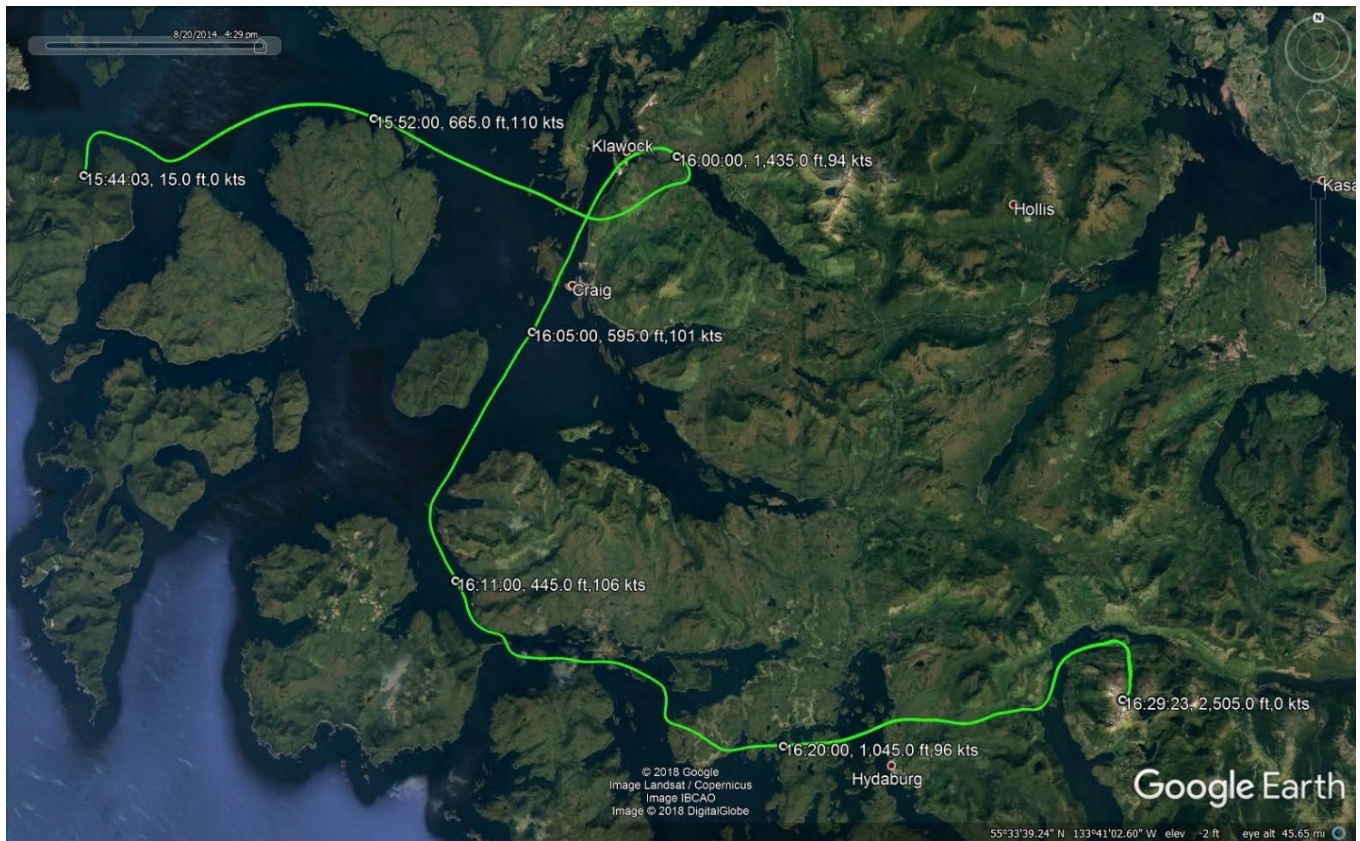
Figure 1. Google Earth overlay of the entire accident flight on July 10, 2018. Indicated airspeed (IAS) values are shown.
