Aviation Investigation Final Report

Location:	Rainy Pass, Alaska	Accident Number:	CEN18FA386
Date & Time:	September 24, 2018, 10:32 Local	Registration:	N1738R
Aircraft:	Cessna U206	Aircraft Damage:	Destroyed
Defining Event:	Controlled flight into terr/obj (CFIT)	Injuries:	1 Fatal
Flight Conducted Under:	Part 135: Air taxi & commuter - Non-scheduled

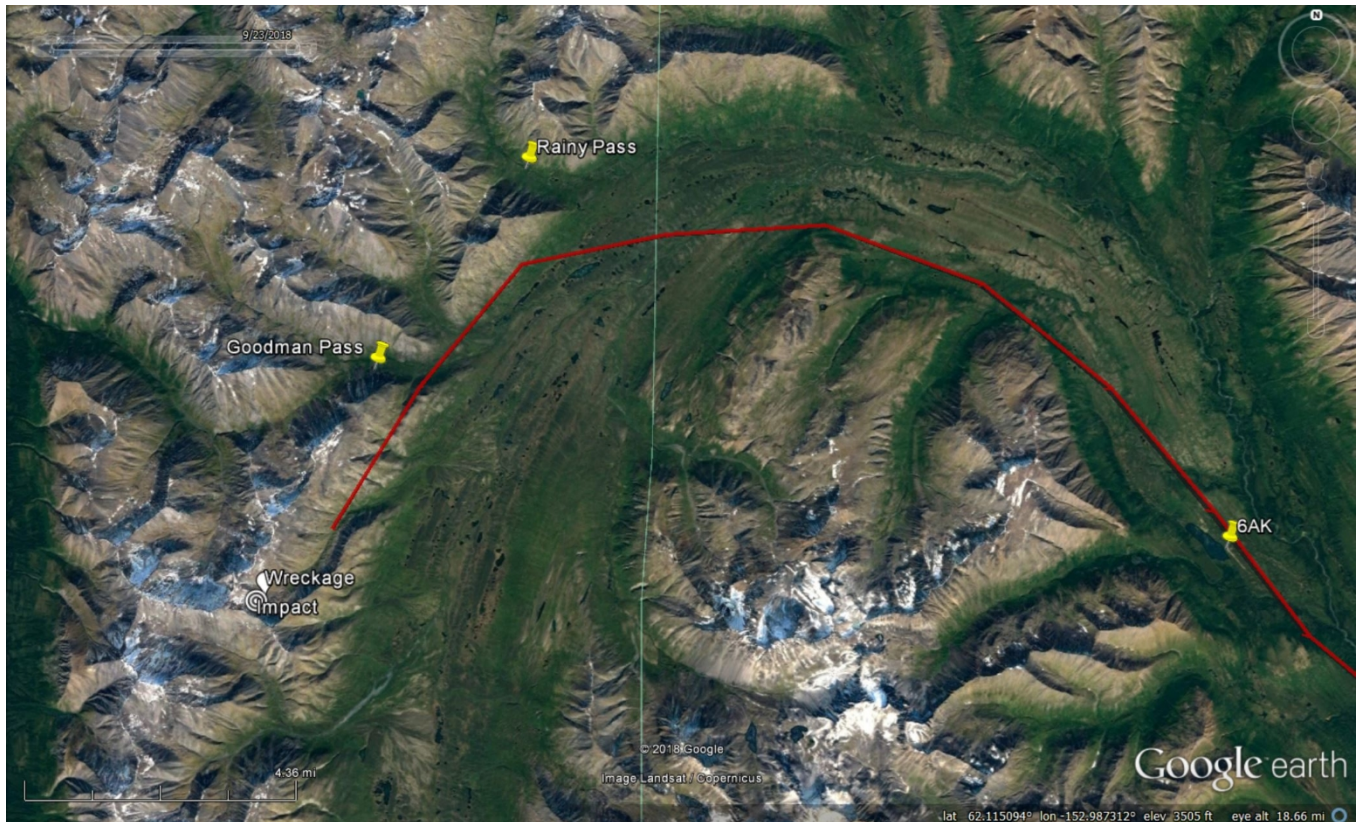
Figure 1 – Flight track from Spidertracks

The operator was tracking the airplane's flight path using Spidertracks (figure 1) and noticed that the track stopped at 1031. A review of the Spidertracks flight data revealed that the airplane changed altitude multiple times, descending as low as 450 ft above ground level (agl) at some points. During the final 7 minutes of the flight the airplane's altitude was between 1,400 ft and 1,900 ft agl, with the final recorded point at 1,000 ft agl and descending. About 30 minutes after the track stopped and the operator was unable to contact the pilot, an Alert Notice was issued for the missing airplane, and the Alaska Air National Guard conducted an aerial search mission to locate the airplane. The wreckage was discovered near the end of a mountain valley on a steep mountain side about 3.5 miles southwest of the mouth of Goodman Pass and next to a box canyon.

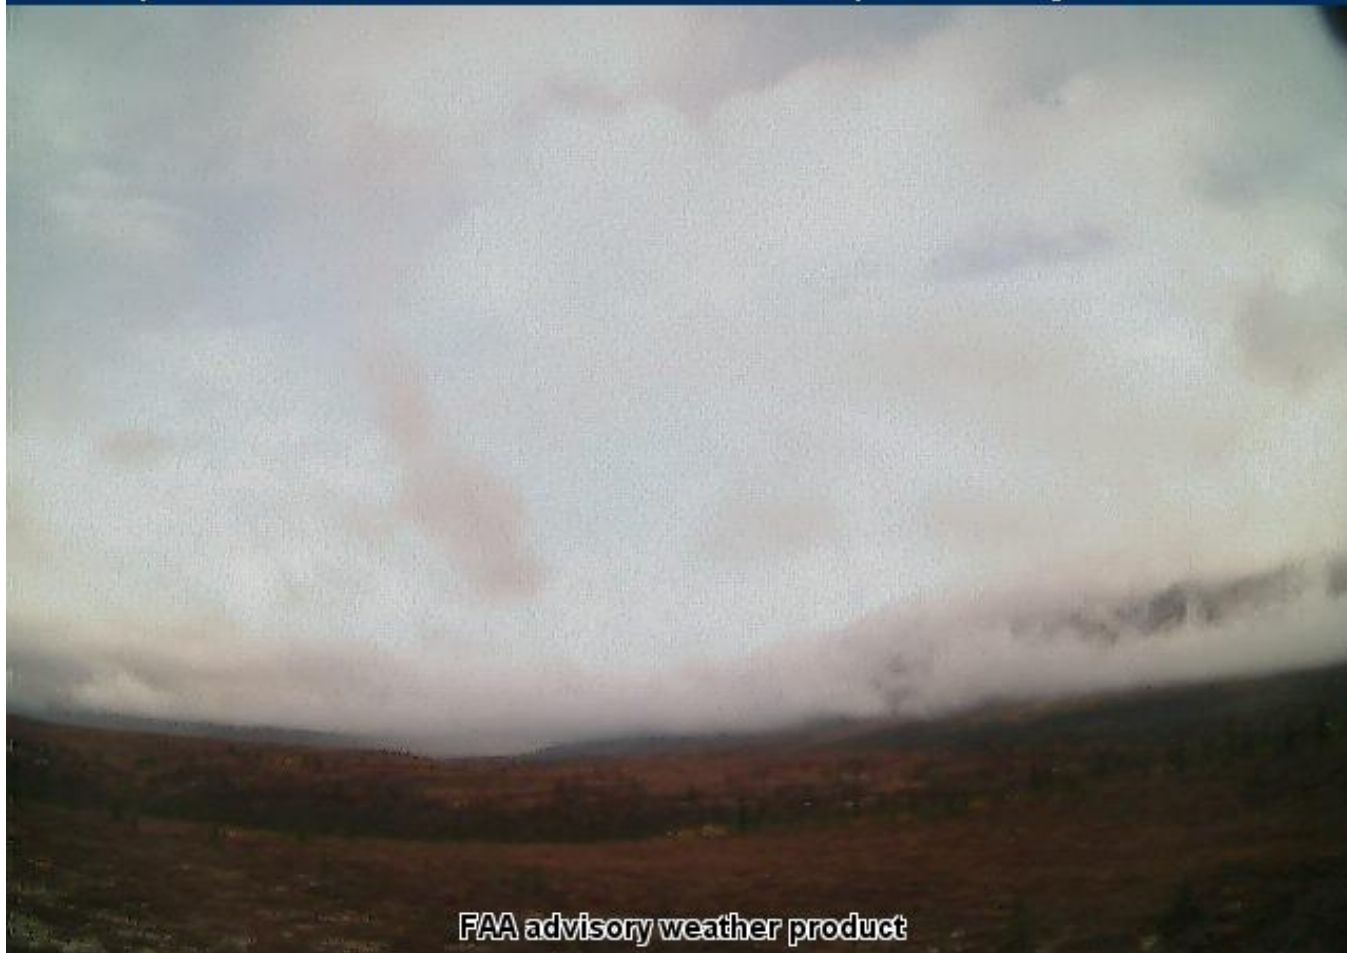
Figure 2 – Facing north at 1017 AKDT

Figures 2 and 3 are images from the cameras near 6AK that depict low layers of stratocumulus clouds surrounding 6AK around the accident time.

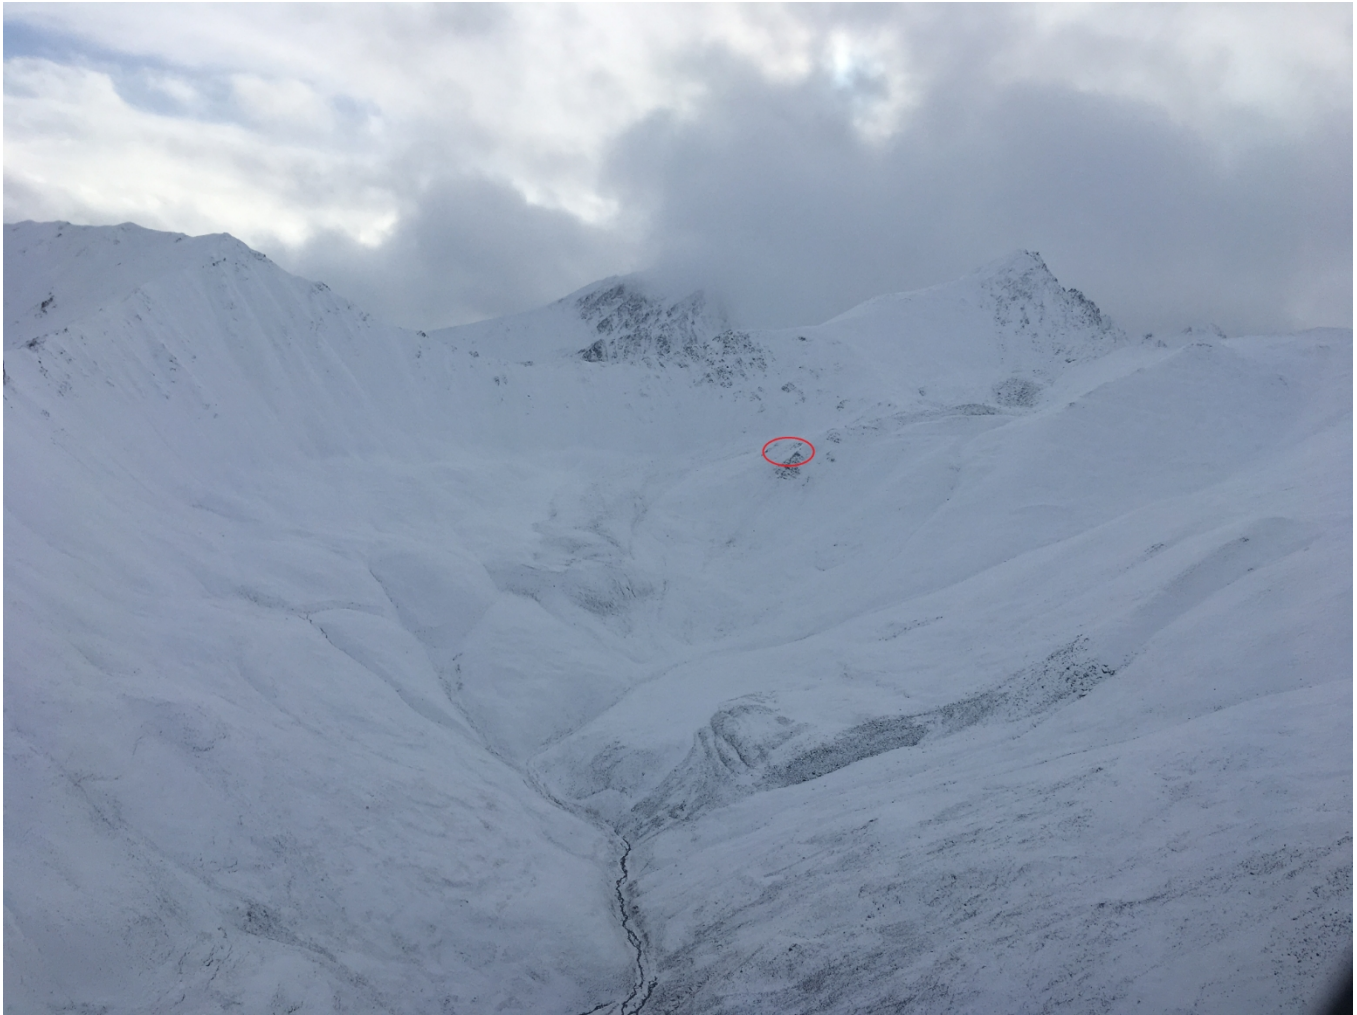
identified by the propeller assembly and cockpit debris, was located about 4,700 ft msl. Figure 4 shows a photo from about the same altitude and heading as the accident airplane's final Spidertracks point, which faces south into the box canyon. The figure shows the initial impact area circled in red. The mountain tops at the back of the box canyon were about 5,000 ft mean sea level.

Figure 4 – Accident location facing south, impact area circled in red
