# Aviation Investigation Final Report

<b>Location:</b>	Watkins, Colorado	<b>Accident Number:</b>	CEN17LA220
<b>Date &amp; Time:</b>	June 8, 2017, 13:40 Local	<b>Registration:</b>	N7328V
<b>Aircraft:</b>	Bellanca 17 30	<b>Aircraft Damage:</b>	Substantial
<b>Defining Event:</b>	Fuel starvation	<b>Injuries:</b>	2 Serious
<b>Flight Conducted Under:</b>	Part 91: General aviation - Personal

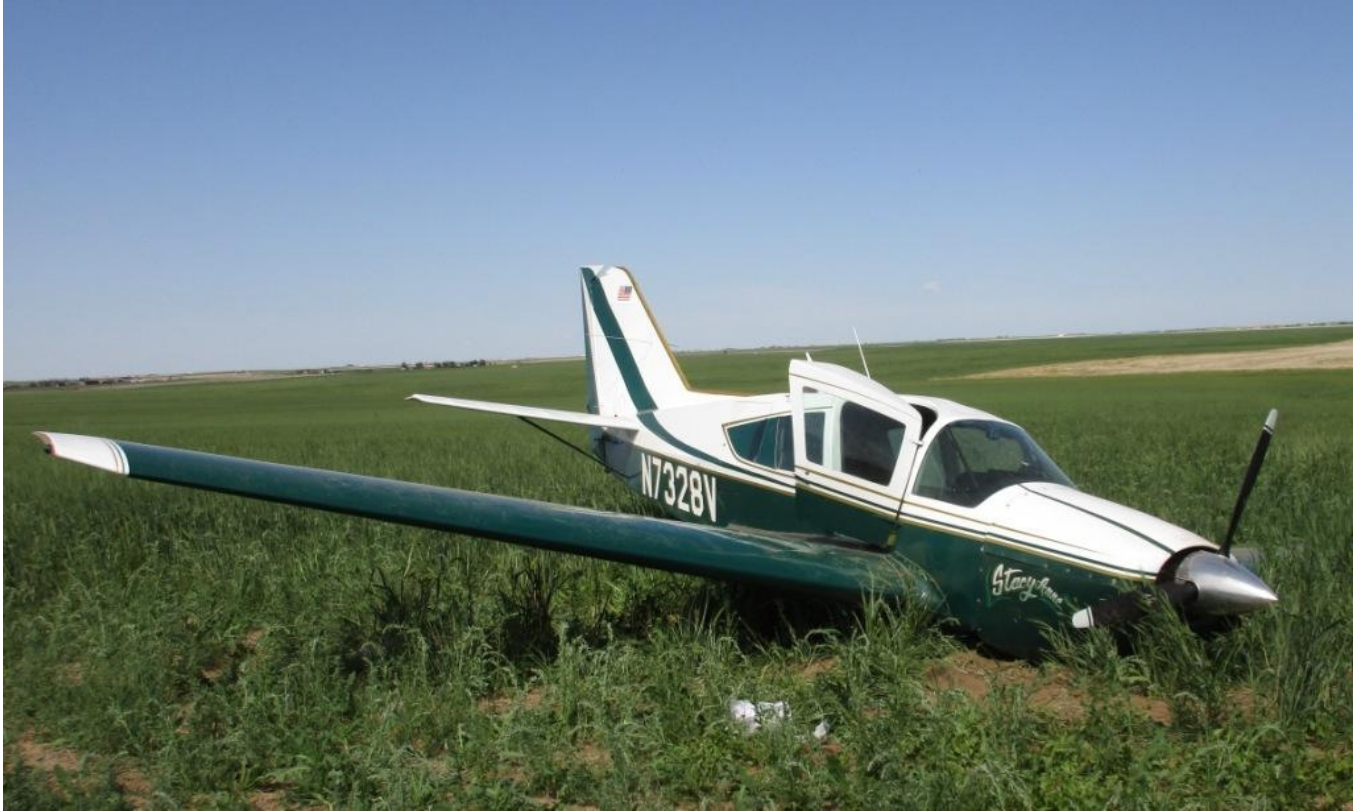
Figure 1 – Accident airplane

The pilot reported that he and the passenger planned to conduct touch-and-go landings at FTG. He added that the main fuel tanks were full before takeoff and he began the flight with the left fuel tank selected. After performing an unknown number of landings, he reportedly switched from the left to the right fuel tank, while in the traffic pattern. He completed one more touch-and-go landing and the engine experienced a loss of power on the on the upwind leg of the traffic pattern. The engine did not show signs of a problem before the loss of power and the fuel gauge indicated full during the entire flight. He reportedly switched back to the left tank and was unable to restart the engine. During the forced landing the airplane impacted a ditch and came to rest upright (figure 1).

A postaccident examination of the airplane by the responding Federal Aviation Administration inspector revealed damage to the airplane's firewall. The fuel selector was positioned to left main fuel tank. The two auxiliary tanks contained fuel to the top of the tanks at the fuel filler port. The right wing was slightly elevated at the accident sight and an undetermined amount of fuel was clearly visible from the right main fuel tank filler port. During the recovery process, left main fuel tank was empty and the other 3 fuel tanks contained about 45 gallons of fuel combined.
