Aviation Investigation Final Report

Location:	Falcon, Colorado	Accident Number:	CEN18LA348
Date & Time:	August 23, 2018, 12:54 Local	Registration:	N2880W
Aircraft:	Piper PA32R	Aircraft Damage:	Substantial
Defining Event:	Loss of engine power (total)	Injuries:	2 None
Flight Conducted Under:	Part 91: General aviation - Personal

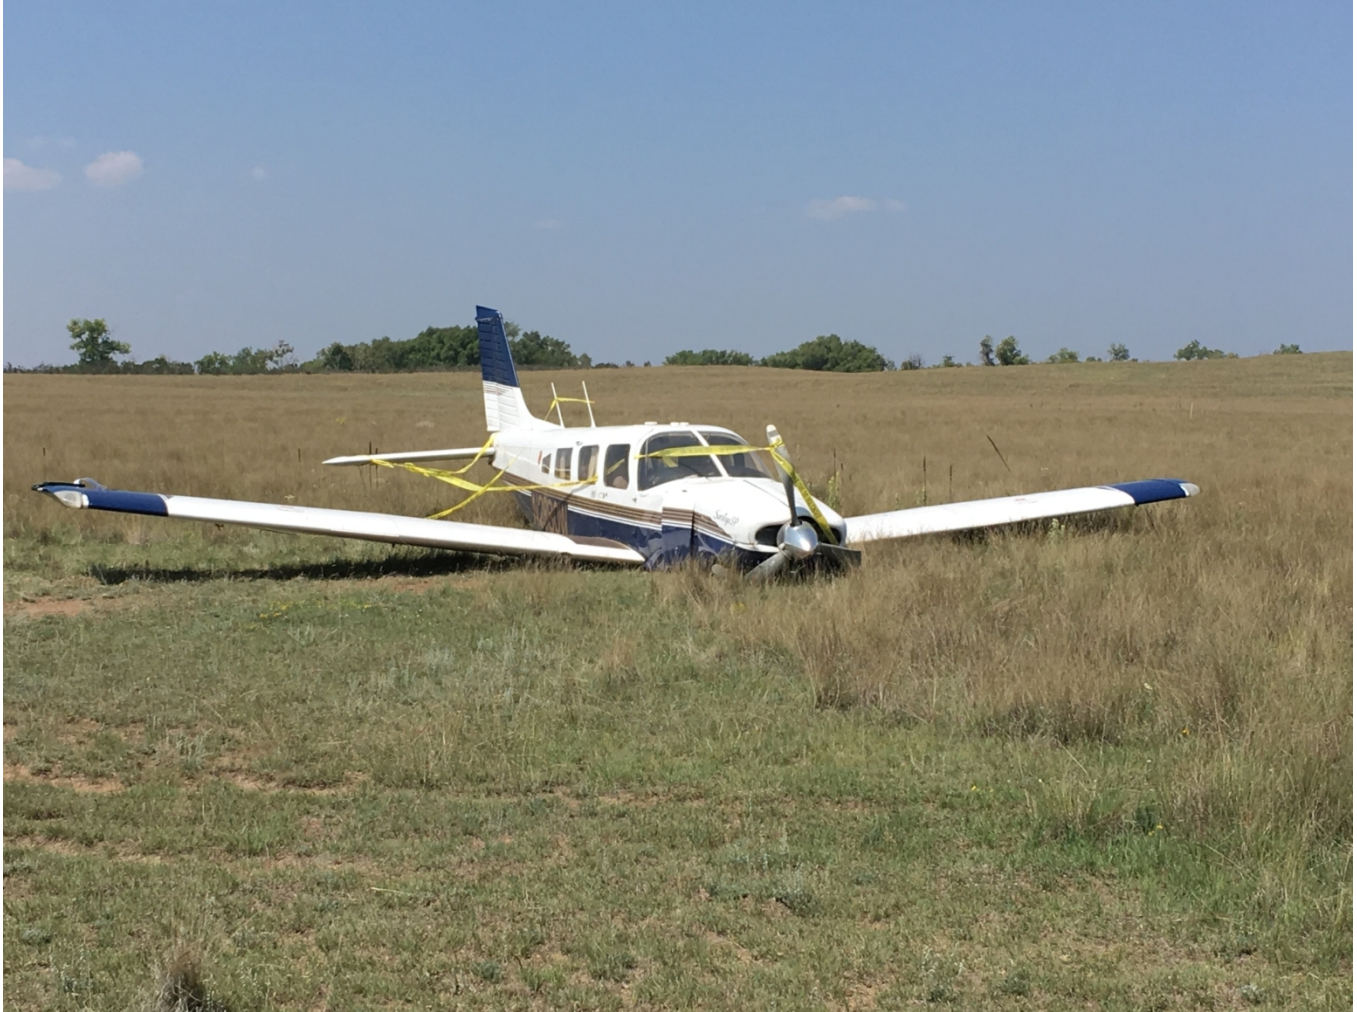
After the accident, the pilot stated that he had flown the airplane from EST to FLY earlier that day and planned to return to EST. During the preflight engine runup and magneto check, the engine was running rough so he taxied the airplane to a maintenance facility at FLY to troubleshoot the issue. The pilot stated that the mechanic checked the magnetos and disconnected a P-lead wire. The mechanic provided information about how the pilot should set the airplane's fuel mixture at a high elevation airport. The pilot completed another engine runup and set the fuel mixture according to the mechanic's instructions, then taxied to the runway for a "mock" takeoff roll to see if the engine was capable of producing takeoff power, which he reported was completed successfully. The pilot then taxied the airplane back to the mechanic and completed one final fuel mixture adjustment to reach full engine power at 2,700 rpm. The pilot then taxied back to the runway and began the takeoff roll; the airplane rotated for takeoff at 76 knots and 10° of flaps were extended. After climbing through 100 ft above ground level (agl), the engine experienced a loss of power and was unable to maintain altitude. The pilot stated that the stall warning horn was sounding so he lowered the nose to increase airspeed, then made a forced landing into a field straight ahead; the airplane stalled and then impacted the ground (figure 1).

Figure 1 – Airplane came to rest in an open field
