Aviation Investigation Final Report

Location:	Austin, Arkansas	Accident Number:	CEN18FA389
Date & Time:	September 26, 2018, 14:42 Local	Registration:	N534MM
Aircraft:	Vans RV 4	Aircraft Damage:	Substantial
Defining Event:	Aerodynamic stall/spin	Injuries:	1 Fatal
Flight Conducted Under:	Part 91: General aviation - Personal

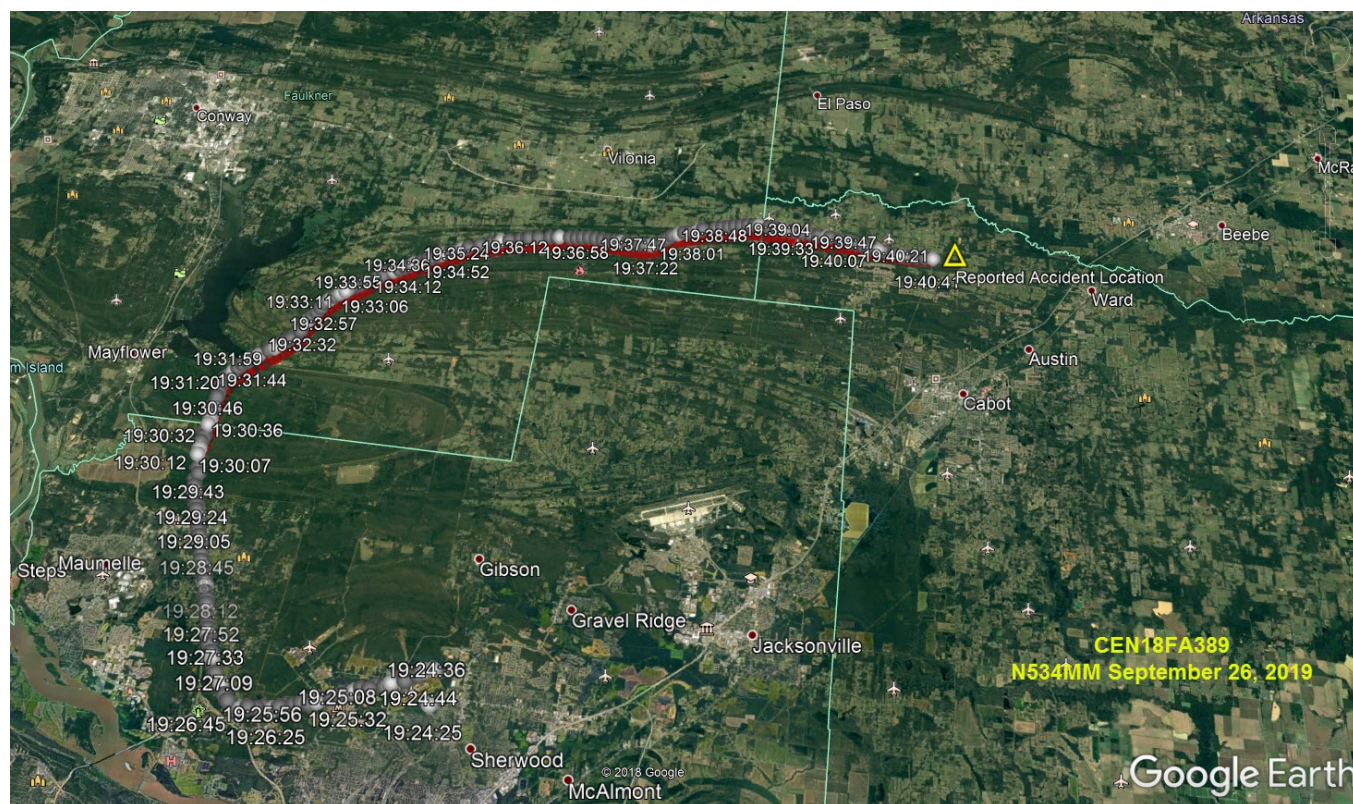
Radar data showed that the airplane departed North Little Rock Municipal Airport (ORK), North Little Rock, Arkansas, about 1424 and flew at an altitude between 2,600 ft and 2,700 ft mean sea level (msl) and a ground speed of between 110 and 120 knots until just west of the pilot's home (see figure 1). The airplane started to descend about 1439 and the ground speed increased to about 145 knots. The last radar location was recorded at 1440:41 about over the pilot's home and the accident site was located in an open field a few hundred feet east of the pilot's home.

Figure 1 - Radar data of accident flight

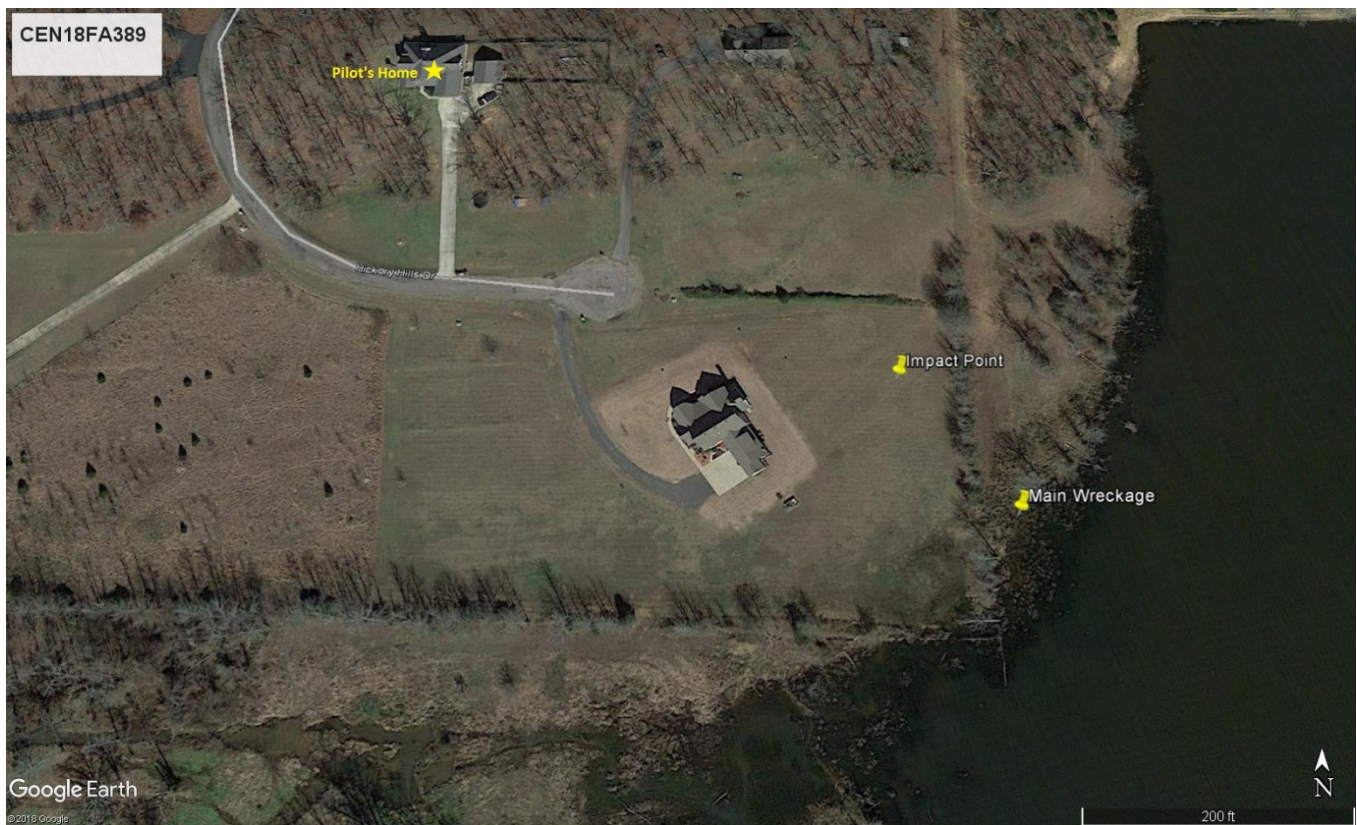
The airplane impacted an open field, vegetated in grass, in a wings-level, nose-low attitude, between 35° and 40° nose down. The main wreckage came to rest about 185 ft south/southeast of the initial impact point oriented on a heading of 323°, on the edge of Rick Lake (see figure 2).

Figure 2: Aerial photograph depicting initial impact point and location of main wreckage
