# Aviation Investigation Final Report

<b>Location:</b>	Ridgefield, Washington	<b>Accident Number:</b>	WPR19FA124
<b>Date &amp; Time:</b>	April 29, 2019, 14:13 Local	<b>Registration:</b>	N90LK
<b>Aircraft:</b>	Vans RV 6	<b>Aircraft Damage:</b>	Substantial
<b>Defining Event:</b>	Loss of control in flight	<b>Injuries:</b>	2 Fatal
<b>Flight Conducted Under:</b>	Part 91: General aviation - Personal

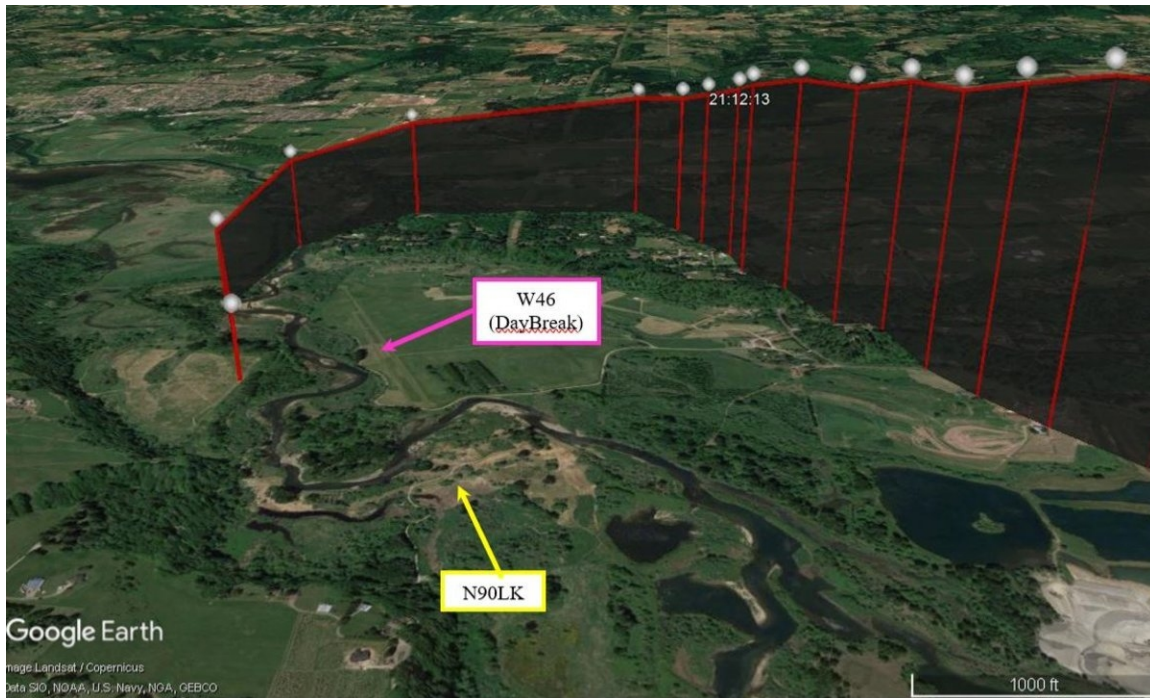
The first radar return with altitude data was recorded at 1404:33 at an altitude of 1,100 ft, about 1/2-mile northeast of Grove Field (1W1), Camas, Washington. The data showed that the airplane was on a northerly heading for about 11 miles before it turned west, directly toward W46. The data showed that the airplane flew parallel to the runway at WA46 at an altitude of 2,500 ft mean sea level (msl). As shown in figure 2, the airplane completed a descending 180° left turn and entered a left downwind for runway 31, where it leveled off at an altitude of about 500 ft above ground level (agl). The final radar target was captured at 1413:42 and depicted the airplane nearly abeam the runway 31 threshold, about 500 ft agl.

Figure 1. View of the last portion of radar data along with the airport location and accident site.
