# Aviation Investigation Final Report

<b>Location:</b>	Cascade, Idaho	<b>Accident Number:</b>	WPR18FA141
<b>Date &amp; Time:</b>	May 13, 2018, 12:30 Local	<b>Registration:</b>	N2377R
<b>Aircraft:</b>	Cessna 182G	<b>Aircraft Damage:</b>	Destroyed
<b>Defining Event:</b>	Controlled flight into terr/obj (CFIT)	<b>Injuries:</b>	1 Fatal
<b>Flight Conducted Under:</b>	Part 91: General aviation - Personal

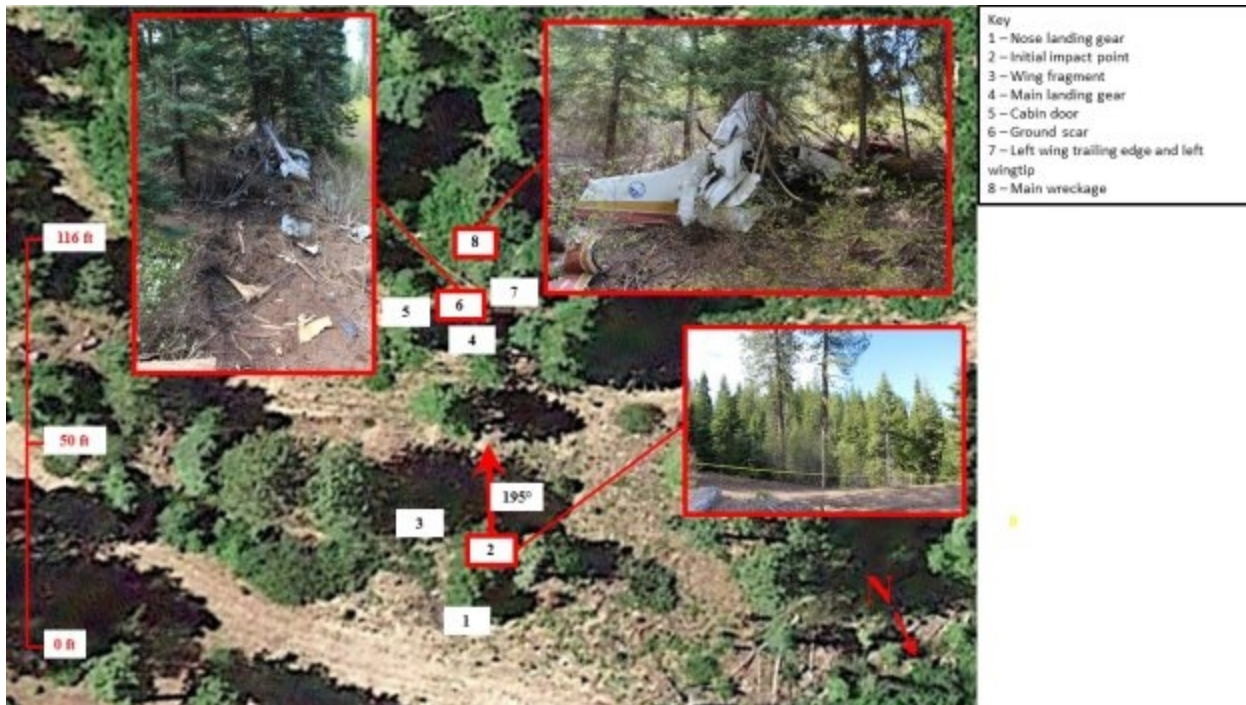
*Figure 1: Wreckage Diagram*

The airplane debris path was located in a wooded area about 41 nm north of BOI and was oriented on a 195° magnetic heading. All major structures of the airplane were accounted for at the accident site, as shown in figure 1. The initial impact point (IIP) was identified by two scars located about halfway up a 70-ft tree. The terrain elevation of the IIP was about 5,800 ft msl. The nose landing gear was located at the base of the tree, and wing fragments were distributed along the wreckage path. A large ground scar was located about 50 ft forward of the IIP in the debris path. The main wreckage comprised the empennage, right wing, main cabin, and engine and was located about 110 ft forward of the IIP. The empennage was vertically oriented and at rest against the right wing, which was beneath a portion of the cabin and instrument panel. The left wing was found in the debris path.
