Aviation Investigation Final Report

Location:	San Francisco, California	Incident Number:	OPS17IA014
Date & Time:	February 15, 2017, 20:00 Local	Registration:	N214NN (A1); N627VA (A2)
Aircraft:	EMBRAER S A ERJ 170-200 LR (A1); Airbus A320 (A2)	Aircraft Damage:	None (A1); None (A2)
Defining Event:	Air traffic event	Injuries:	N/A (A1); N/A (A2)
Flight Conducted Under:	Part 121: Air carrier - Scheduled (A1); Part 121: Air carrier - Scheduled (A2)

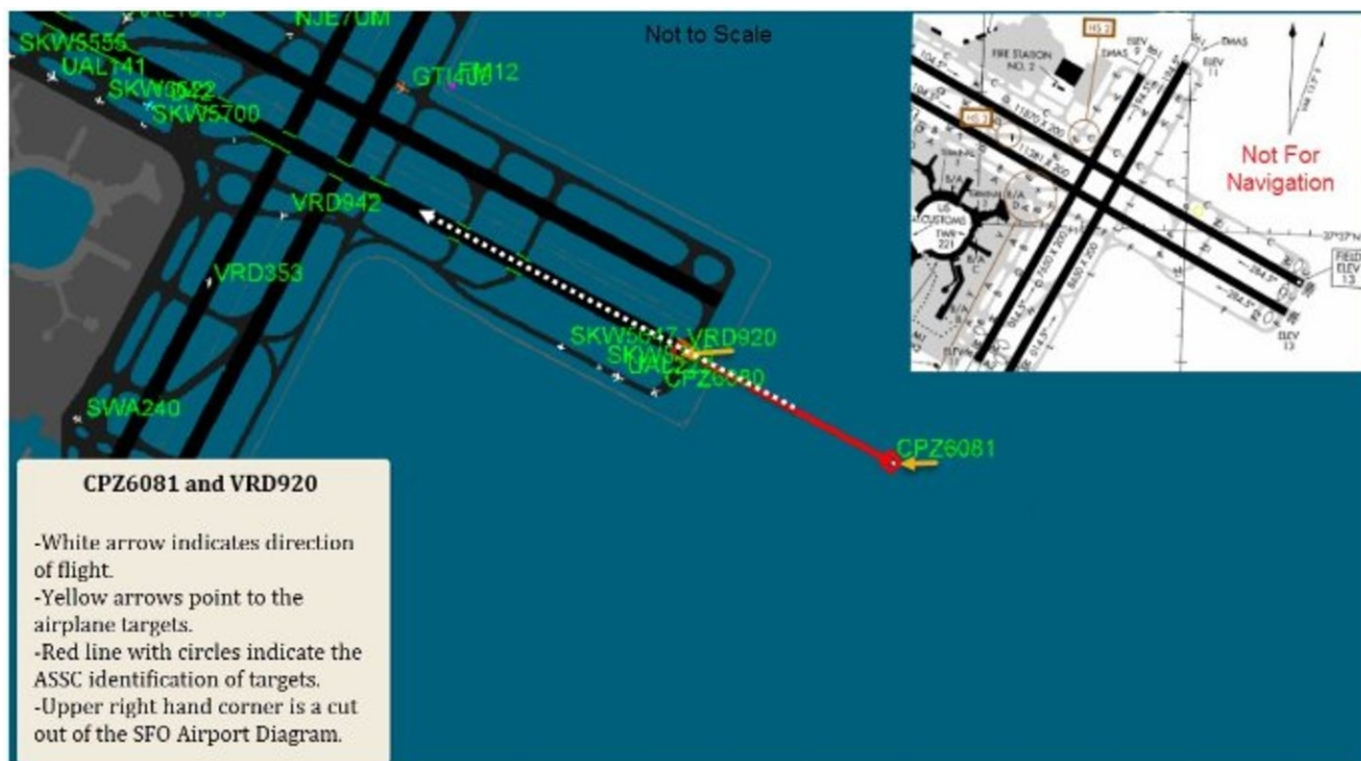
The airport surface surveillance capability (ASSC) system functioned as designed and produced the appropriate alert when CPZ6081 was approximately .85 nautical mile final runway 28L. The local controller took timely and appropriate action when the ASSC alerted and issued go-around instruction to CPZ6081; the pilot adhered to the go-around instruction.

At 2000:13, the airport surface surveillance capability (ASSC) system display in SFO ATCT generated an aural and visual alert indicating a conflict between CPZ6081 and VRD920. FAA radar and ASSC data indicated that CPZ6081 was about .85 mile from the runway 28L threshold and at 500 feet, and VRD920 was in LUAW runway 28L.

Six seconds after the ASSC alert was generated the local controller instructed the pilot of CPZ6081 to "go around." The pilot acknowledged, "go around, go around." ASSC data indicated CPZ6081 was approximately .56 mile from the runway threshold and at 300 feet at the time the local controller issued

Figure 1. ASSC display screenshot illustrating the position of VRD920 and CPZ6081 when the SFO local controller issued go around instructions.
