# Aviation Investigation Final Report

<b>Location:</b>	New Albany, Mississippi	<b>Accident Number:</b>	CEN19FA119
<b>Date &amp; Time:</b>	April 13, 2019, 15:14 Local	<b>Registration:</b>	N265DS
<b>Aircraft:</b>	Rockwell International NA-265-65	<b>Aircraft Damage:</b>	Destroyed
<b>Defining Event:</b>	Electrical system malf/failure	<b>Injuries:</b>	3 Fatal
<b>Flight Conducted Under:</b>	Part 91: General aviation - Personal

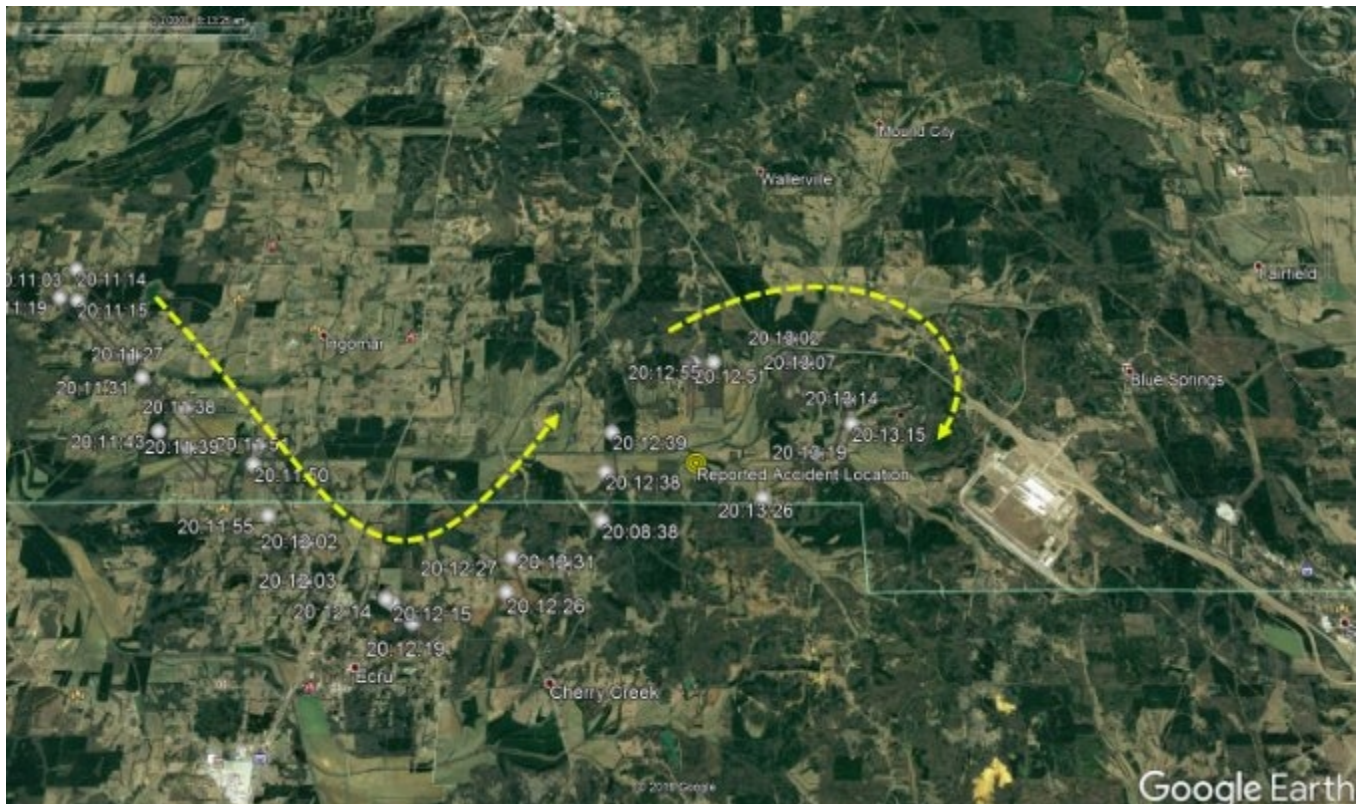
Figure 1 - Radar Track (All times in UTC)

From 1506 to 1510, the airplane maintained an approximate heading of 080°. At 1510, the airplane turned right to a heading of 120°, and at 1512, the airplane made a left turn to a heading of 040°.

current] voltage problems." The last radio call received from the flight was an acknowledgement of a heading assignment to 095° at 1513. The airplane disappeared from radar about 30 seconds later and the controller tried unsuccessfully to raise the flight on the radio at that time. Radar data showed the airplane began a right turn at 1513 that continued to a heading of about 270° until radar contact was lost at 1513:26. The final radar return was about 1/2 mile southeast of the accident location. See figure 1.
