Aviation Investigation Final Report

Location:	Fillmore, California	Accident Number:	WPR19LA016
Date & Time:	October 27, 2018, 10:45 Local	Registration:	N6834R
Aircraft:	Cessna T210	Aircraft Damage:	Substantial
Defining Event:	Loss of engine power (total)	Injuries:	2 Minor
Flight Conducted Under:	Part 91: General aviation - Personal

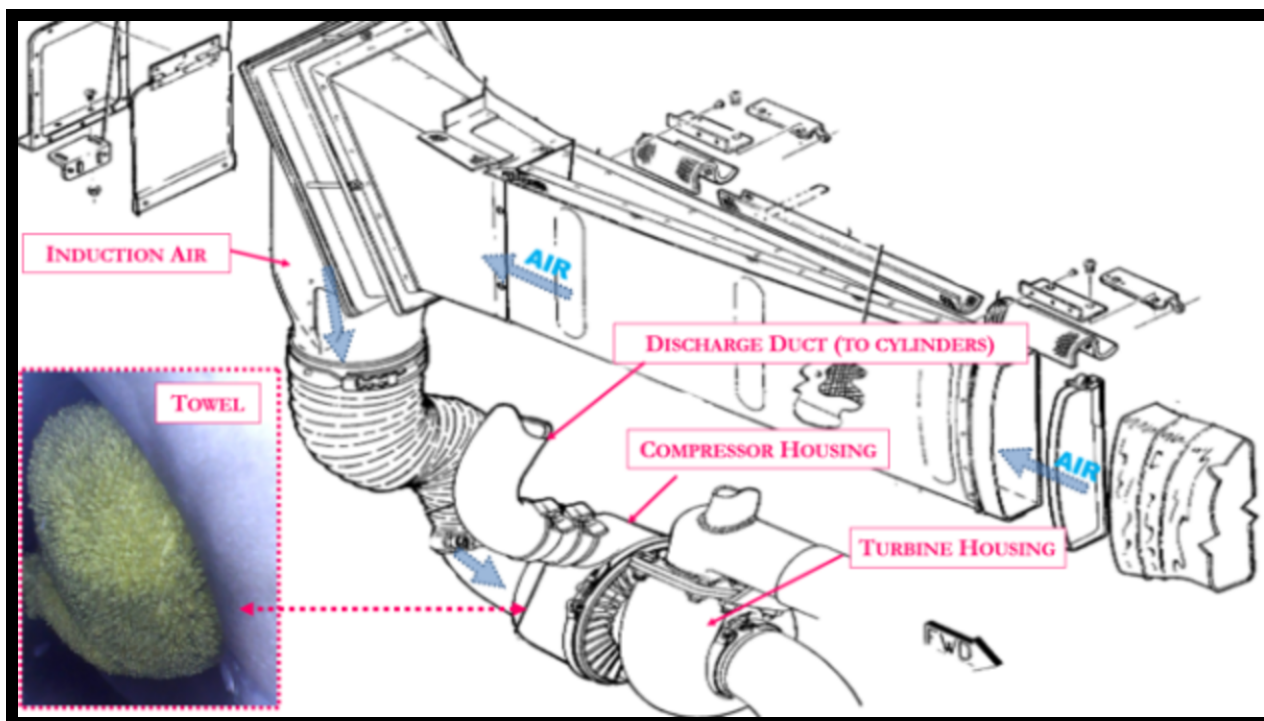
Examination revealed a cloth towel blocking the turbocharger inlet tube that had become entangled with the turbocharger compressor wheel. The towel likely blocked the inlet air from reaching the cylinders, which resulted in a loss of engine power. The pilot stated that during the last oil change, about 34 flight hours before the accident, he removed the airbox and placed a towel in the inlet scat tubing (not disconnected) in an effort to protect the turbocharger from foreign object damage.

A total loss of engine power as a result of the pilot's failure to remove a towel from the engine's air induction following maintenance.

The turbocharger compressor outlet pipe/hoses (discharge duct) were disassembled, and oil was present in the conduit. The rubber connector nearest the turbo compressor inlet was removed and a lighted electronic borescope was used to inspect the inlet tube. A yellow terry cloth towel (rag) was discovered blocking the turbo inlet tube and the towel had become entangled with the turbo charger compressor wheel. (see Figure 1.)

Figure 1: Turbocharger System (showing towel blocking inlet)

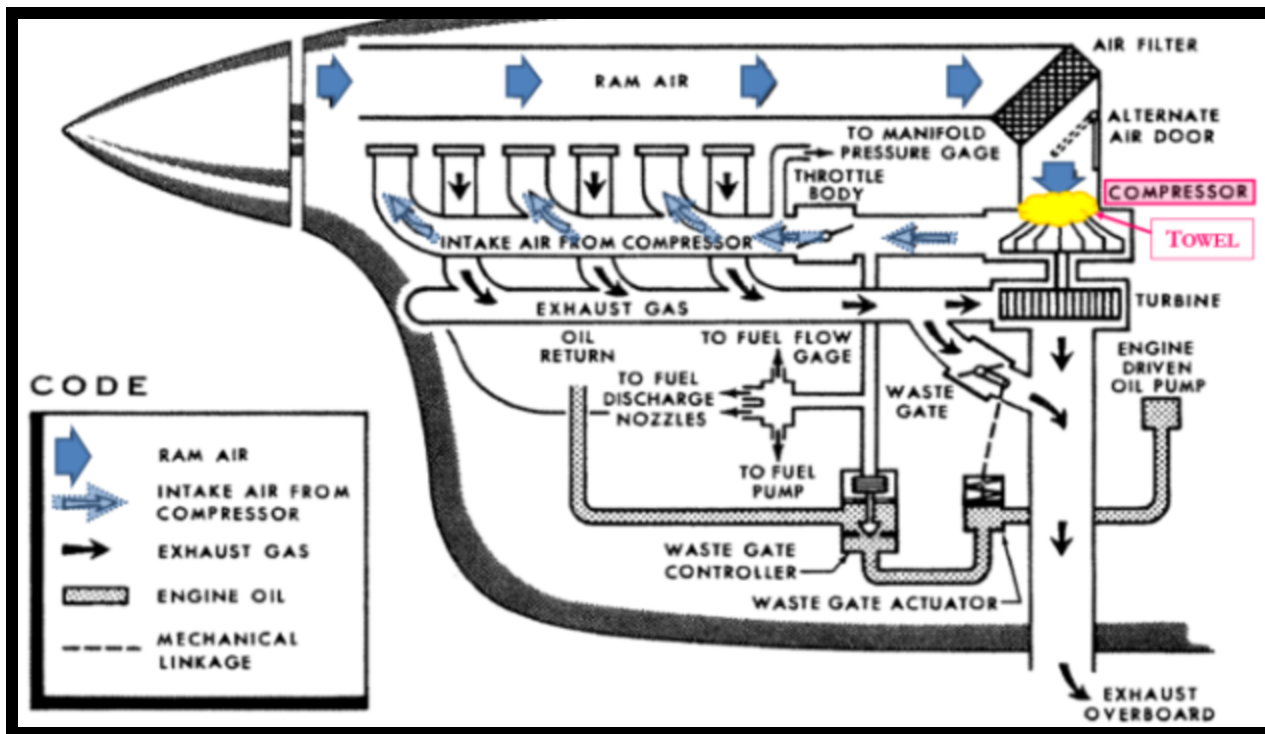
The compressor wheel was damaged, and several blades were distorted. After the towel was removed, the compressor wheel was free to rotate. When the turbocharger was unable to rotate normally, the ring seals which are used to seal the turbocharger shaft (between the compressor and turbine wheel) will allow oil to escape the shaft bearing area and enter the compressor section. If the airplane is inverted, the oil could migrate through the discharge duct to the upper deck pressure plumbing to the fuel injectors. From injectors the oil could build in the cylinders and, when inverted, drain into the fuel manifold. Additionally, with the induction tube blocked, no ram air would enter the cylinders. (see Figure 2.)

Figure 2: Turbocharger System (showing towel blocking inlet)

The oil filter displayed a date of June 8, 2018. The pilot stated that the airplane had accrued about 34 hours since the oil change. He stated that to access the oil filter, he removed the airbox and placed a towel in the scat tubing (not disconnected) in an effort to protect the turbocharger from foreign object damage.
