Aviation Investigation Final Report

Location:	Mineral Wells, Texas	Accident Number:	CEN19LA133
Date & Time:	May 2, 2019, 17:02 Local	Registration:	N8160C
Aircraft:	Cirrus SR20	Aircraft Damage:	Substantial
Defining Event:	Part(s) separation from AC	Injuries:	2 None
Flight Conducted Under:	Part 91: General aviation - Personal

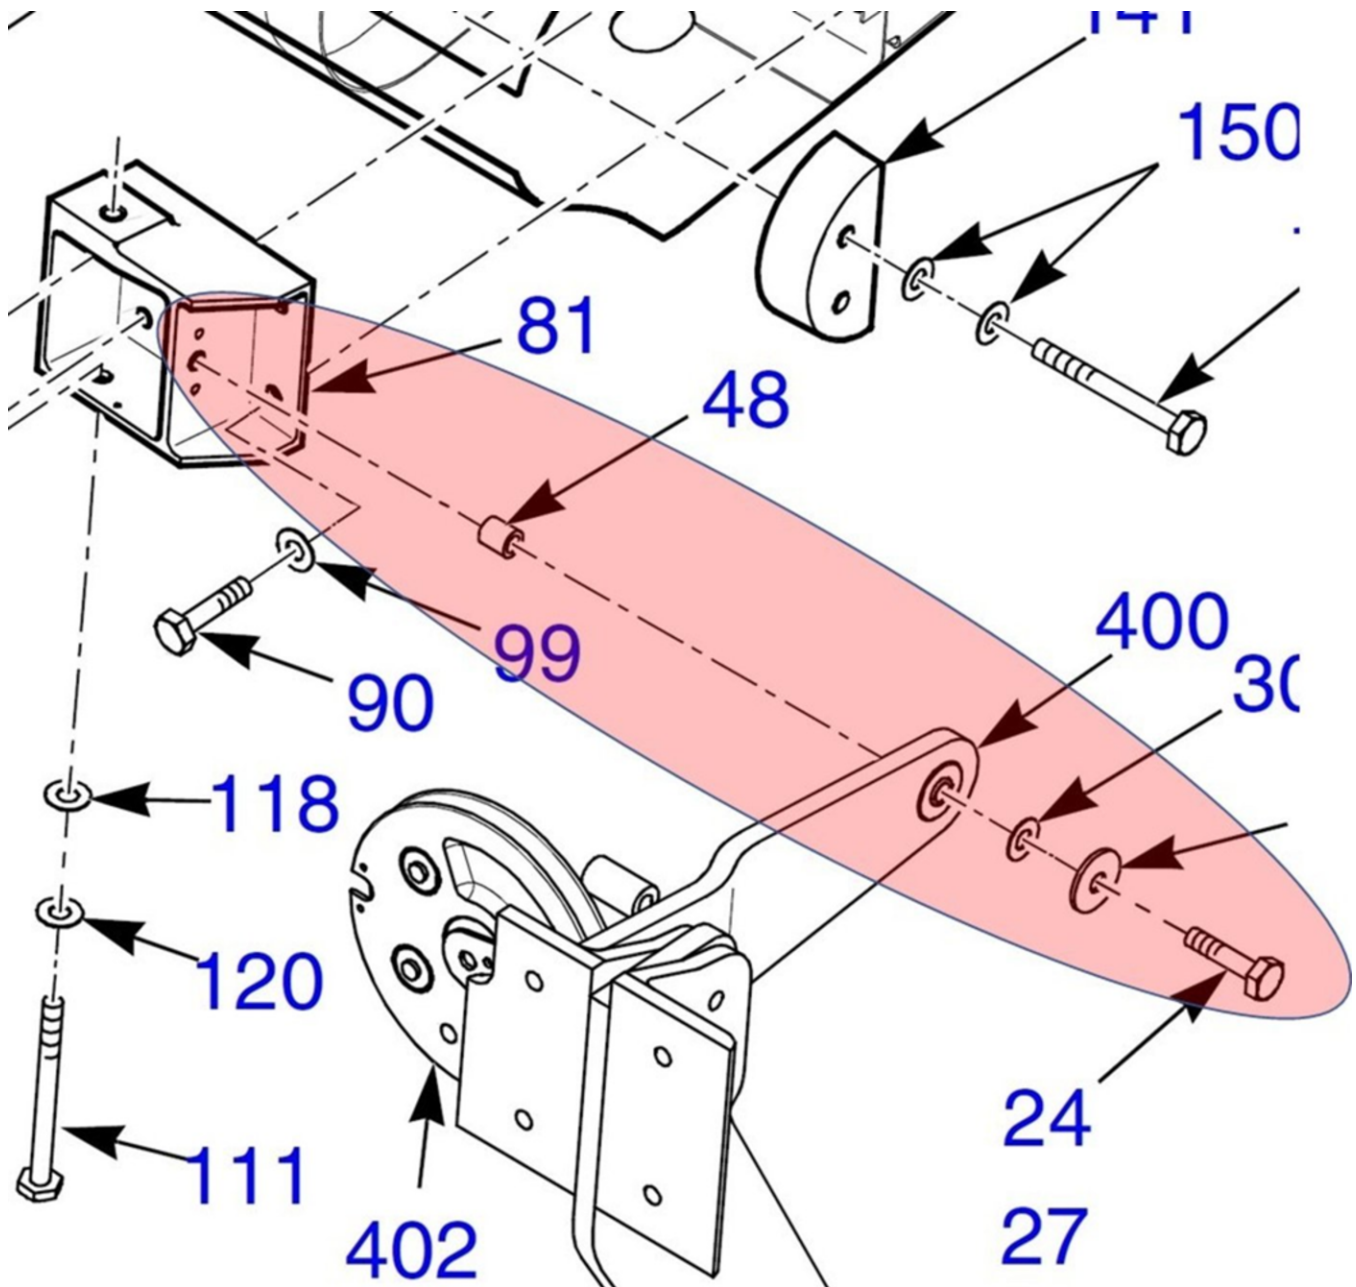
According to the Cirrus SR20 illustrated parts catalog, the right aileron is attached to the wing by two bolts installed through inboard and outboard hinge supports, which are attached to the wing rear spar. Each hinge bolt passes through a bearing housed in its respective hinge support and is threaded into a nut plate that is riveted to an attachment bracket, which is bolted to the aileron spar (see figure 1). According to the Cirrus SR20 maintenance manual, the inboard and outboard hinge bolt assemblies are torqued between 20 and 25 inch-pounds when fully seated. Each hinge bolt head is safety wired to a tab that is riveted to the aileron.

Figure 1. Right aileron inboard hinge assembly.

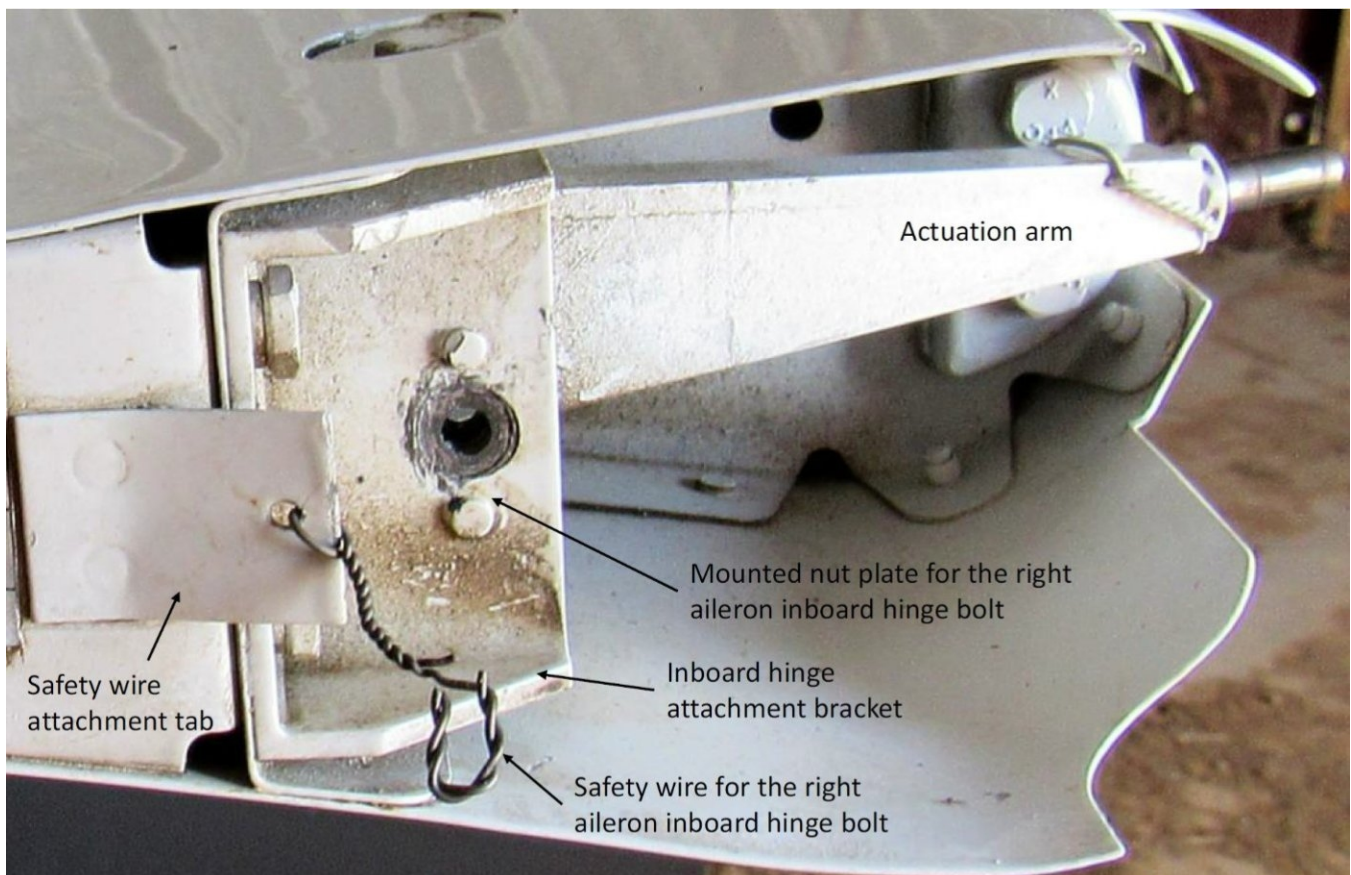
The right aileron was found in one piece along the final approach path to runway 31 in a wooded area about ½ mile from the approach end of the runway. The outboard attachment point was embedded with grass and mud, and the outboard trailing edge corner was bent. The remaining surfaces of the aileron were relatively straight with minor scratches. Figure 2 shows that the inboard attachment bracket remained bolted to the aileron spar and appeared undamaged, the nut plate remained riveted to the bracket, the inboard safety wire tab remained riveted to the aileron, and twisted safety wire was attached to its tab.

Figure 2. Right aileron inboard attachment bracket and safety wire with riveted tab.

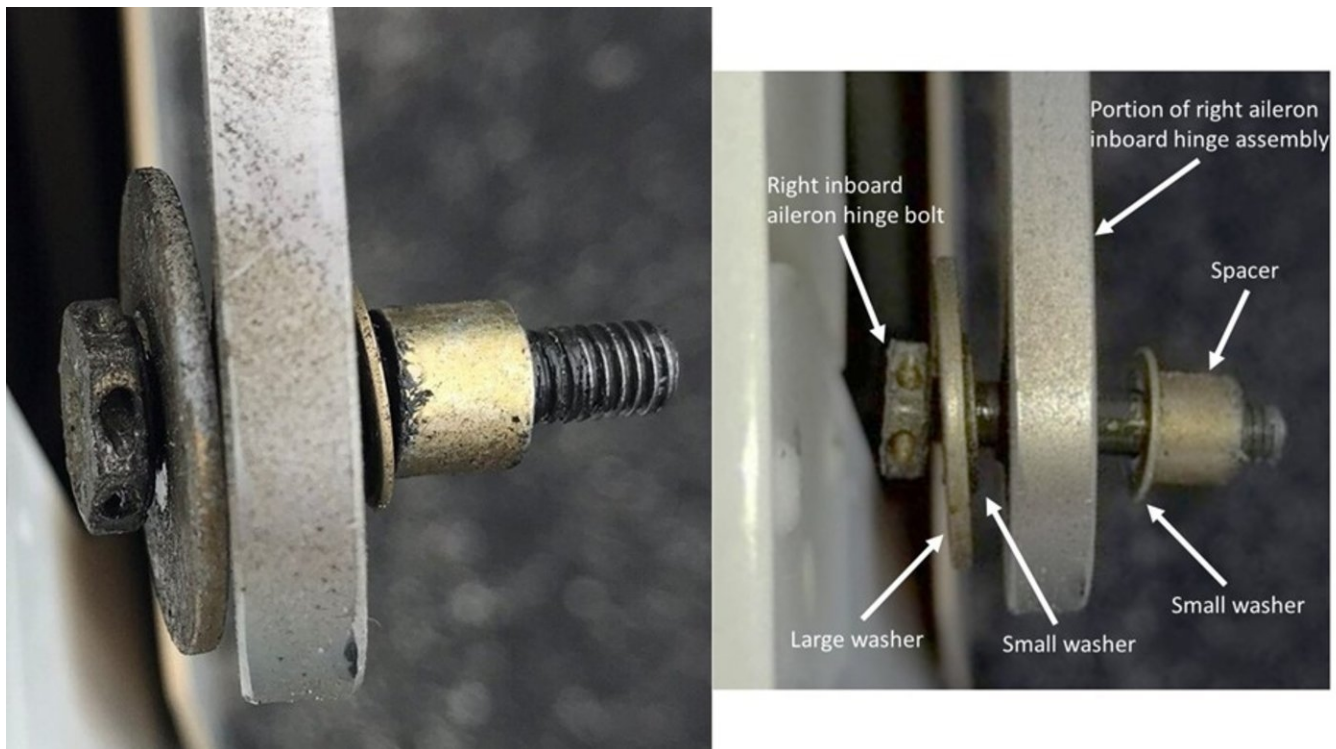
The airplane's right aileron inboard hinge assembly consisted of a bolt (NAS6203-11H) with one large washer (MS63040-3), two small washers (NAS1149F0332P), and a spacer (see figure 3). Although the Cirrus SR20 illustrated parts catalog specified an NAS6203-9H or NAS6203-10H hinge bolt for the assembly, there was ample space behind the nut plate to accommodate the longer NAS6203-11H hinge bolt. Additionally, the assembly should have had only one small washer instead of two; (NAS1149F0332P) in addition to the large washer and spacer. The additional small washer had been installed between the bearing and the spacer.

Figure 3. Right aileron inboard hinge bolt with associated washers and spacer.

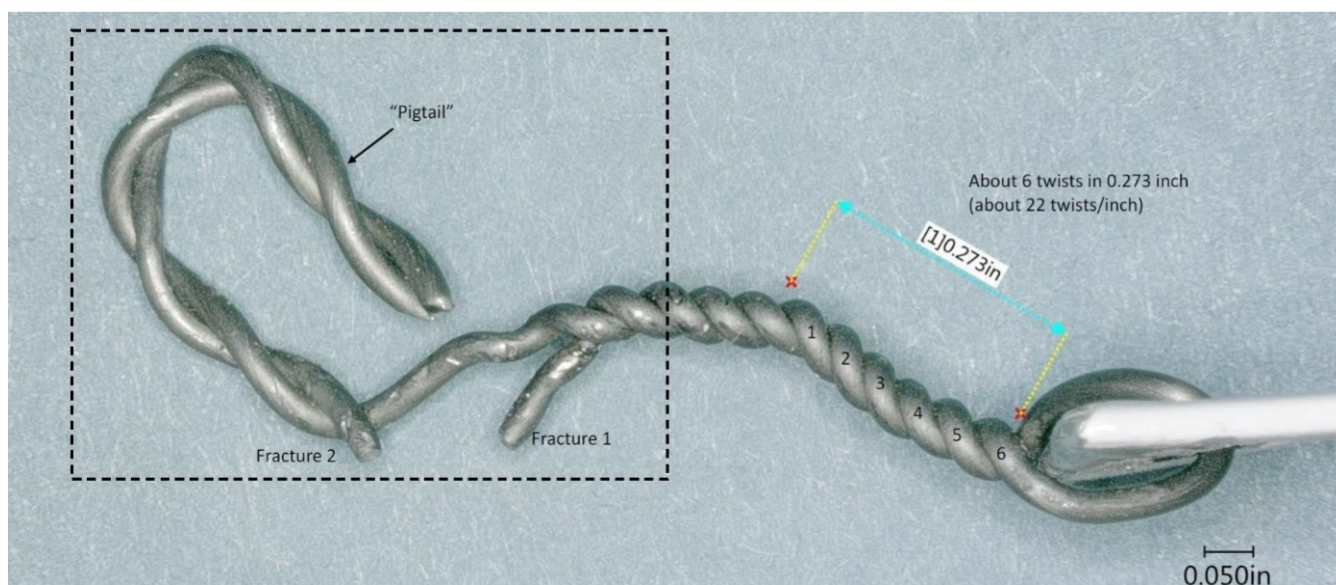
The right aileron inboard hinge bolt with its associated washers and spacer, the inboard attachment bracket with its riveted nut plate, and the fractured safety wire with its attached tab were examined by the National Transportation Safety Board Materials Laboratory. Measurements of the fractured safety wire were consistent with 0.032-inch safety wire. Adjacent to the attachment tab, the safety wire was twisted about 22 times per inch (see figure 4). The Cirrus SR20 maintenance manual specified that safety wire that was 0.032 inch in diameter was to be installed with 6 to 12 twists per inch. The safety

Figure 4. Right aileron inboard hinge attachment bolt safety wire with twist count.

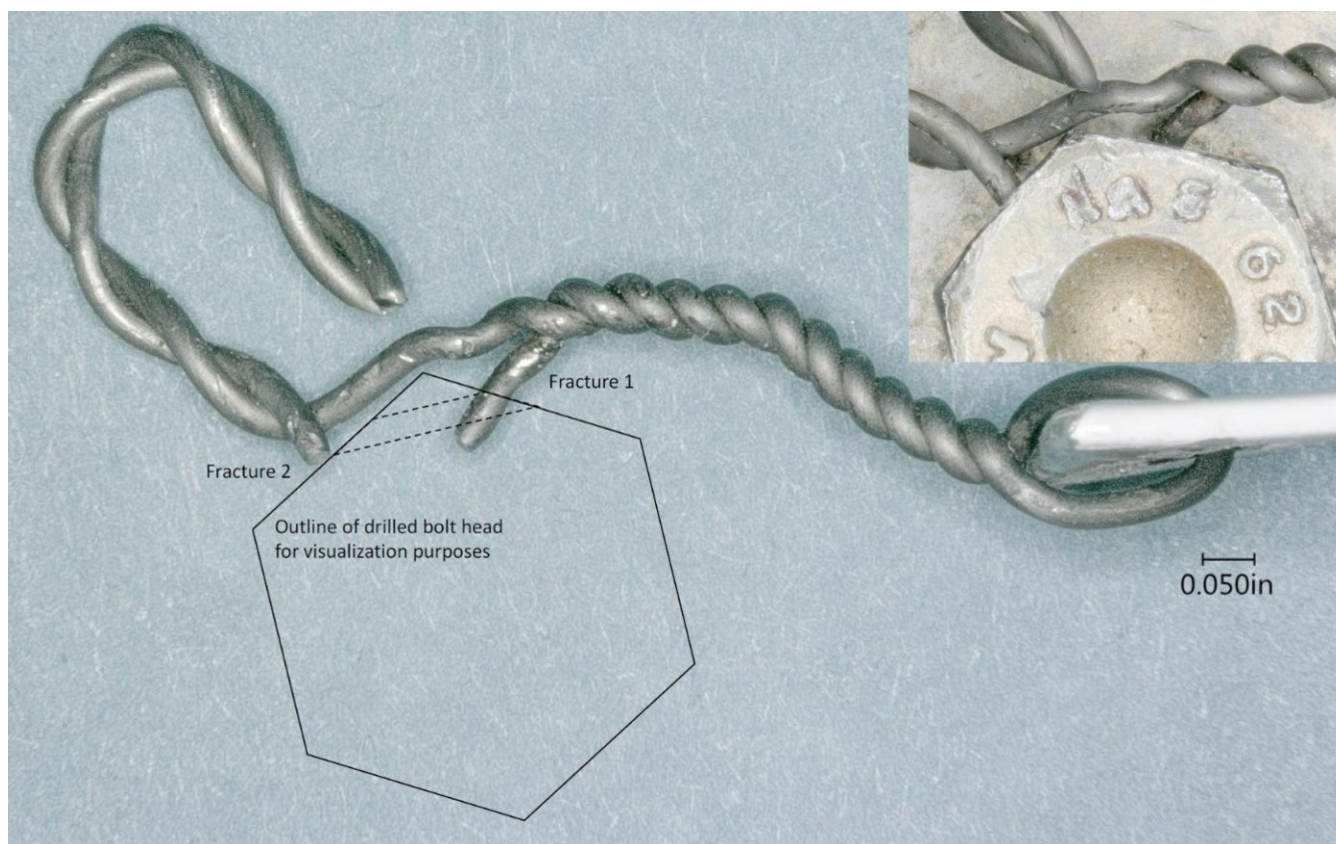
wire was fractured where it threaded through a drilled hole in the inboard hinge bolt head (see figure 5). Fractographic analysis revealed that the safety wire had fractured due to torsional overstress.

Figure 5. Right aileron inboard hinge attachment bolt safety wire with fracture position on bolt head depicted.

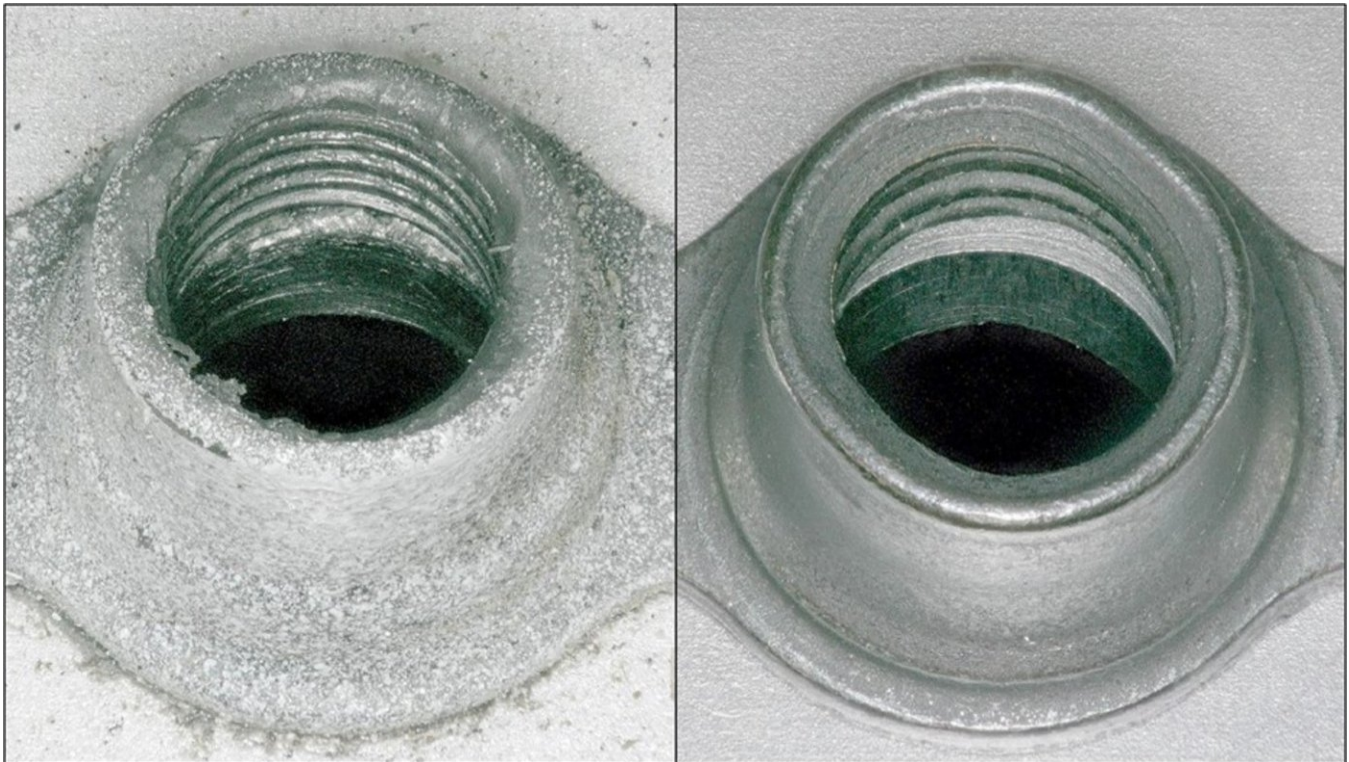
The right aileron inboard hinge bolt exhibited circumferential wear to its grip area, and the threads were intact, fully formed, and in good condition. The associated nut plate had intact, fully formed threads that were also in good condition. The periphery of the threaded portion of the nut plate was relatively round. Typically, when manufactured, the periphery of the threaded portion of a nut plate is intentionally deformed to an oblong or oval shape to provide mechanical resistance (or thread-locking) to the mating bolt threads (see figure 6). The thread roots of the hinge bolt and nut plate were found partially filled with a black grease.

Figure 6. Right aileron inboard hinge nut plate (left) and exemplar nut plate (right).
