Aviation Investigation Final Report

Location:	Burns, Oregon	Accident Number:	WPR19LA020
Date & Time:	October 27, 2018, 07:50 Local	Registration:	N3267S
Aircraft:	Cessna 182	Aircraft Damage:	Substantial
Defining Event:	Landing gear collapse	Injuries:	3 None
Flight Conducted Under:	Part 91: General aviation - Personal

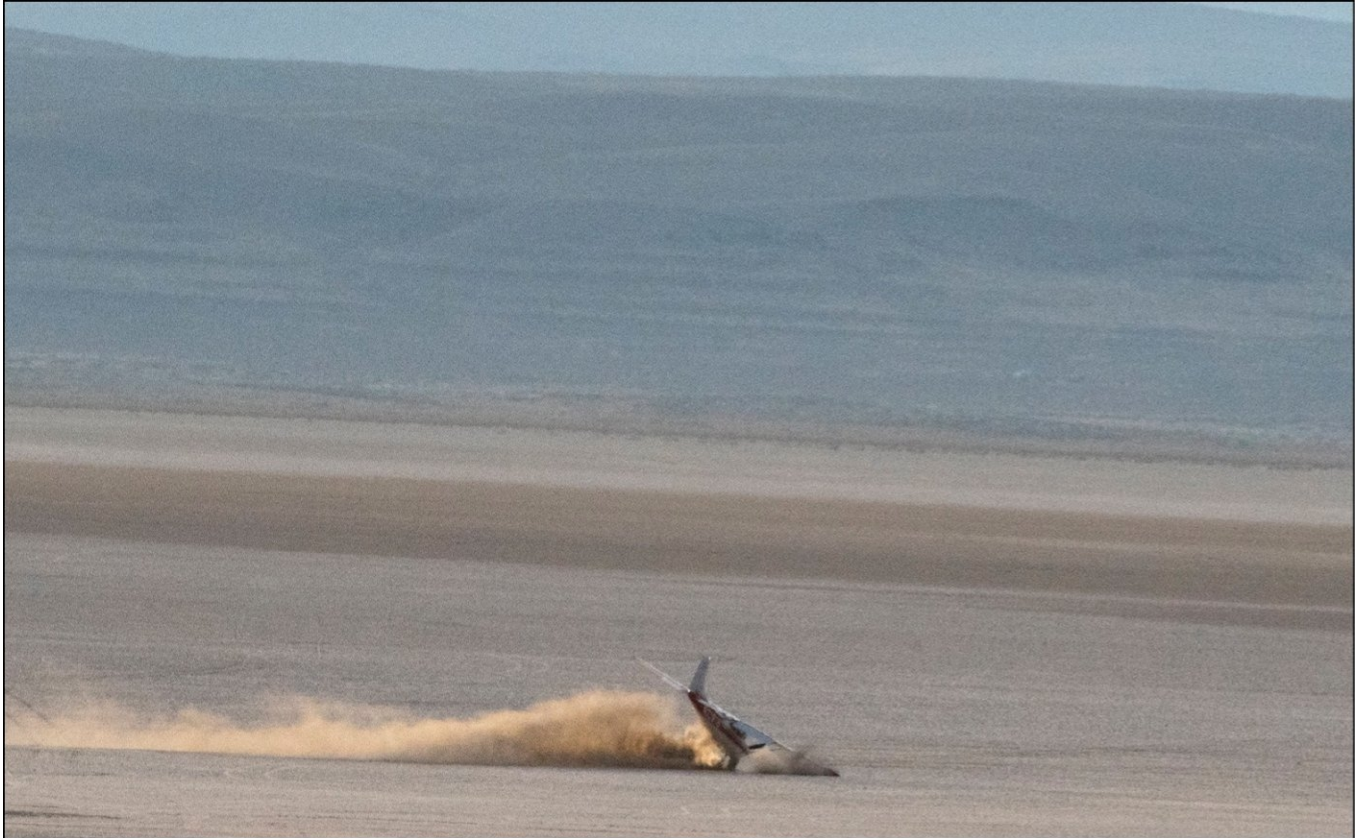
A witness reported that she observed airplanes landing in the landing area and took photographs of part of the accident sequence. She stated that the accident airplane touched down and the airplane suddenly pitched up in the air, then the nose was pushed into the desert terrain (see figure 1).

Figure 1: The accident airplane impacting the ground.

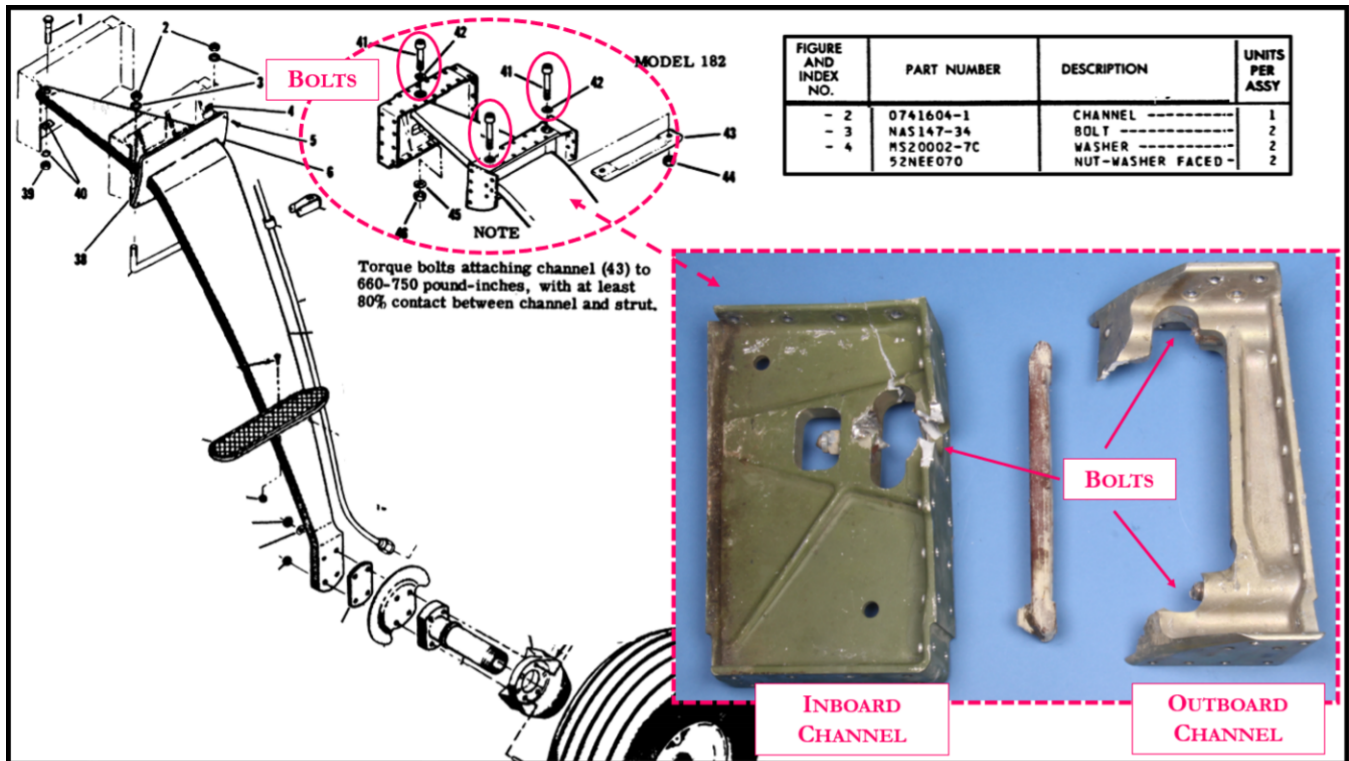
The main landing gear consisted of two channels that attached to each leg. The inboard channel contained a bolt that was attached through a hole in the gear leg (see figure 2). The outboard channel was clamped around the gear leg, and a forward and aft bolt secured the clamp. The Textron Aviation Maintenance Manual contained a note stating that the bolts attaching the outboard channel must be torqued from 660 to 750 inch-pounds with at least 80% contact between the channel and strut.

Figure 2: Main landing gear leg diagram and accident parts

The National Transportation Safety Board Materials Laboratory's examination of the left main landing gear's remaining channels and bolts revealed that the inboard support had two rounded rectangular cavities, which had contained an attachment bolt; the lower remnant of this bolt and the nut along the threaded portion of the shank were still affixed to the support. The upper portion of the bolt (the head) was missing, and the fracture surface displayed a 45° slanted orientation. Adjacent to the bolt on the support side was a V-shaped impact mark consistent with an adjacent component colliding with the support and moving downward (or outboard). A portion of the upper flange on the support had fractured and liberated, with cracks emanating from this position. The upper left portion of the support exhibited a crack emanating from the upper rectangular cavity, consistent with overstress fracture and another component impacting, fracturing, and deforming the support flange upward.

The bolts had been plated with cadmium, a corrosion inhibitor. However, corrosion pitting was observed along the threads, which is consistent with fatigue cracking in the thread roots of both bolts (the right bolt only exhibited small fatigue cracks, less than 100 μm in depth). While the cadmium plating can provide protection to the underlying alloy steel, corrosion pitting can still occur. This may be due to the operational environment, including locations near saltwater, as well as from a crevice corrosion mechanism.

The bolt exhibited a hardness of 31 Rockwell C Hardness Scale, which generally corresponds to a tensile strength of 141,000 pounds per square inch. With a crack depth of 0.13 inch, which is 32% of the bolt cross section, the fracture toughness of the bolt would be reduced by at least 45%.
