Aviation Investigation Final Report

Location:	Punta Gorda, Florida	Accident Number:	ERA19LA065
Date & Time:	December 13, 2018, 14:00 Local	Registration:	N145MM
Aircraft:	CZECH SPORT AIRCRAFT AS Piper Sport	Aircraft Damage:	Substantial
Defining Event:	Fuel related	Injuries:	1 Minor
Flight Conducted Under:	Part 91: General aviation - Personal

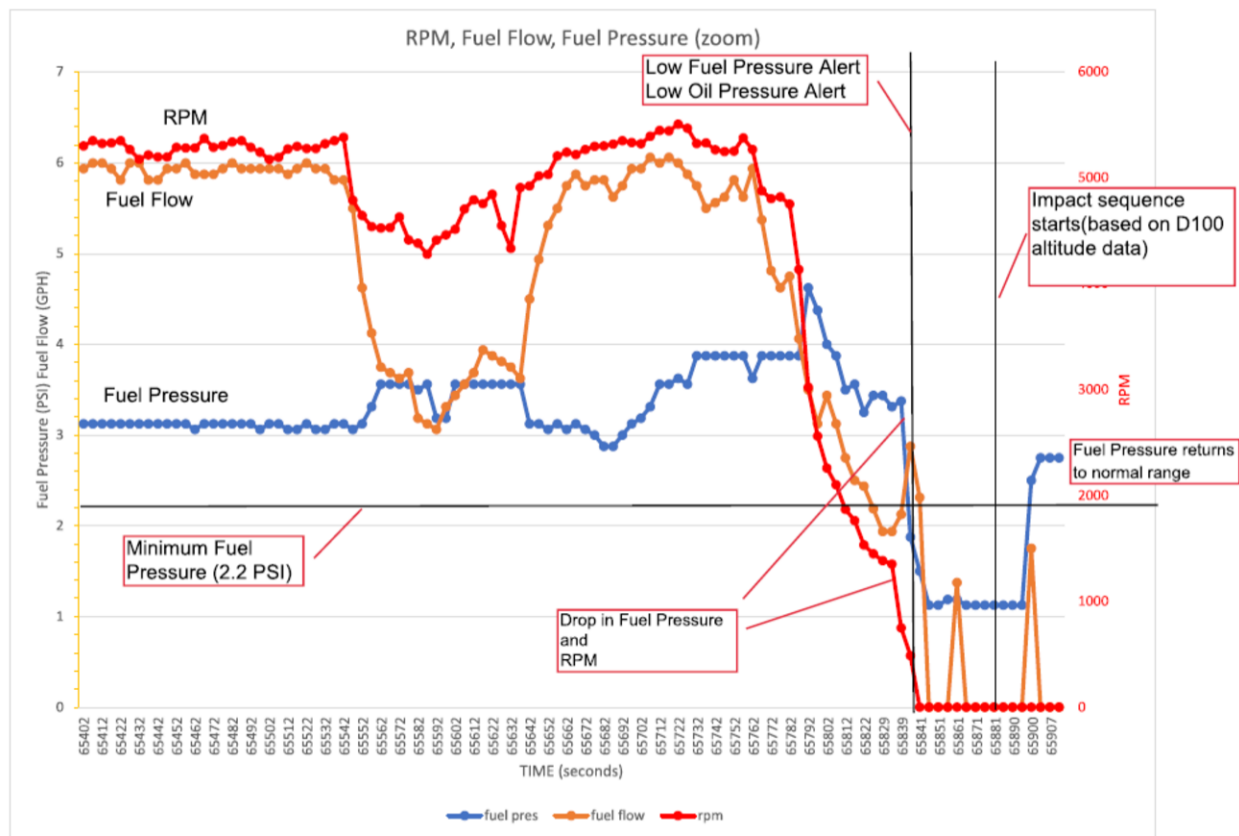
Near the end of the flight, the engine power decreased from about 4,700 rpm to 1,300 rpm over 52 seconds. Immediately afterward, engine power decreased to 0 rpm over 7 seconds, where it remained until impact about 40 seconds later (at the time the engine lost power, the recorded values for fuel quantity were 8.3 gallons in the left tank and 13.1 gallons in the right tank). Just as the rpm began to decrease from 1,300, the fuel pressure decreased from about 3.3 psi to 1.1 psi. As the fuel pressure decreased, the fuel flow increased momentarily from 1.9 GPH to 2.8

GPH before decreasing to 0 GPH. After impact, the fuel pressure increased to about 2.75 psi, where it remained until the recorded data ended, about 10 seconds later (see figure).

Figure - Selected data from engine monitor at end of flight.
