Aviation Investigation Final Report

Location:	Sitka, Alaska	Accident Number:	ANC18FA044
Date & Time:	June 8, 2018, 20:00 Local	Registration:	N1203A
Aircraft:	Piper PA18	Aircraft Damage:	Substantial
Defining Event:	Aerodynamic stall/spin	Injuries:	2 Fatal
Flight Conducted Under:	Part 91: General aviation - Personal

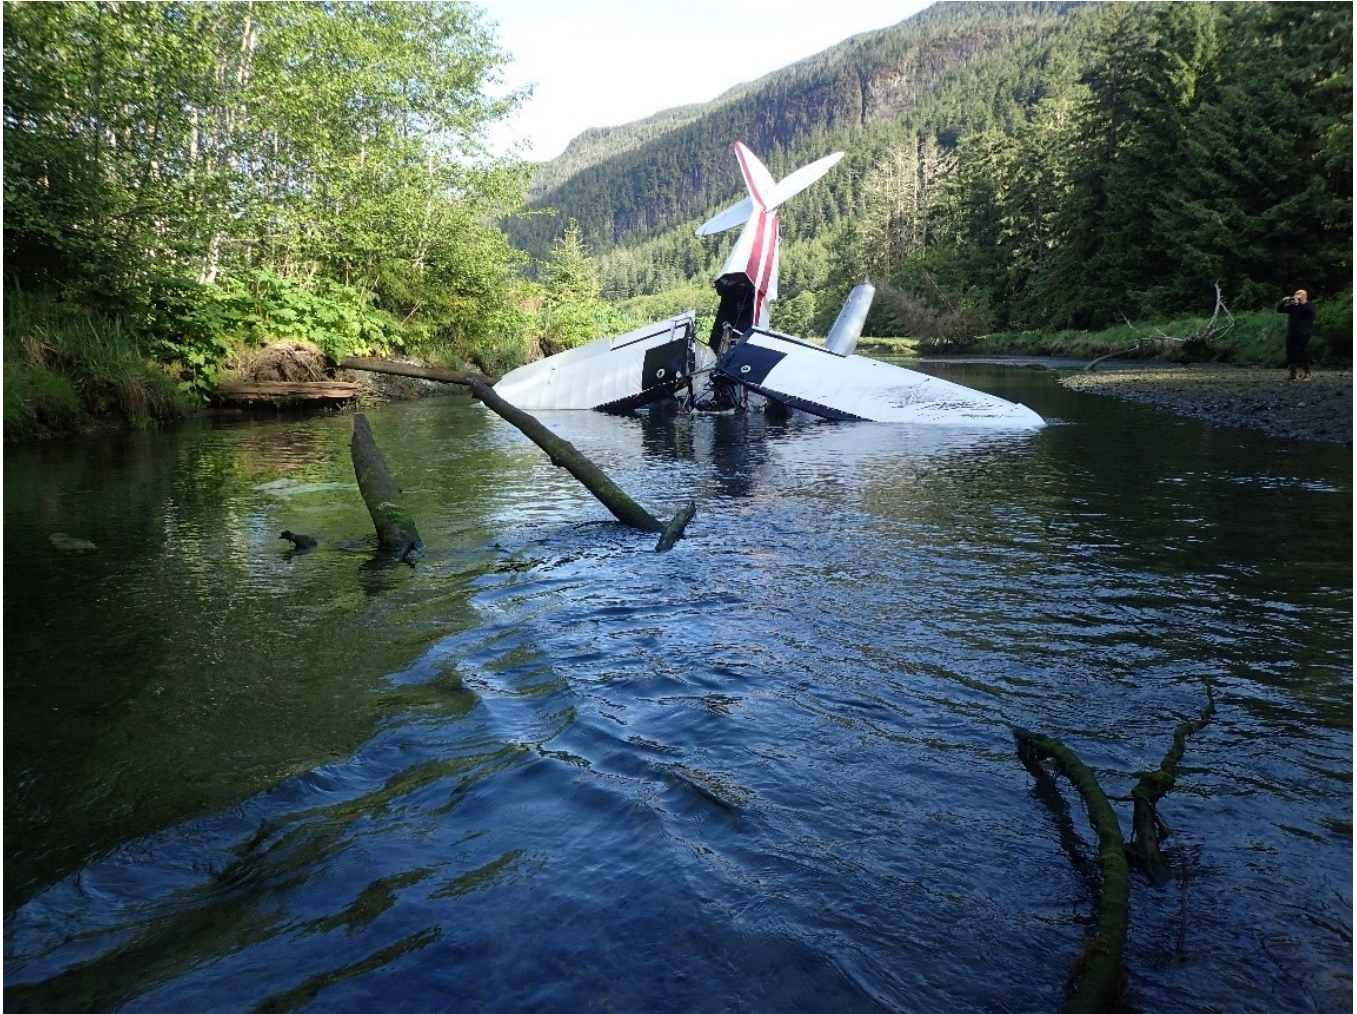
The airplane impacted the river bottom in a 70 ° nose down attitude with the front floats absorbing much of the energy and the aft fuselage displaced and twisted right, indicative of impact during a stall/spin. All flight controls were intact and continuous, and the engine exhibited no anomalies. The propeller blades exhibited rearward bends with torsional twist and some chordwise scrapes, and propeller strikes were evident on deadfall trees trunks at the initial impact site, which are all indications of impact with engine power. The right fuel tank cap was not located but given that there was evidence of engine power at impact, it is unlikely that fuel siphoning/exhaustion was causal. It is likely that the pilot was maneuvering the airplane in slow flight to show the passenger wildlife, and, in doing so, exceeded the airplane's critical angle of attack, resulting in the stall.

The airplane came to rest about 70° nose-down and wings-level into a small brackish river that was subject to the Katlian Bay tidal effects (see figure 2). National Transportation Safety Board investigators and a Federal Aviation Administration (FAA) safety inspector accessed the accident site on June 12 at low tide, after the wreckage had been exposed to multiple tidal cycles of 2 to 8 ft of depth. The wreckage was heading upriver, about 110°, with the forward 3 ft of the aluminum floats severely buckled and deformed upward about 70°. The aft fuselage was displaced and twisted to the right. The initial impact site was identified about 20 ft upstream where a depression of about 6-by-6 ft with small airplane debris and the engine cowlings was present on the river bottom. At the impact site were 2 large trees trunks that appeared to be waterlogged deadfall consistent with other old tree debris in the river. One of the trunks had fresh propeller cuts. The trees surrounding the river had no evidence of impact. All major components were located at the site.

Figure 2. West view of wreckage on the Katlian River.

Flight control continuity was established at the accident scene. The aileron control cable was separated at the left wing root with broomstick signatures indicative of an overload failure at impact. The left wing root leading edge exhibited an indentation that corresponded to the diameter of a deadfall tree trunk that was present at the initial impact site. The left and right wings were separated at the rear connections and rotated forward. The left flap control rod was fractured with dull overload signatures. The right flap was attached and in the up position. The empennage, with attached rudder and elevator was displaced and twisted to the right.
