Aviation Investigation Final Report

Location:	Melville, New York	Accident Number:	WPR18FA155
Date & Time:	May 30, 2018, 13:48 Local	Registration:	N62382
Aircraft:	North American SNJ 2	Aircraft Damage:	Destroyed
Defining Event:	Loss of control in flight	Injuries:	1 Fatal
Flight Conducted Under:	Part 91: General aviation

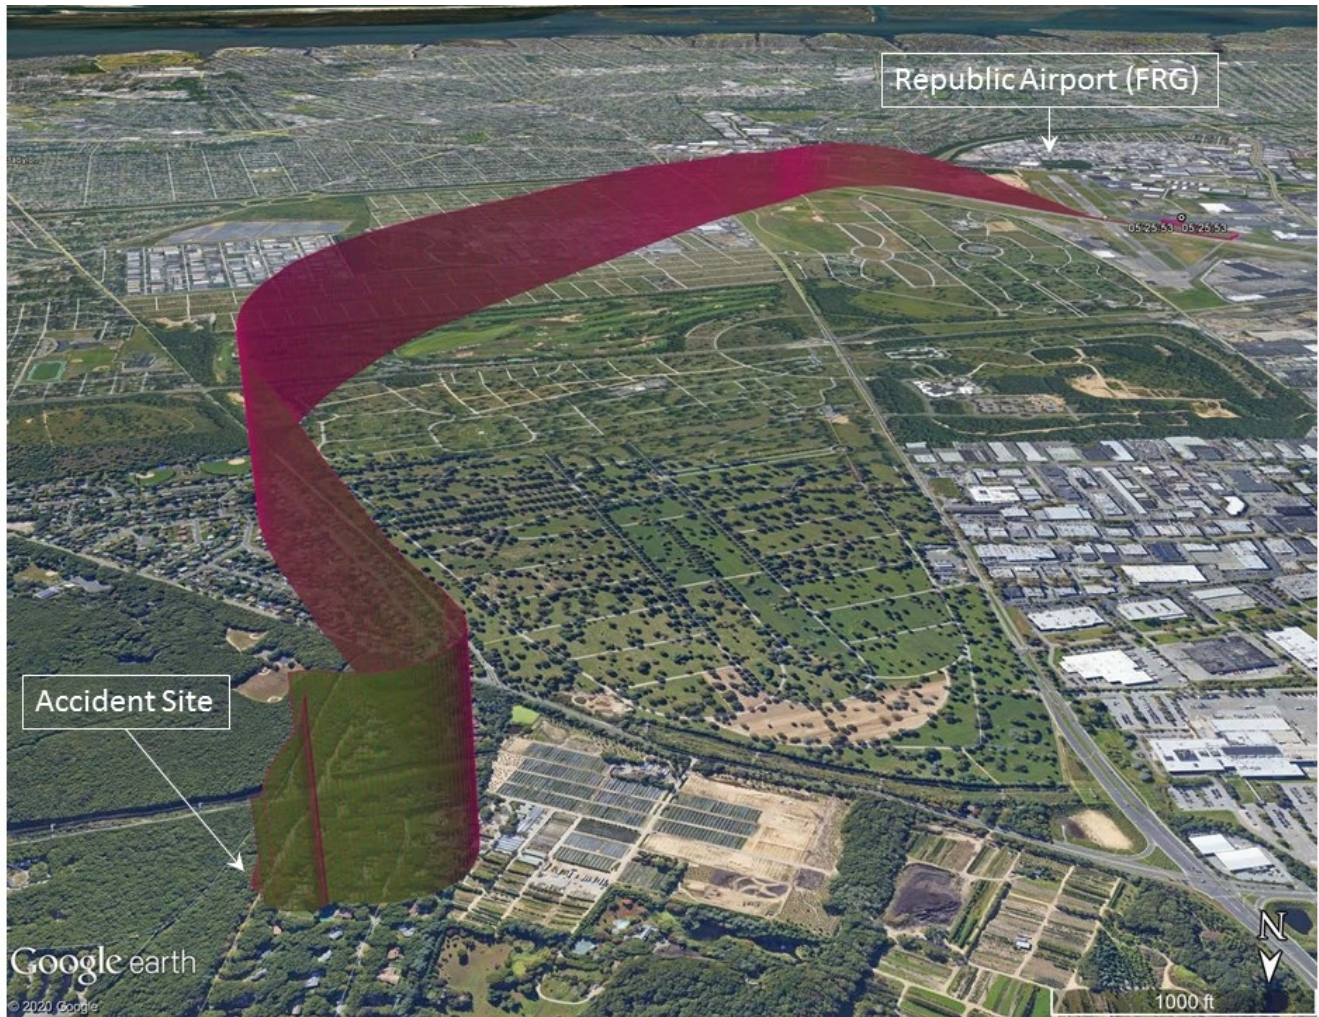
Figure 1-Accident Flight Track and Accident Site

Flight track data showed the airplane depart from runway 14 and turn northeast, climbing to an altitude of about 1,200 ft mean sea level (msl), before turning northwest as it climbed to about 1,300 ft msl. The airplane then turned sharply right about 360° and started losing altitude. The airplane continued to lose altitude as it completed about three more 360° turns before the data ended in the vicinity of the accident site. (See Figure 1).

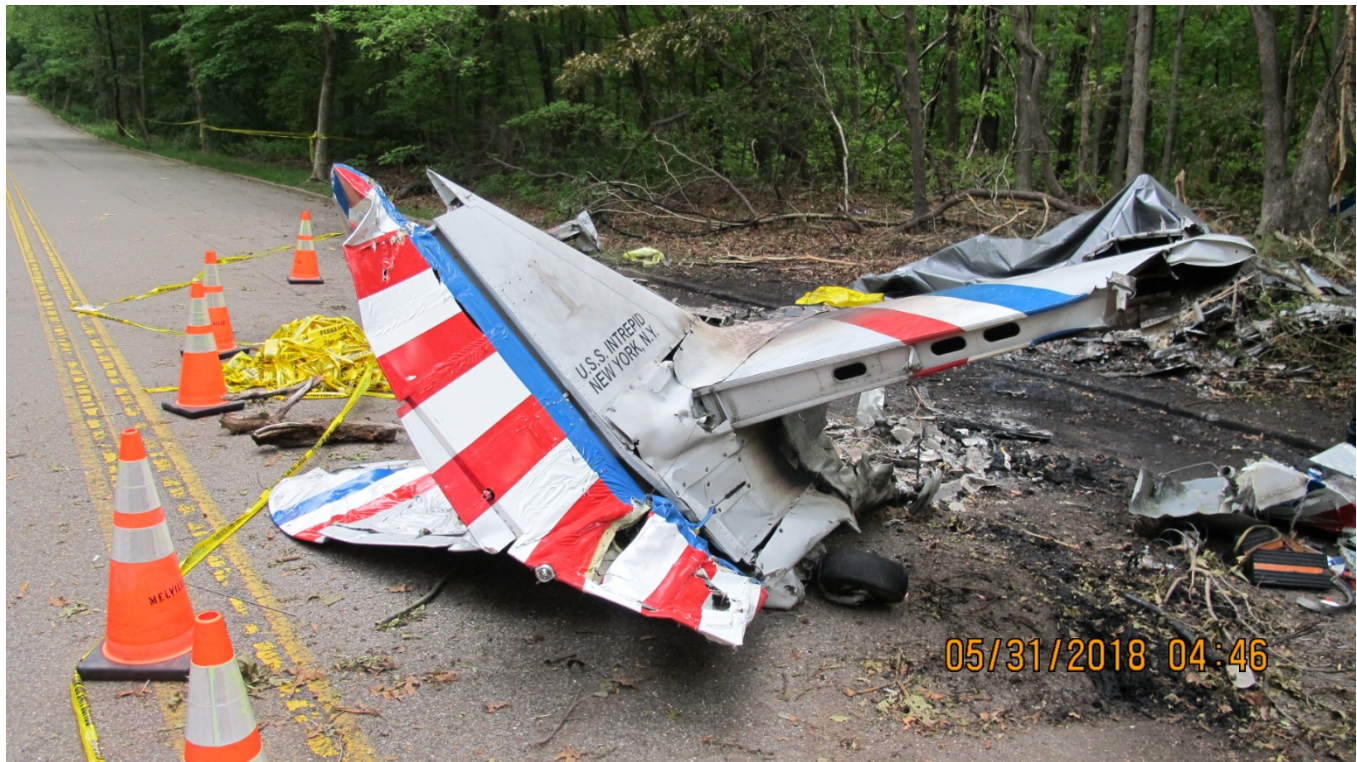
Figure 2-Accident Site

The main wreckage and the wreckage debris were contained within a 50-ft radius. Several trees above and near the accident site were damaged, and limbs and large branches were found throughout the site. The first identified point of contact (FIPC) with the ground was a crater near the engine and propeller assembly. The main wreckage was upright, and the engine and propeller assembly were partially embedded in the crater. The main wreckage was mostly consumed by postimpact fire. All flight control surfaces were found at the accident site. (see Figure 2)
