Aviation Investigation Final Report

Location:	Ferdinand, Indiana	Accident Number:	CEN18TA233
Date & Time:	June 18, 2018, 22:45 Local	Registration:	N3002X
Aircraft:	Cessna 150F	Aircraft Damage:	Substantial
Defining Event:	Loss of engine power (total)	Injuries:	1 Serious, 1 Minor
Flight Conducted Under:	Part 91: General aviation - Personal

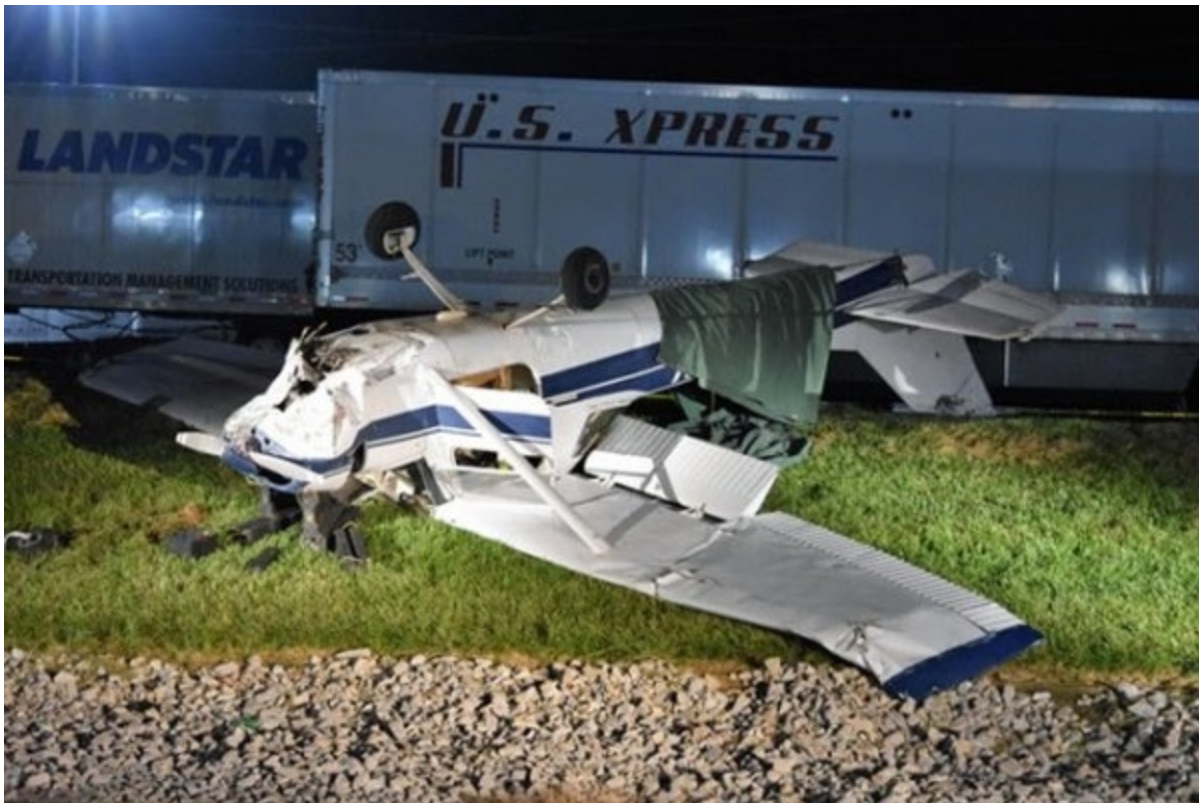
On June 18, 2018, about 2245 eastern daylight time, a Cessna 150F airplane, N3002X, made a forced landing in a parking lot then nosed over in an embankment. The private rated pilot sustained serious injuries and the passenger sustained minor injuries. The airplane sustained substantial damage. The airplane was registered to Gas Publishing LLC and operated by the pilot under the provisions of Title 14 *Code of Federal Regulations* Part 91 as a personal flight. Night visual meteorological conditions prevailed at the time of the accident and no flight plan had been filed. The flight departed Central Wisconsin Airport (CWA), Mosinee, Wisconsin, about 1700 central daylight time and was en route to Perry County Municipal Airport (TEL), Tell City, Indiana.

Figure 1 – Accident Site (photo courtesy of the Indiana State Police)

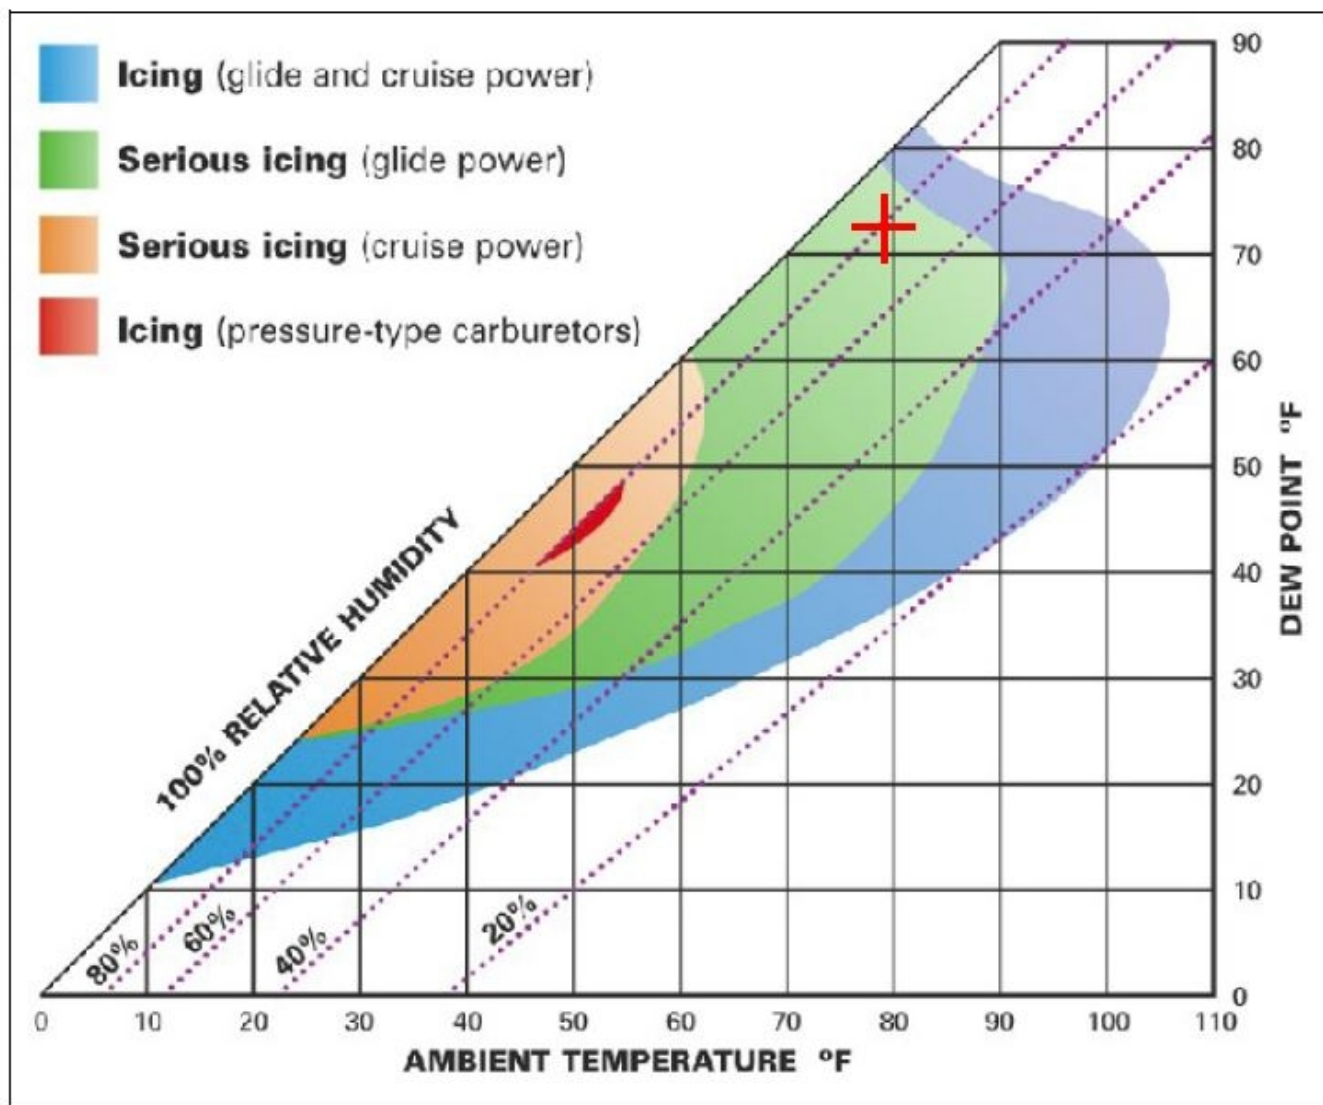
The carburetor icing probability chart included in Federal Aviation Administration Special Airworthiness Information Bulletin No. CE-09-35, Carburetor Icing Prevention, indicated that the airplane was operating in an area that was associated with a serious risk of carburetor ice accumulation at glide power settings (figure 2).

Figure 2 – Carburetor icing probability chart
