Aviation Investigation Final Report

Location:	Chicago, Illinois	Incident Number:	OPS18IA015
Date & Time:	June 21, 2018, 09:58 Local	Registration:	B-18711
Aircraft:	Boeing 747	Aircraft Damage:	None
Defining Event:	Miscellaneous/other	Injuries:	4 None
Flight Conducted Under:	Non-U.S., commercial

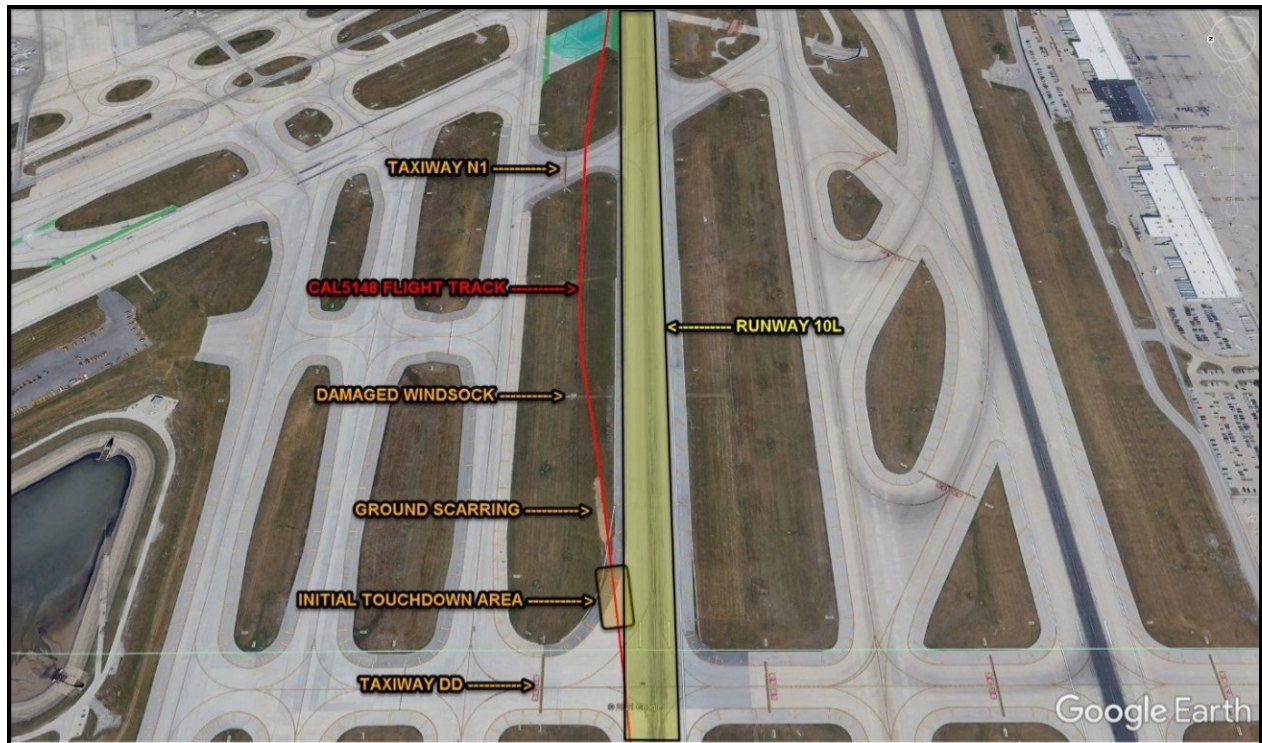
While on short final and attempting to land, CAL5148 drifted left of the runway centerline and the left main landing gear touched down left of the runway, but still on the paved surface. The airplane then traveled into the grass between taxiway DD and taxiway N1 leaving deep ground scarring and damaging a windsock. Figure 1 shows the accident airplane's flight track overlaid on satellite imagery in which the ground scarring can still be seen. CAL5148 executed a go-around and subsequently returned to the airport, landing on runway 9R without further incident at about 1020.

Figure 1. Figure showing a portion of CAL5148’s flight track, with initial touchdown area and other pertinent information also illustrated.

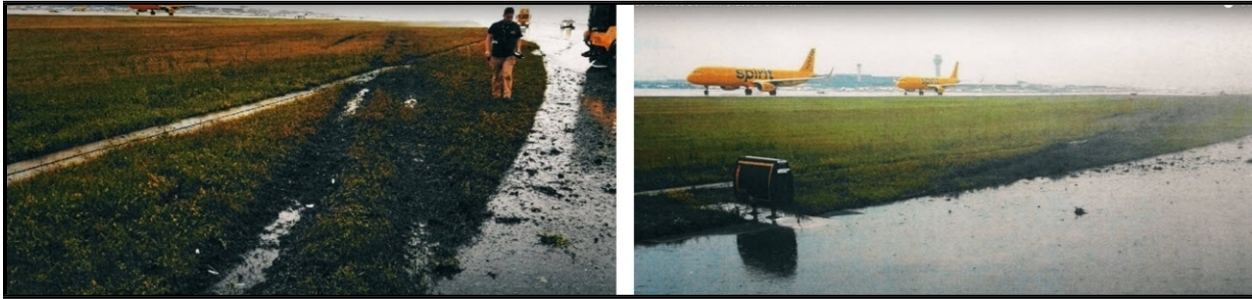
Deep ground scarring was visible near where the aircraft had touched down left of the runway on the paved surface and extending into the grass between taxiway DD and taxiway N1 (see figure 3).

Figure 3. Photographs of the ground scarring caused by the left main landing gear of CAL5148. [Source: FAA]

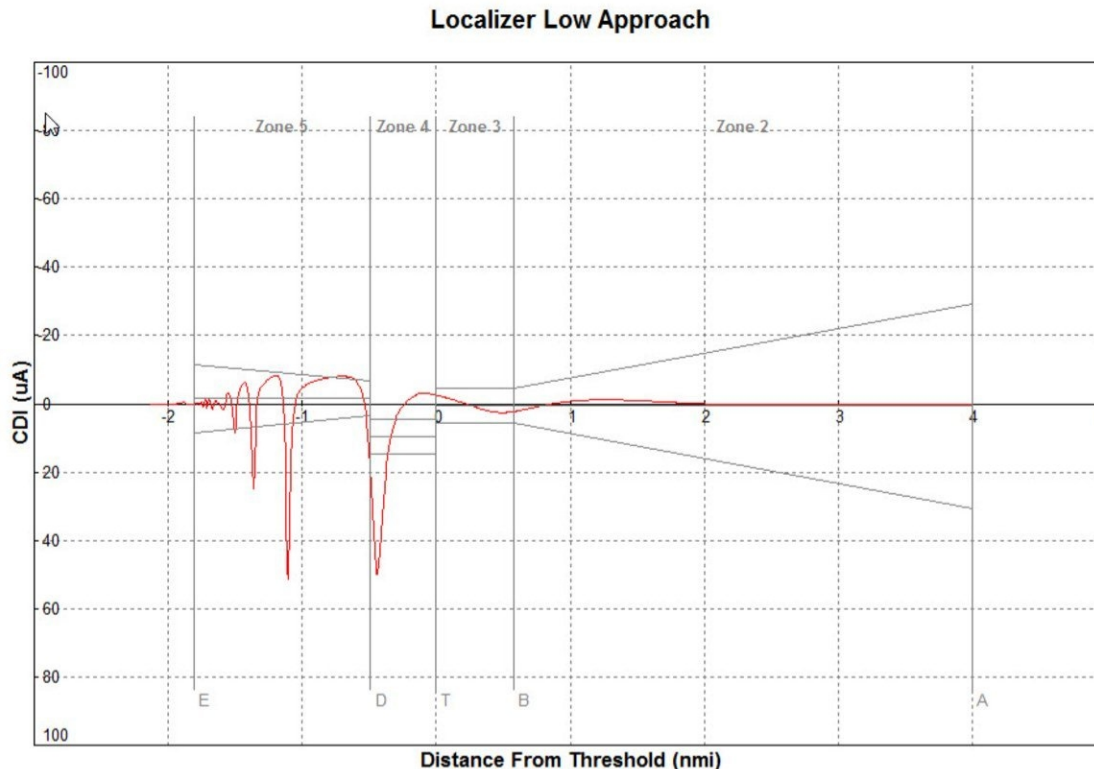
Math modelling of this event was conducted by the FAA's National Resource Engineer for Navigation. The FAA applied a model that could consider if objects, like buildings and aircraft, could affect localizer and glide slope quality; however, this model was not capable of assessing the effects of an aircraft flying directly over the antenna. Therefore, an analysis was performed with ENY3544 located 2,800 feet from the localizer and 450 feet above the runway. Using several assumptions for aircraft orientation, the model's output was consistent with the localizer deviations determined from the CAL5148 FDR data (see figure 4).

Figure 4. Graph displaying the simulation results of the math modelling conducted by the FAA.

The graph in figure 4 illustrates modelling simulation results of the effect of a regional jet [ENY3544] departing and overflying the runway 10L localizer at KORD. The location of the Regional Jet simulated was based on Airport Surface Detection Equipment – Model X (ASDE-X) surveillance data of the regional jet and B747 [CAL5148] positions around the time of the runway excursion. On the graph, the red line represents predicted deviations of the aircraft course deviation indicator for the localizer. The vertical scale is the predicted deflection in micro-amps. For an aircraft course deviation indicator, 150 micro-amps would produce full-scale deflection of the indicator. The horizontal scale is the B747 position referenced to runway threshold. The distance labels “0” and “T” are at the threshold. The numerical values are in nautical miles. The letters are used to illustrate flight inspection areas of interest. Point “D” is 3,000 feet down the runway from the threshold and is the end of the touchdown zone. The deviation beginning 0.25 mile from threshold would lead the aircraft to turn left to continue to follow the localizer course line during an autoland approach. Upon completion, the National Resource Engineer for Navigation who performed the modelling wrote, *“I am 90% confident that the location of departing ENY3544 caused sufficient Multipath (signal reflection) to produce a fly left indication to arriving CAL5148.”*
