# Aviation Investigation Final Report

| <b>Location:</b> | Norco, California | <b>Accident Number:</b> | WPR19FA118 |
| <b>Date &amp; Time:</b> | April 22, 2019, 12:09 Local | <b>Registration:</b> | N9MB |
| <b>Aircraft:</b> | Northrop N9M | <b>Aircraft Damage:</b> | Destroyed |

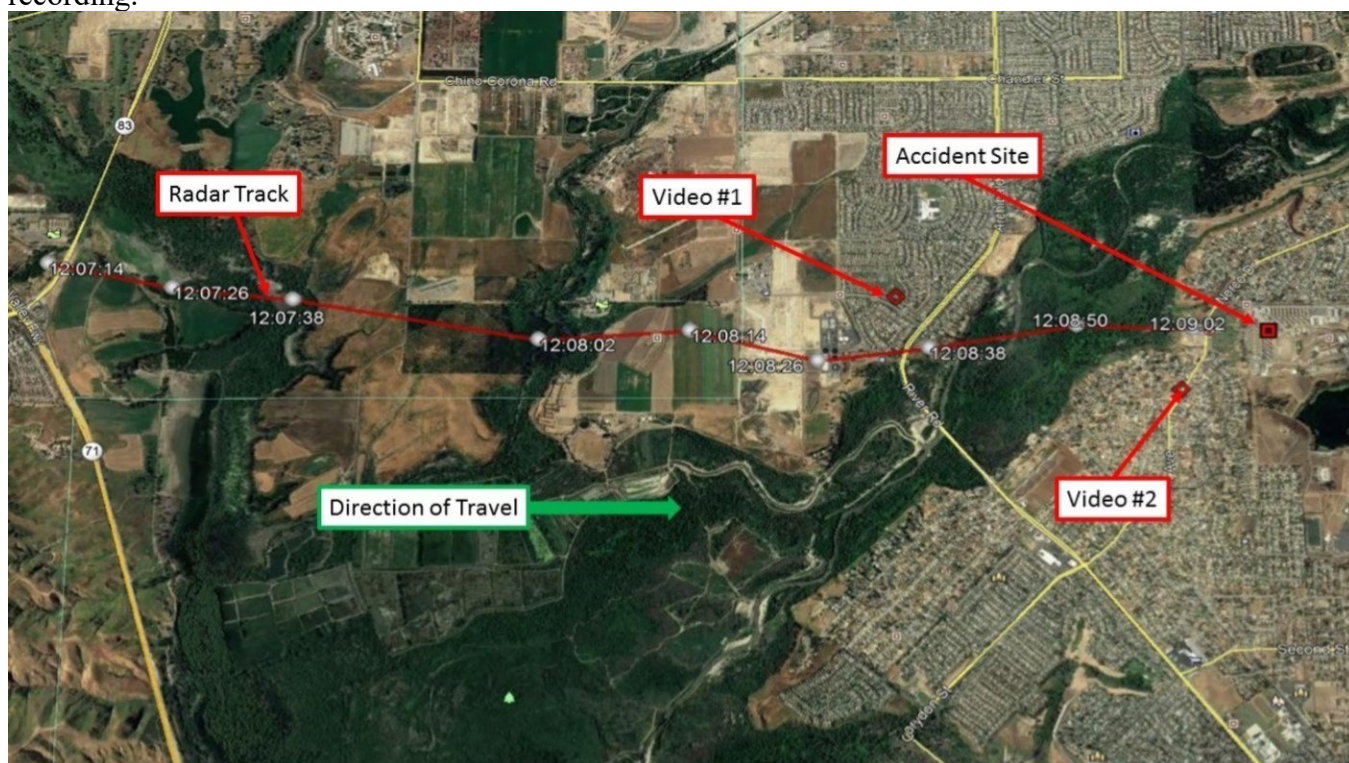
Review of radar data obtained from the Federal Aviation Administration (FAA) showed a primary radar target on an easterly heading about 3 miles south of Chino Airport, Chino, California, as seen in figure 1; no altitude information was available. The last return was about 0.3 mile west of the accident site.

Figure 1. View of radar track information, with witness video locations depicted.

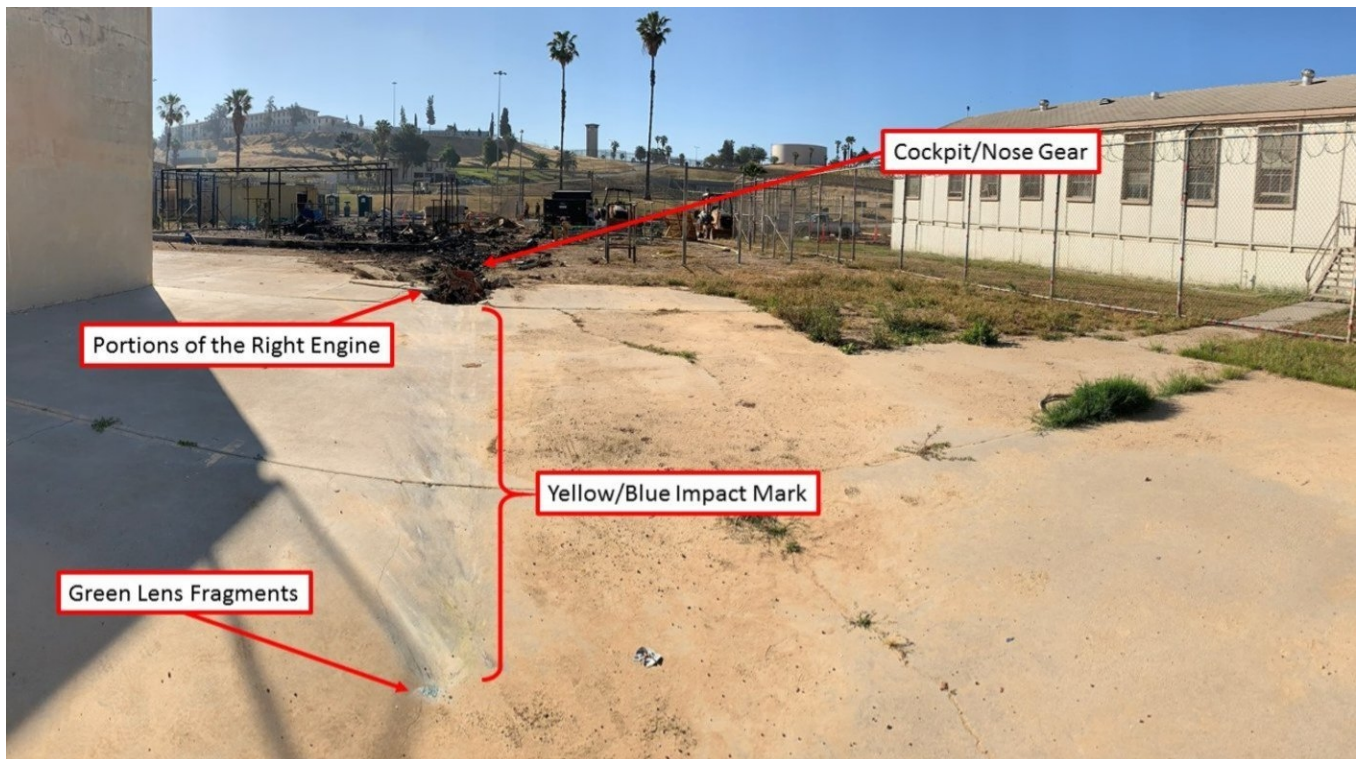
The airplane impacted the outpatient housing yard of the California Rehabilitation Center. The debris path was oriented on a heading of about 124° magnetic and measured about 474 ft long and 200 ft wide. The first identified point of contact (FIPC) was green lens fragments, consistent with the right wing navigational light lens, as shown in figure 2. From the FIPC, a blue-and-yellow colored mark extended about 32 ft to a large ground impression/crater that measured about 2 ft deep and 3 ft wide. Within the ground scar were remains of the right engine. The ground scar extended about 16 ft and contained portions of the cockpit, nose landing gear, and airframe structure. Wood debris, various fragments of both engines, and airframe structure were located throughout the debris path. The left and right propeller assemblies were located about 100 ft from the FIPC. The farthest portion of debris was a propeller blade tip, located about 474 ft from the FIPC.

Figure 2. Initial impact marks and start of debris path.

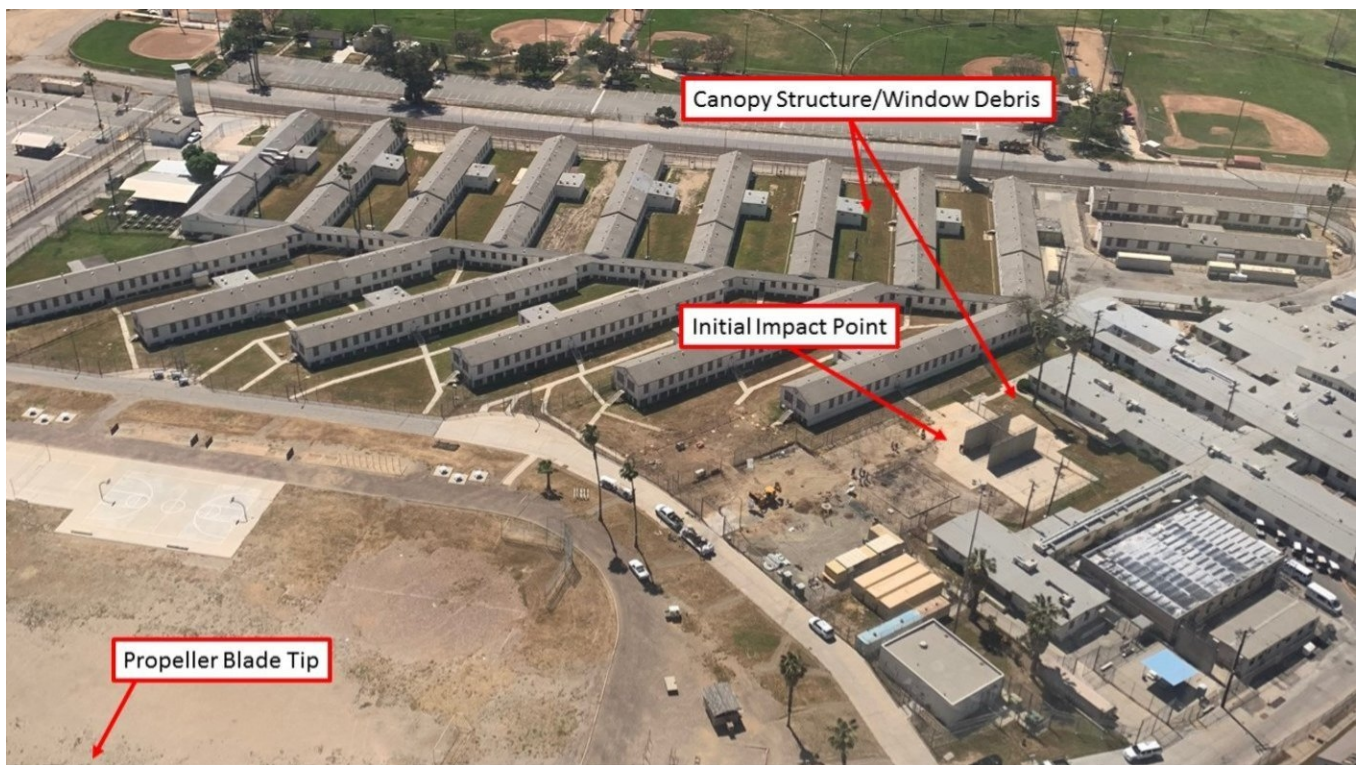
Canopy structure and window debris was located about 60 ft northwest of the FIPC and about 330 ft west of the FIPC. Both areas where window and canopy structure were located were in the opposite direction of the debris path, as shown in figure 3.

Figure 3: Accident site overview.
