Aviation Investigation Final Report

Location:	Baton Rouge, Louisiana	Accident Number:	CEN18LA285
Date & Time:	July 20, 2018, 14:30 Local	Registration:	N327BK
Aircraft:	Smith Aerostar601	Aircraft Damage:	Substantial
Defining Event:	Loss of engine power (total)	Injuries:	2 None
Flight Conducted Under:	Part 91: General aviation - Personal

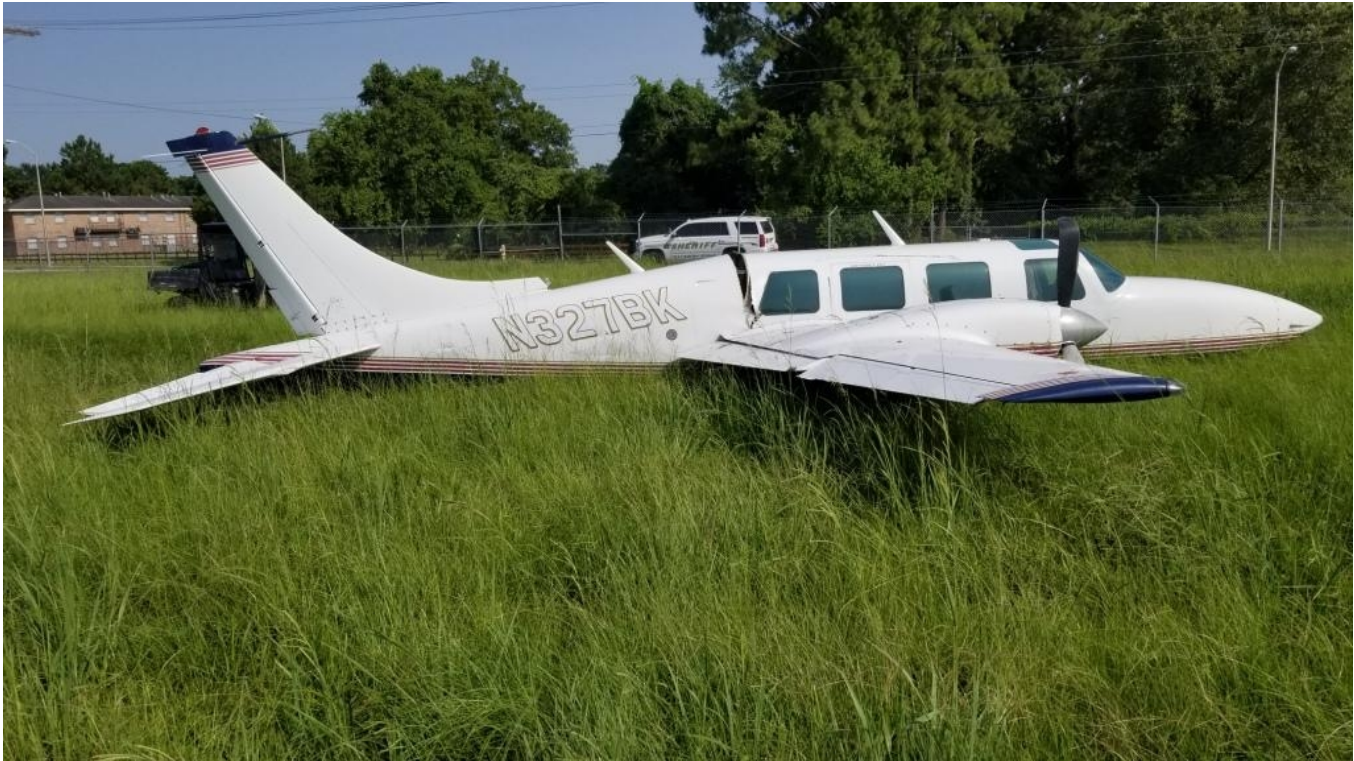
Figure 1 – Accident airplane

After the accident the pilot stated that he completed a preflight inspection about 1400, then boarded the airplane and started both engines. While holding short of runway 31, he performed a pre-takeoff check of the airplane including a run-up for each engine with no anomalies noted. During the takeoff roll he advanced the throttles to takeoff power, then rotated. Shortly after rotation he noticed the right engine was not producing full power and the engine speed was decreasing. With no remaining runway available to land, he continued and looked for an off-field landing location. He retracted the landing gear and feathered the right propeller. The airplane was unable to maintain altitude so the pilot made a hard forced landing to a grass-covered field (figure 1) about 1 mile northwest of the departure end of runway 31.
