# Aviation Investigation Final Report

<b>Location:</b>	Kingsland, Texas	<b>Accident Number:</b>	CEN19FA122
<b>Date &amp; Time:</b>	April 21, 2019, 14:43 Local	<b>Registration:</b>	N25TX
<b>Aircraft:</b>	Rans S7	<b>Aircraft Damage:</b>	Destroyed
<b>Defining Event:</b>	Loss of control in flight	<b>Injuries:</b>	2 Fatal
<b>Flight Conducted Under:</b>	Part 91: General aviation - Personal

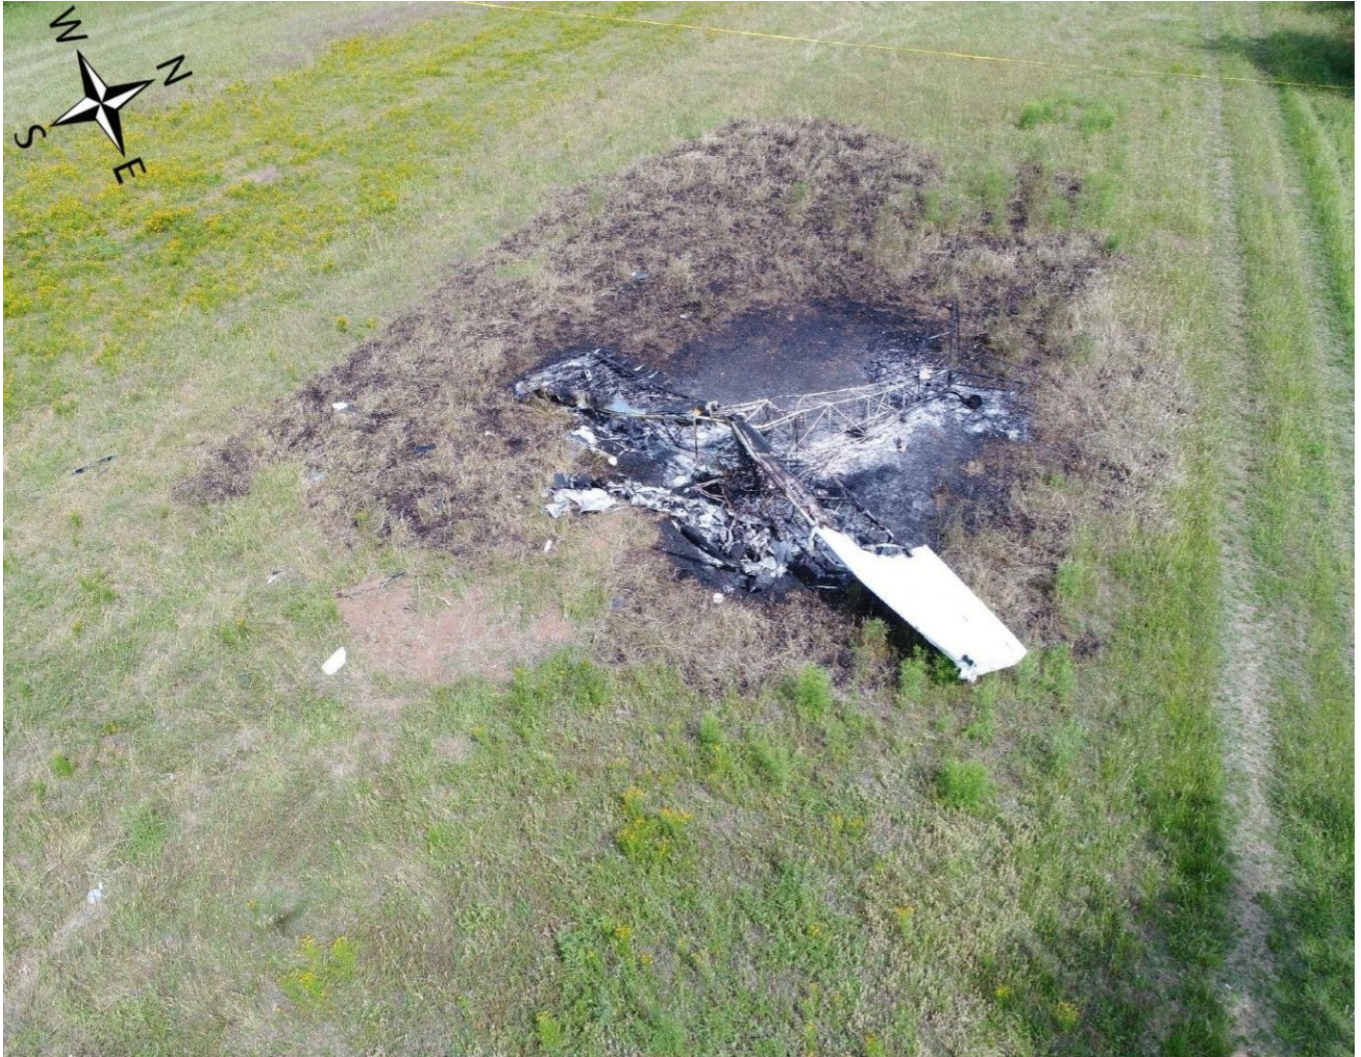
The airplane departed on runway 16 and impacted the ground near the south end of the runway, as seen in figure 1.

Figure 1 – Aerial image of the accident site
