Aviation Investigation Final Report

Location:	Friendswood, Texas	Accident Number:	CEN18TA330
Date & Time:	August 13, 2018, 11:00 Local	Registration:	N42218
Aircraft:	Piper J3C	Aircraft Damage:	Substantial
Defining Event:	Loss of control on ground	Injuries:	1 None
Flight Conducted Under:	Part 91: General aviation - Personal

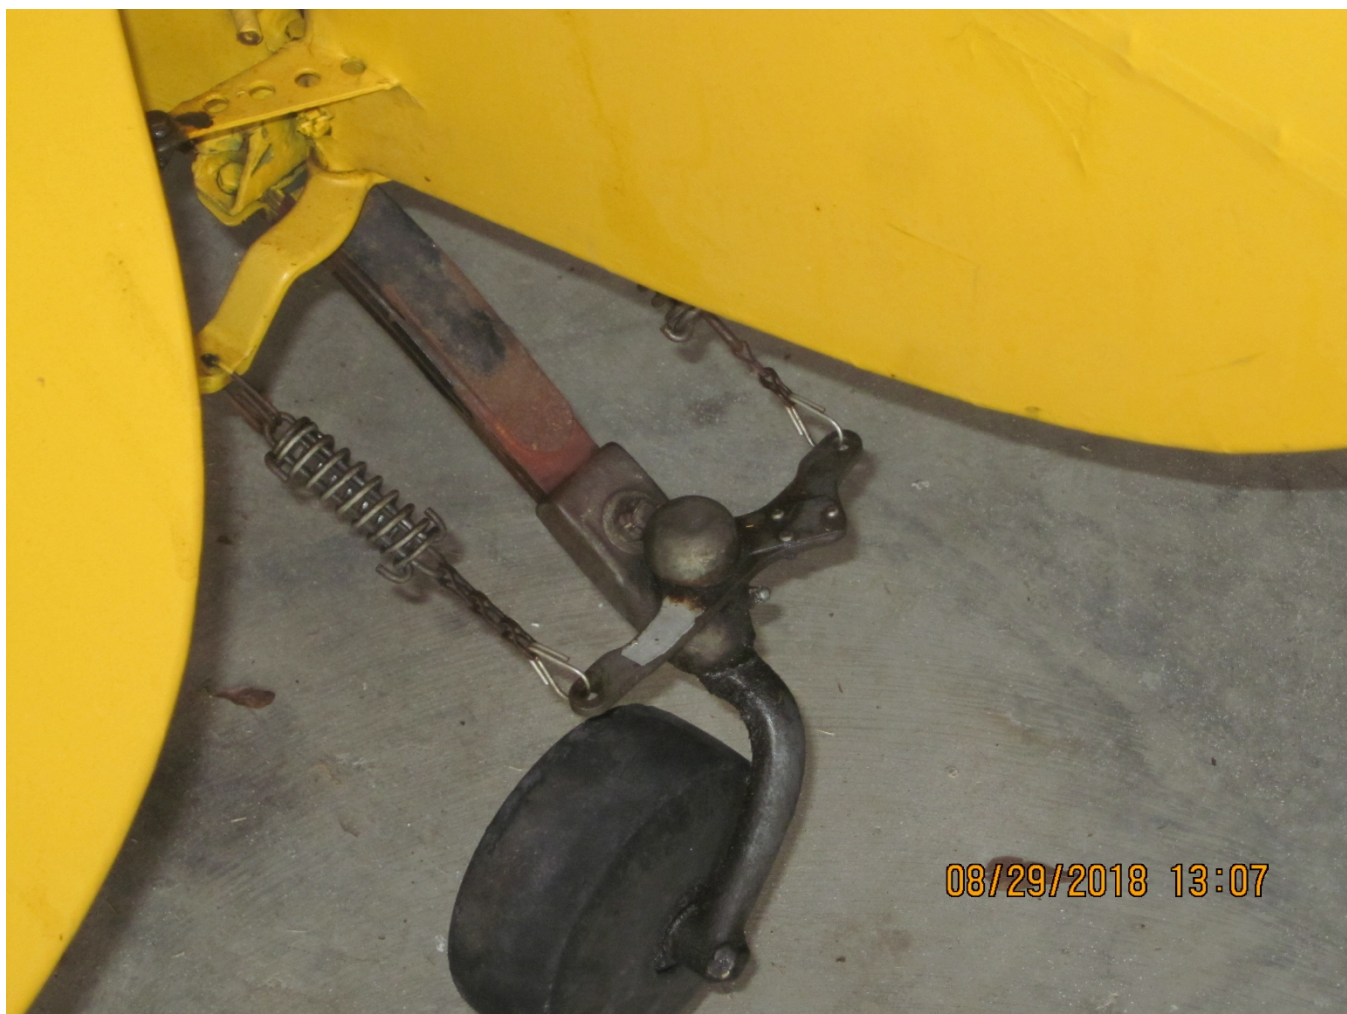
A postaccident examination of the airplane revealed that the tailwheel locking mechanism pins were worn and degraded. The locking mechanism could not withstand even a small amount of side pressure; as pressure was applied to the tailwheel, the locking mechanism would unlock and the tailwheel would swivel out of alignment.

It is likely that, due to the degraded locking pins, the tailwheel became unlocked before the final landing and was out of alignment during the landing roll, which precluded the pilot from regaining directional control. It is the pilot's responsibility to ensure that the airplane is in a safe condition for flight; in this case, the pilot did not ensure that the tailwheel locking mechanism was in good working condition before he decided to conduct the flight.

The pilot's decision to conduct a flight in an airplane that had a tailwheel with degraded locking pins, which allowed the tailwheel to unlock and swivel out of alignment and precluded the pilot from regaining directional control on the ground during a crosswind landing.

A postaccident examination of the airplane revealed that the Maule tailwheel locking mechanism pins were worn down and degraded. The locking mechanism could not withstand even a small amount of side pressure. As pressure was applied to the tailwheel, the locking mechanism would unlock and the tailwheel would swivel out of alignment (figure 1).

Figure 1 – Unlocked Tailwheel
