Aviation Investigation Final Report

| Location: | Willow, Alaska | Accident Number: | ANC18TA070 |
| Date & Time: | September 8, 2018, 23:53 Local | Registration: | N8070Z |
| Aircraft: | Cessna U206 | Aircraft Damage: | Substantial |

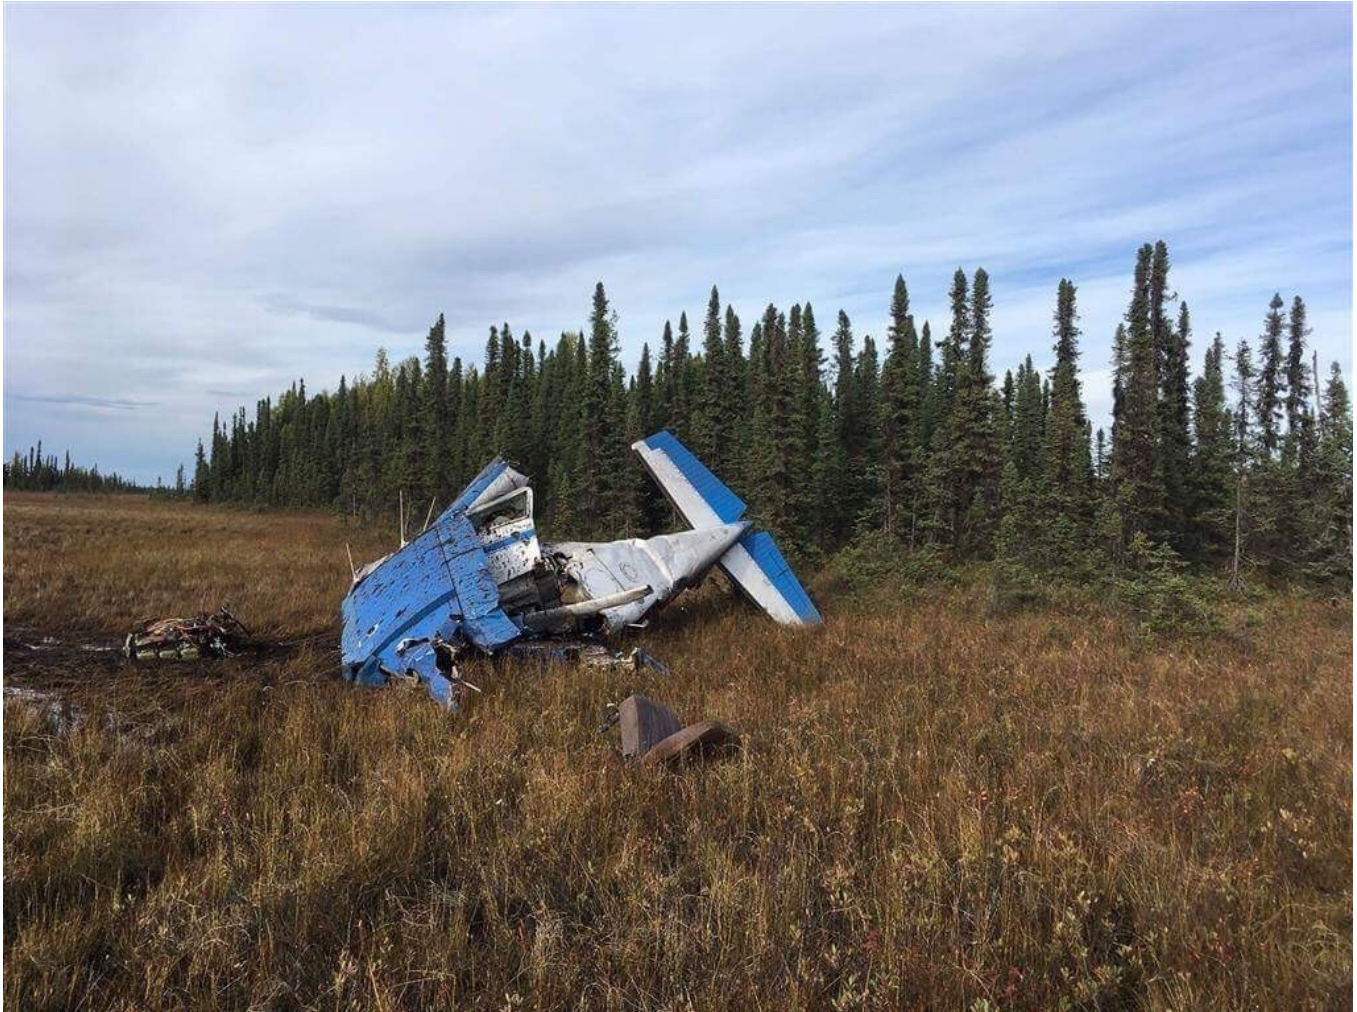
Figure 1. N8070Z wreckage

impacted the marsh-covered terrain right wing first in a nose down attitude. Both pilots egressed the fragmented wreckage through a tear in the fuselage. The flight instructor located the pilot's iPhone in the marsh and called the Rescue Coordination Center and a family member. They were unable to reach survival gear due to the large wreckage field and their serious injuries. They were rescued about 0150 by the Air National Guard. The airplane sustained substantial damage to the wings, fuselage and empennage. Refer to figure 1.
