Aviation Investigation Final Report

| Location: | Skwentna, Alaska | Accident Number: | ANC19FA038 |
| Date & Time: | March 6, 2019, 17:30 Local | Registration: | N7469A |
| Aircraft: | Cessna 172 | Aircraft Damage: | Substantial |

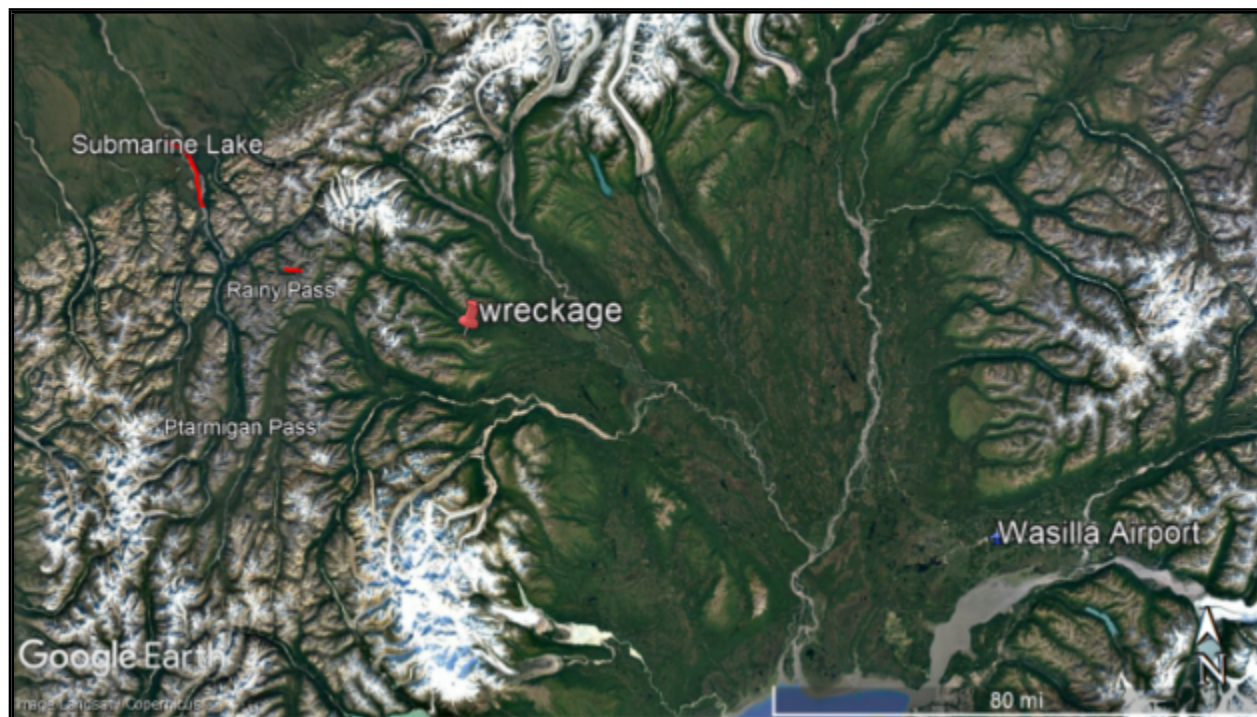
A review of archived FAA primary radar data revealed that the missing airplane departed Submarine Lake at 1655 and flew south along the south fork of the Kuskokwim River at an altitude of about 4,000 ft mean sea level (msl) (about 2,500 ft above ground level [agl] and below surrounding mountain tops). See figure 1. The radar track ended about 10 miles south of Submarine Lake 8 minutes after takeoff. A target that was believed to be the missing airplane appeared 11 minutes later, 5 miles north of Rainy Pass, at an altitude about 6,700 ft msl, heading east. The airplane climbed to 6,900 ft msl before the

track ended 1.4 minutes later. At 1715:09, the last radar data target was recorded on a track of about 110°, a groundspeed of 102 knots, and an altitude about 1,000 ft above the nearest mountain peak. The highest terrain in the vicinity of the expected flight route was 6,500 ft msl, and then decreased to about 4,000 ft msl near the wreckage.

Figure 1. Radar flight track data (red) and wreckage location.

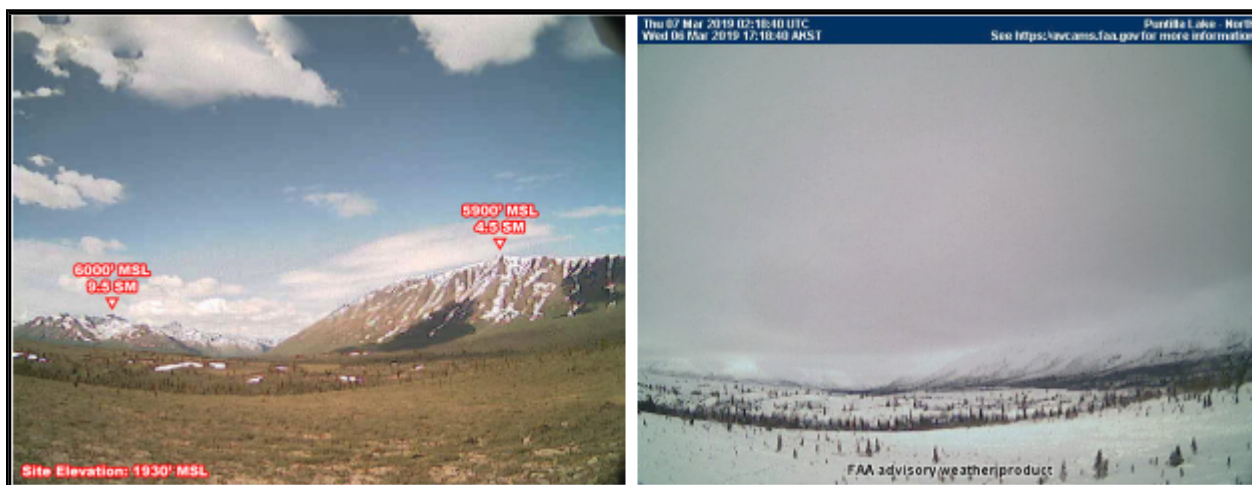
Archived images from FAA aviation weather cameras at Puntilla Lake, located 16 miles west of the accident site, depicted obscured mountain tops and visibility between 4.5 and 9.5 miles about the time of the accident (see figure 2).

Figure 2. Images from the FAA Puntilla Lake -North weather camera on a clear day (left) and at 1718 on the day of the accident (right.)

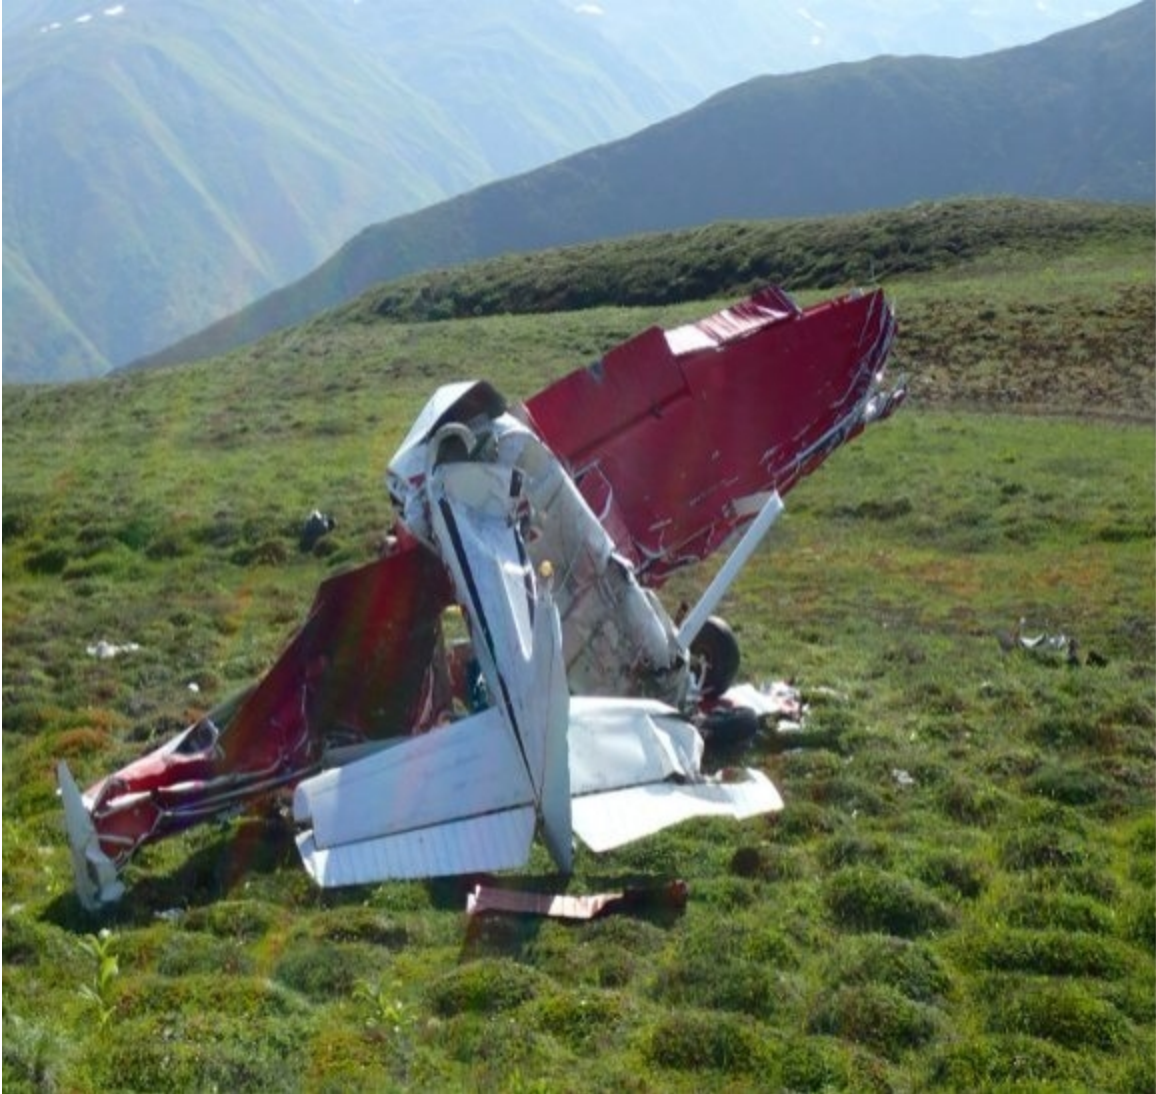
A postaccident examination of the airframe and engine revealed no evidence of mechanical malfunctions or failures that would have precluded normal operation. The damage to the airplane indicated that it impacted the ground in a nose-down, near-vertical attitude with a rear fuselage twist, which was consistent with an aerodynamic stall and spin.

The airplane came to rest on an open, grass-covered ridge, at an elevation of 3,241 ft, and a heading of 107°. The fuselage was about 80° nose-down, leaning left 30°. All major components were present at the site, and the debris was contained within a radius of 30 ft. The aft fuselage was twisted and displaced to the left with extensive buckling evident. The nose and engine section were displaced right and crushed into the ground. The wings were attached and exhibited extensive fore-to-aft leading edge deformation and compromised fuel tanks (see figure 3).

Figure 3. The airplane at the accident site.
