PIC16(L)F1824/1828 Family Silicon Errata and Data Sheet Clarification

The PIC16(L)F1824/1828 family devices that you have received conform functionally to the current Device Data Sheet (DS41419D), except for the anomalies described in this document.

Note: This document summarizes all silicon errata issues from all revisions of silicon, previous as well as current. Only the issues indicated in the last column of [Table 2](#) apply to the current silicon revision (**A5**).

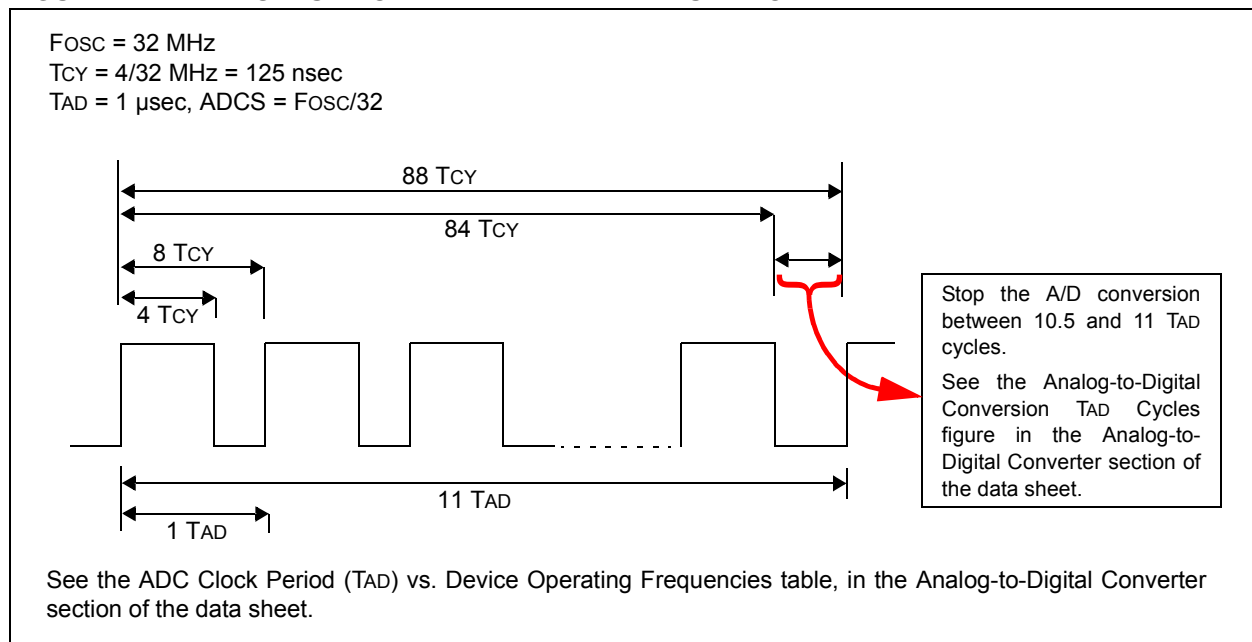
FIGURE 1: INSTRUCTION CYCLE DELAY CALCULATION EXAMPLE

An ADC conversion may not complete under these conditions:

1. When Fosc is greater than 8 MHz and it is the clock source used for the ADC converter.
2. The ADC is operating from its dedicated internal FRC oscillator and the device is not in Sleep mode (any Fosc frequency).

When this occurs, the ADC Interrupt Flag (ADIF) does not get set, the GO/DONE bit does not get cleared, and the conversion result does not get loaded into the ADRESH and ADRESL result registers.

In Figure 1, 88 instruction cycles (Tcy) will be required to complete the full conversion. Each TAD cycle consists of 8 Tcy periods. A fixed delay is provided to stop the A/D conversion after 86 instruction cycles and terminate the conversion at the correct time as shown in the figure above.

Note: The exact delay time will depend on the TAD divisor (ADCS) selection. The Tcy counts shown in the timing diagram above apply to this example only. Refer to Table 3 for the required delay counts for other configurations.

Method 3: This method is provided if the application cannot use Sleep mode and requires continuous operation at frequencies above 8 MHz. This method requires early termination of an ADC conversion. Provide a fixed time delay in software to stop the A-to-D conversion manually, after all 10 bits are converted, but before the conversion would complete automatically. The conversion is stopped by clearing the GO/DONE bit in software. The GO/DONE bit must be cleared during the last ½ TAD cycle, before the conversion would have completed automatically. Refer to Figure 1 for details.

```
BSF    ADCON0, ADGO    ; Start ADC conversion
                        ; Provide 86
                        ; instruction cycle
                        ; delay here
BCF     ADCON0, ADGO    ; Terminate the
                        ; conversion manually
MOVF    ADRESH, W       ; Read conversion
                        ; result
```

TAD	Instruction Cycle Delay Counts
Fosc/64	172
Fosc/32	86
Fosc/16	43
