# CAPITAL NEEDS ASSESSMENT

## Meany Lodge

47.2804, -121.3203 Stampede Pass Road, Easton, WA 98925

**April 5, 2022**

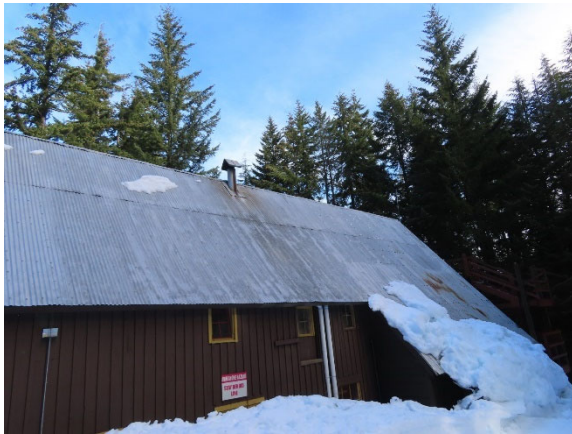
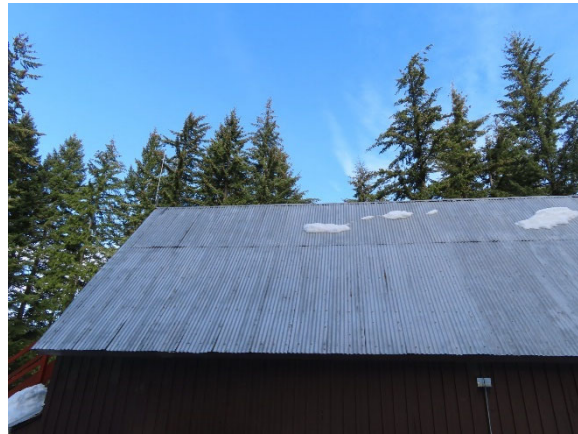
The roof of this building has reached the end of its serviceable life and should be replaced at this time. We recommend the installation of a new standing-seam metal roof surface in 2022. If installed properly, the new metal roof surface should have a lifespan of 30 to 50 years; for budgetary purposes, we have assumed 40 years.

Metal Roof on Lodge

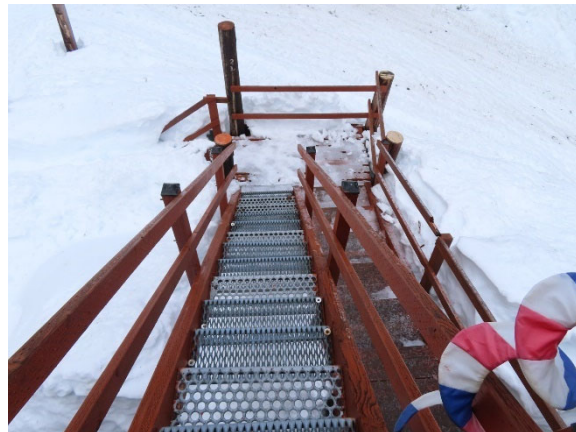
There are stairwells/fire escapes on the west and east sides of this building. We have included rot repairs and painting of these stairwell/fire-escapes on the same schedule as the rest of the buildings and have factored this into the budget.

West Fire Escape

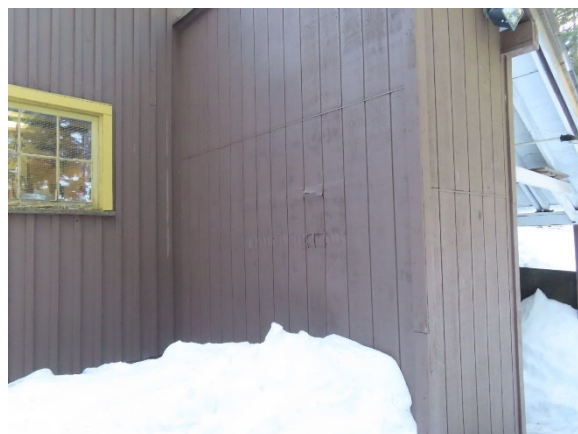
There is consistently snow up against the wood siding and trim of this building, which consistently lead to wood rot in the siding and trim of this building. We understand that volunteers at this lodge periodically replace siding and trim, as necessary. However, we have budgeted for a spot siding and trim repair prior to each painting cycle.

T1-11 Plywood Siding Delaminating

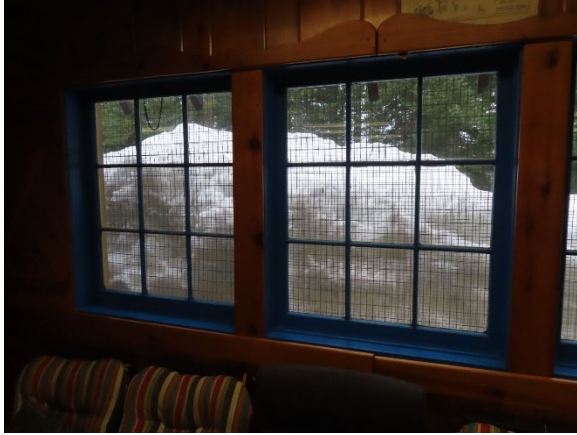
The majority of the windows on this building are older and there is an opportunity to significantly improve the energy efficiency of this building by replacing these windows with new vinyl-frame windows. The current windows do appear to be adequately restricting moisture entry to the building, so this is not an urgent need. Therefore, we have budgeted for window replacement in 2027; five years from now. This upgrade can be moved up or back as necessary.

Typical Windows

Until the windows are completely replaced, we recommend merely spot replacing cracked windows as necessary via the general operating budget.

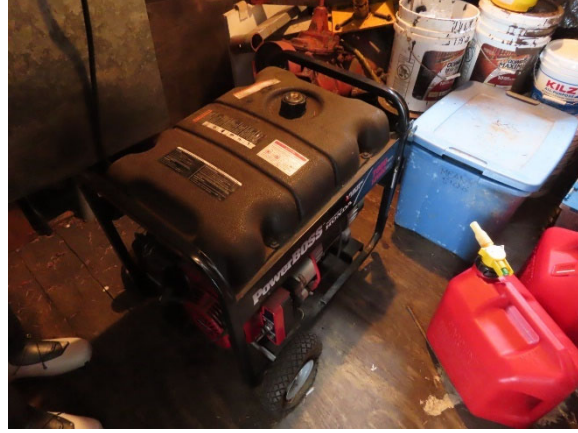
One of Two Honda Generators

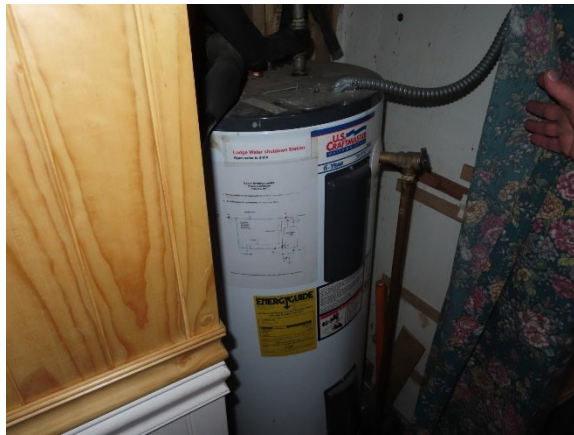
50-Gallon Lower-Level Water Heater Manufactured in 2003

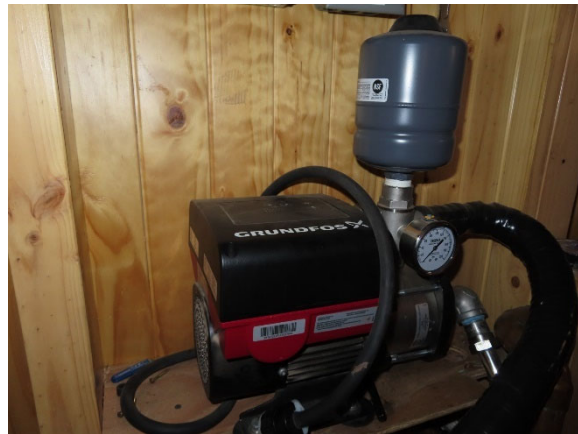
Grundfos Booster Pump

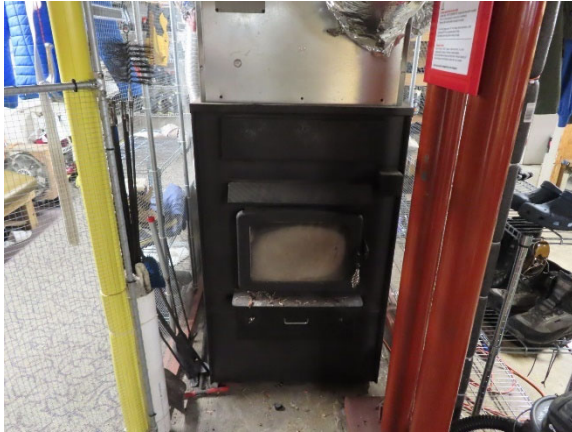
The building is currently primarily heated by a wood stove. We understand that the committee ultimately plans to replace this wood stove with a wood boiler in the next 5 to 7 years. For the purpose of this study, we have planned for this wood boiler to be installed in 2028 at a budgetary cost of \$12,000.

Basement Wood Furnace

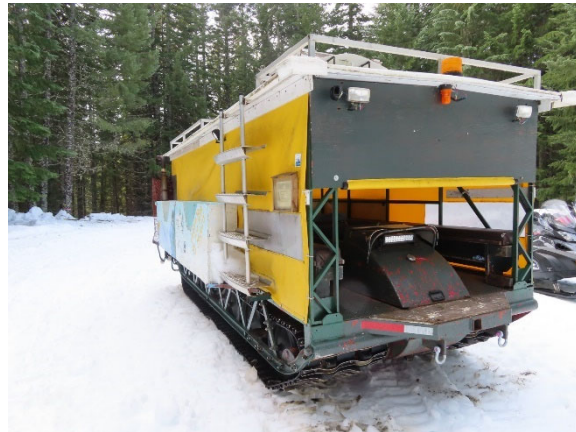
“Tomcat” Modified People-Mover Snow Cat

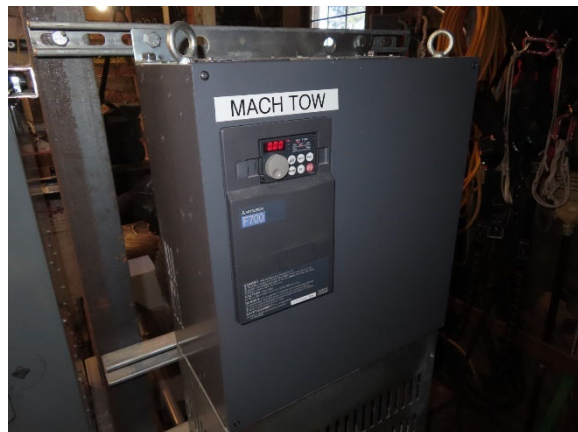
We understand that the controls for all 3 rope tows were installed in 2013. We have also assumed that these controls will have a 20-year lifespan.

Mach Tow Controls
