Planning for the Un-plannable: Redundancy, Fault Protection, Contingency Planning and Anomaly Response for the Mars Reconnaissance Orbiter Mission

Todd J. Bayer¹

NASA Jet Propulsion Laboratory, California Institute of Technology, Pasadena, California, 91109

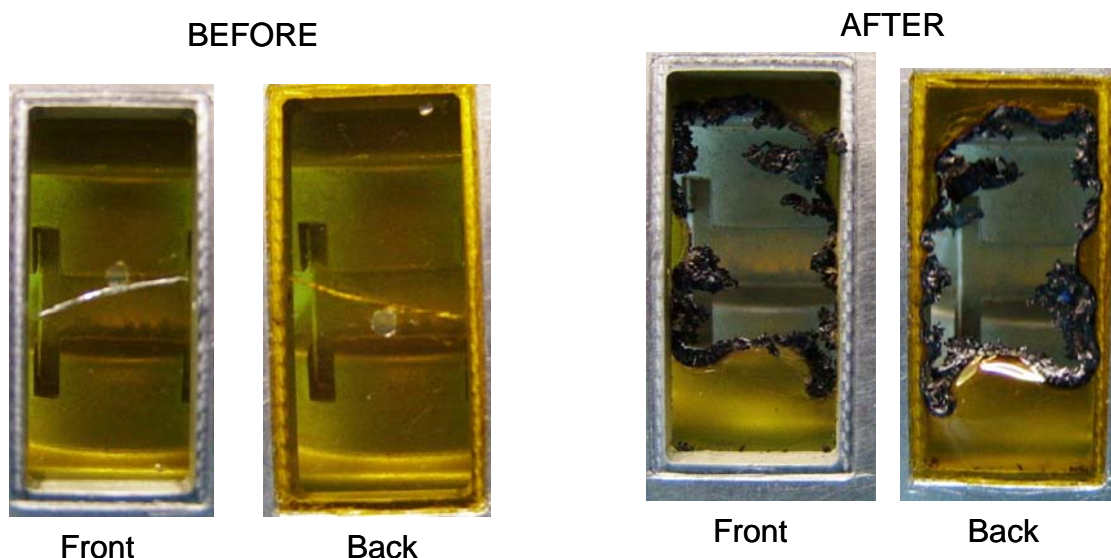
Figure 3. Kapton Pyrolysis From Metal Sliver at 100W RF

Analysis of the onboard telemetry and RF downlink characteristics indicates that the switch is stuck in an intermediate position. The RF signal is ~1dB less than nominal, indicating that a mechanical interference is preventing proper positioning of the switch mechanism. Clearances within the switch are small, which means that small amounts of debris could easily cause the switch rotor to bind. An extensive investigation concluded that the most likely root cause was conductive debris (perhaps from flaked plating) floating in the zero g environment, which eventually came into contact with a polyimide tape window at one of the active WTS RF ports. These windows are used as a contamination barrier on the WTS RF ports, but they may have contributed to the severity of the anomaly. Vent holes in the windows can admit contamination, adhesive on the inward-facing side of the tape can entrap it long enough to initiate RF breakdown, and the breakdown can cause the polyimide tape itself to pyrolyze, injecting a large amount of polyimide tape debris into the switch and causing it to bind. Laboratory testing has demonstrated the window destruction mechanism, as shown in Fig. 3. The initiating debris used in testing, a small metal sliver, can be seen in the “before” images. Possible causes other than mechanical interference have also been examined, but do not appear consistent with the observable data. The project does not currently plan any more actuation attempts of the failed wave guide switch; further loss of downlink power would be possible if the switch were to stick in a less favorable position than it is in now.

Lessons learned: The primary lessons learned in this anomaly relate to telecom subsystem design and the consequences of contamination. The use of polyimide tape as a contamination barrier at the RF ports of the waveguide switch provides a significant source of additional debris if the polyimide pyrolyzes. The polyimide tape adhesive provides a mechanism to entrap conductive debris which could trigger pyrolysis under the right conditions. When designing high power RF systems, more serious consideration should be given to the role of contamination in causing RF-breakdown.
