Scope

The SAMA7G5 Series device that you have received conforms functionally to the current SAMA7G5 Series device data sheet (DS60001765) or SAMA7G5 Series System-in-Package (SiP) data sheet (DS50003577), except for the anomalies described in this document.

Table 1. SAMA7G5 Series Device Identification

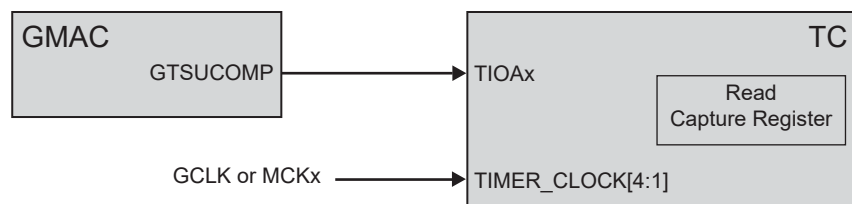
The trigger/capture input B of TC1.TIOB1 is driven internally by the GTSUCOMP signal of the Ethernet MAC (GMAC), but the feature does not work.

Routing the GTSUCOMP signal to one timer counter input can be done at PCB level. GTSUCOMP is multiplexed on the PB2 line, therefore PB2 can be externally looped back to one of the timer counter inputs, as shown in the following figure.
