# Cement Bond Log Report for 33847-CBL.las

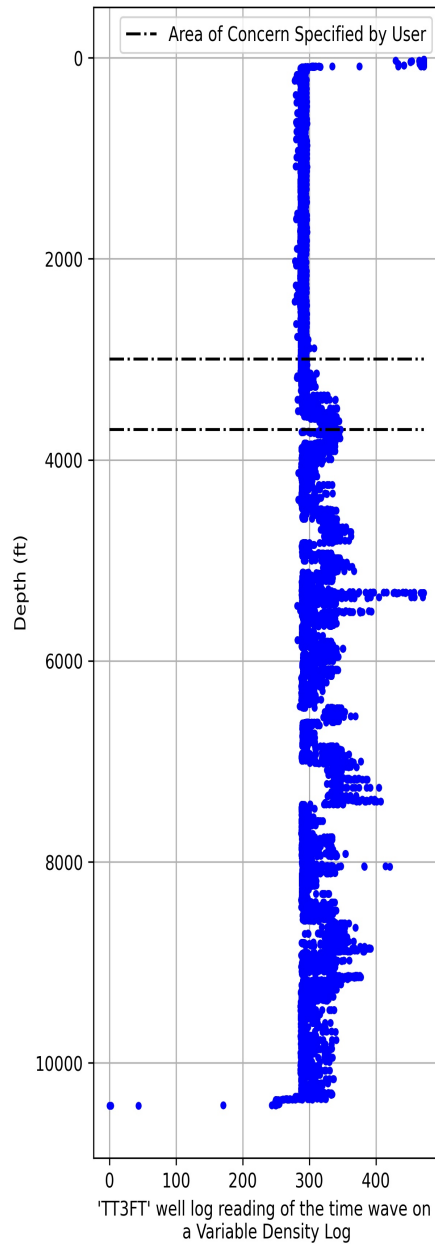
This is the time of return for the transmission  
on 33846-CBL.las

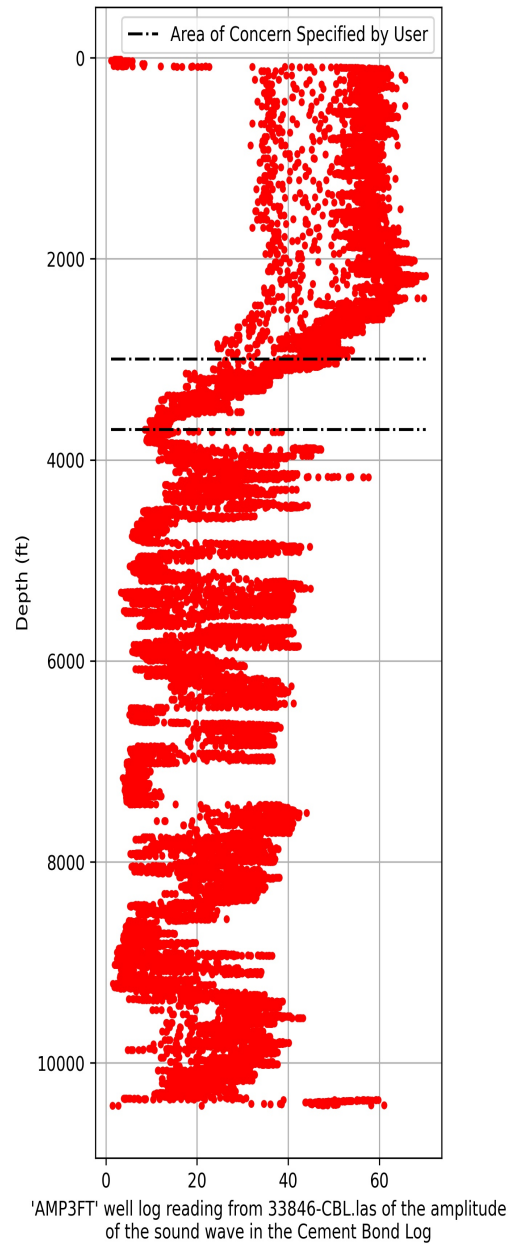
This is the sound wave amplitude  
of 33846-CBL.las
