Tiltmeter Monitoring Report: m032

A. Peens-Hough, 03/02/2020

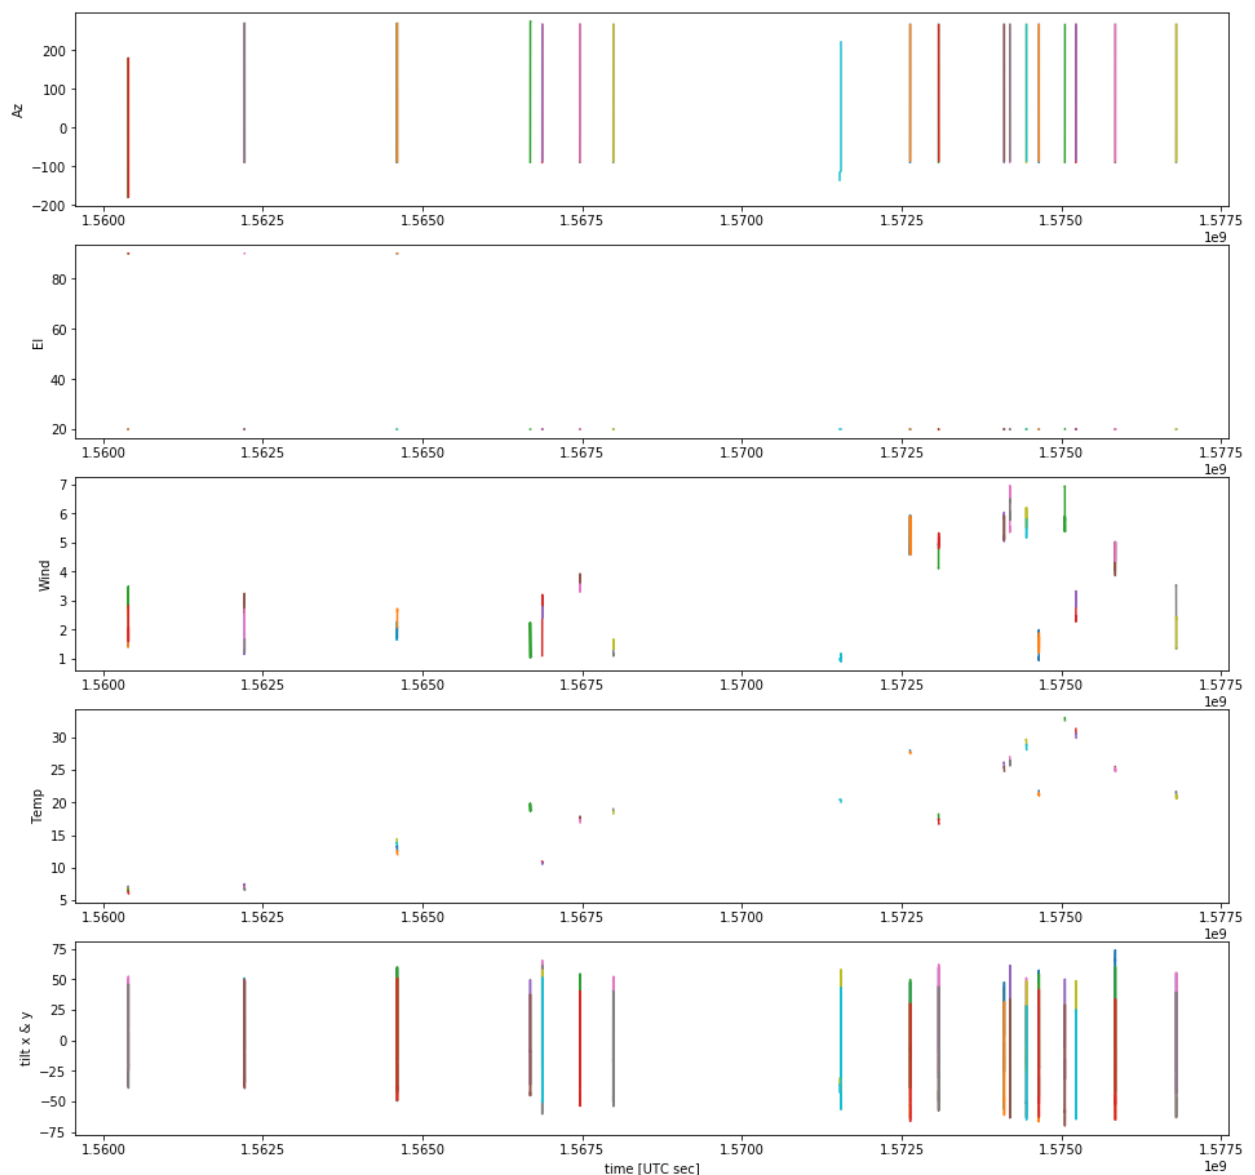
Figure 1: Overview of raw data record for m032.

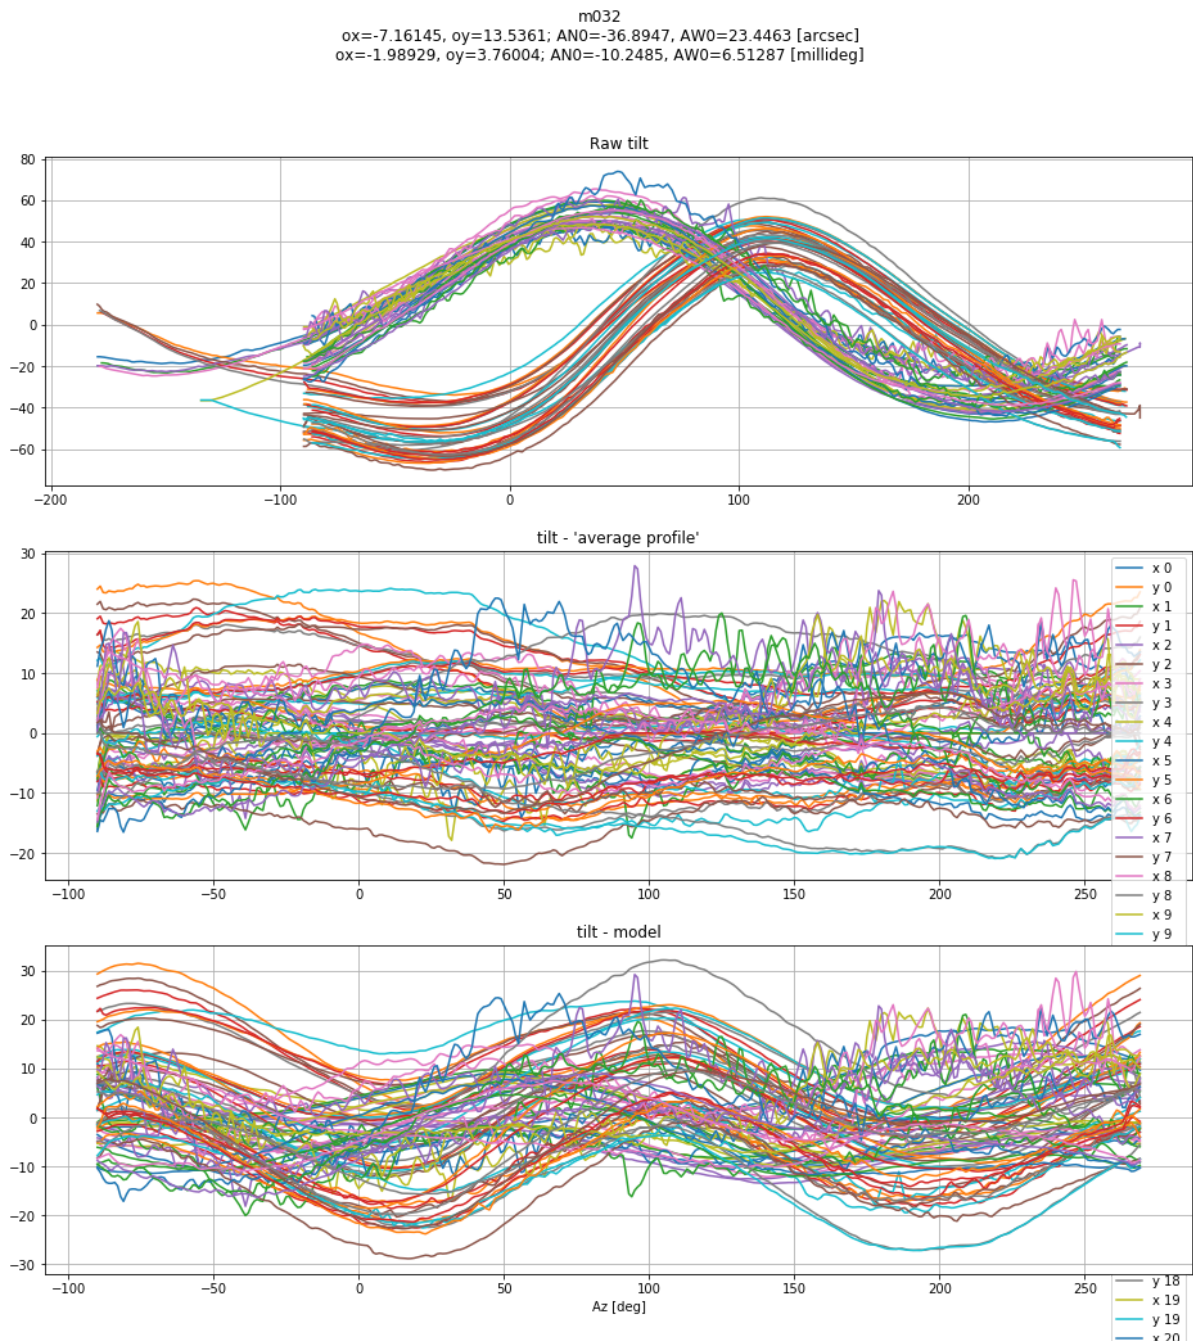
Figure 2: Summary of measured tilt data and residuals to "reference models".

The fitted coefficients show a clear drift in the 'oy' coefficient over the period spanning from around 31 July 2019 (fit index ~7) until around 18 November 2019 (fit index ~24). This coefficient represents the offset of the tilt sensor platform relative to the pedestal. There is no significant evidence for drift in the orientation of the pedestal itself. Such a drift is unexpected from a physical design perspective and may be an indication that the sensor's temperature scale factor is configured incorrectly **ACTION1**.

ACTION1: investigate the cause of the drift of 'oy'- first confirm that tilt sensor temperature scale factor agrees with calibration certificate.

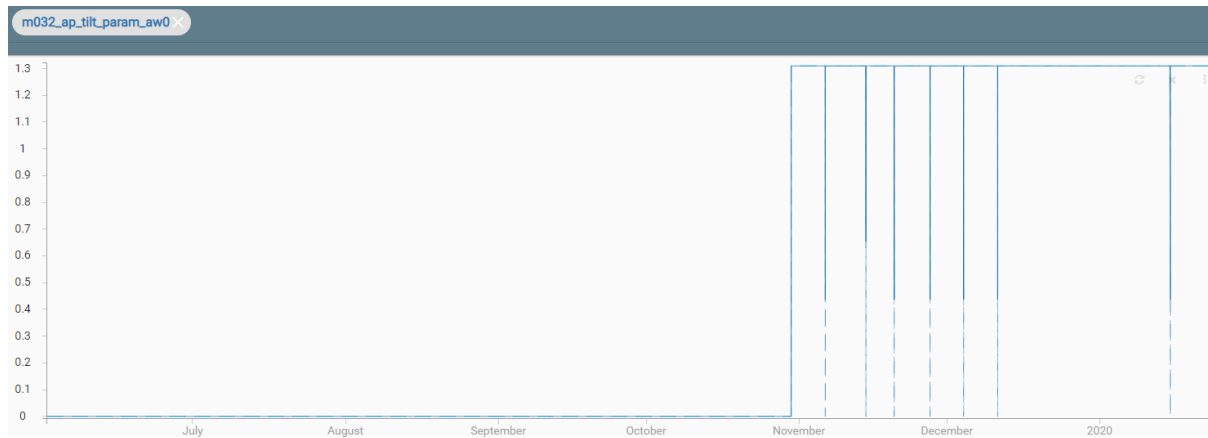
From the sensor history it can be seen that the value for tilt-param-aw0 changed on 30 October 2019 from the earlier value 0 to the value reflected in the table above. This was the desired outcome of ACU release VA_AP-1.2.5 that was installed on that date.

Figure 4: Sensor log record for m032.ap.tilt-param-aw0

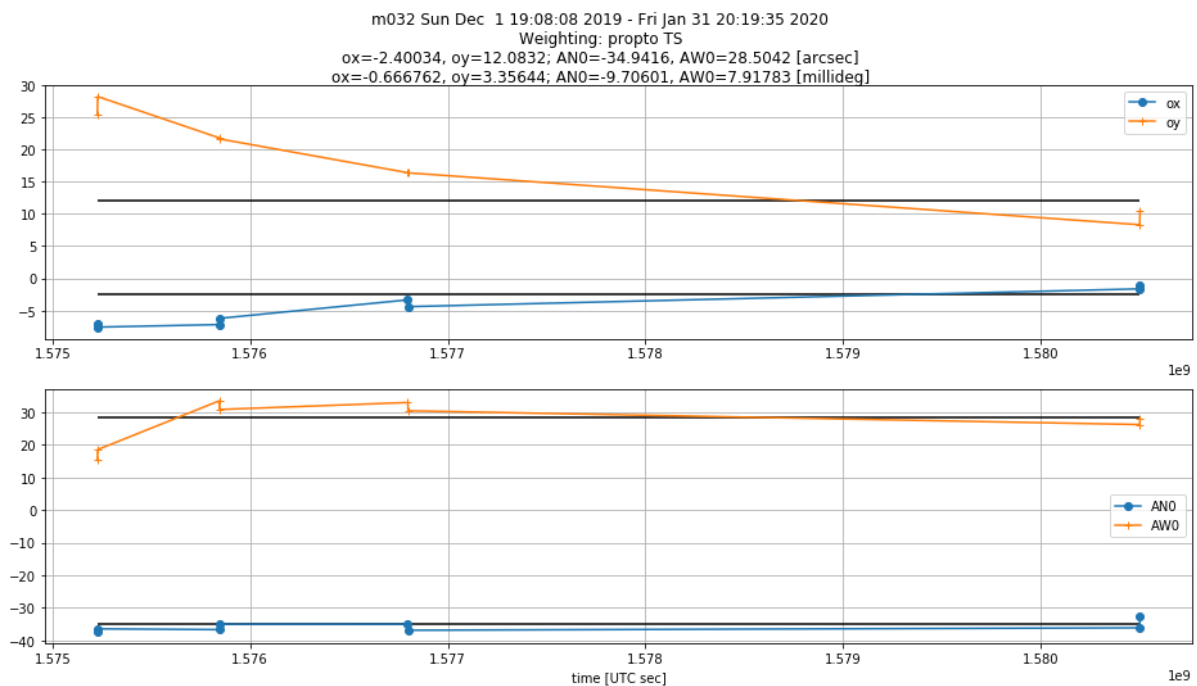
Tilt calibration as on 01/02/2020:

Note: offsets were NOT added to values configured at time of tilt cal (trends do not seem to be influenced by config change, specifically offsets don't converge to zero as expected if necessary to add "configured" offsets)

X offset: -0.598 -> -0.648

Y offset: 2.396 -> 3.305

AN0: -10.21 -> -9.699

AW0: 6.90 -> 7.930

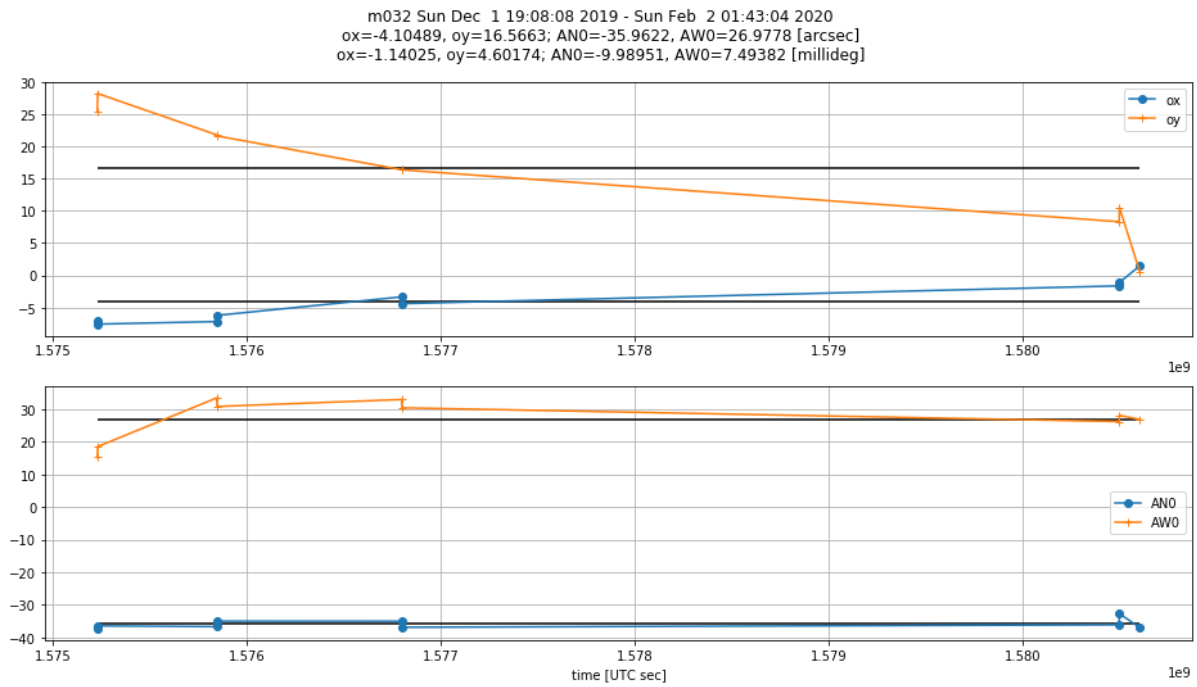
Tilt calibration as on 02/02/2020:

Note: now it seems clear that the offsets are indeed influenced by configuration change, so it is correct to add "configured" offsets in force when tilt is measured for calibration!

X offset: -0.648 -> -0.648 +0.579 = -1.23

Y offset: 3.305 -> 3.305 +0.398 = 3.70

AN0: -9.699 -> -10.32

AW0: 7.930 -> 8.14

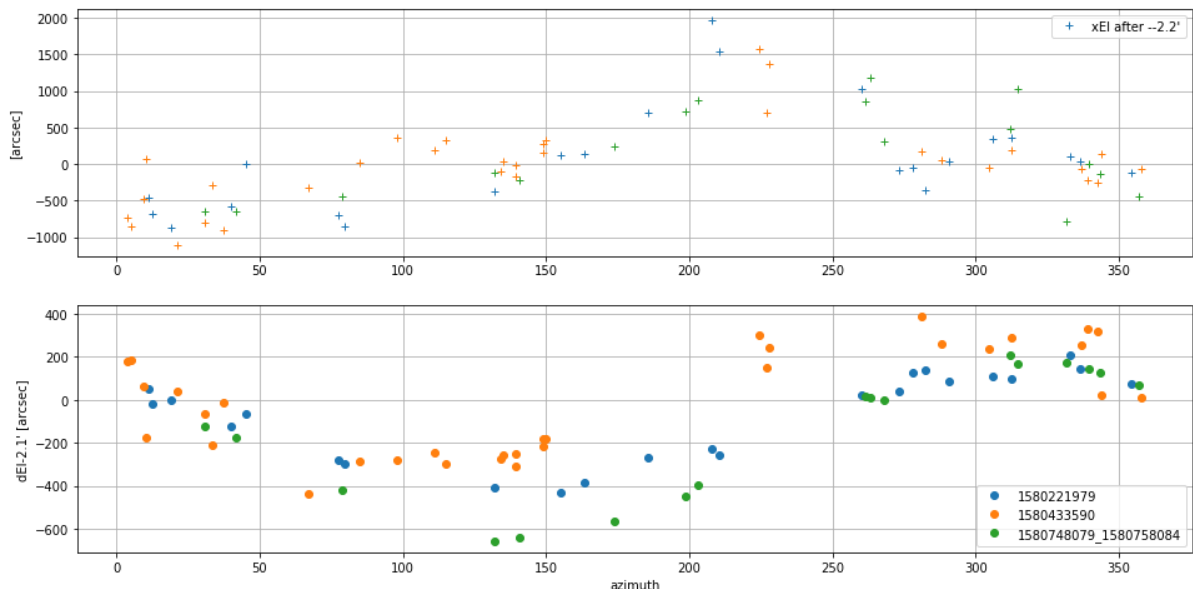
Assessment: FAIL! dEI has not been reduced further and the AN & AW terms remain far from zero. Comparison of pointing residuals vs azimuth for m032 with 2019 calibration (blue), after first calibration update (orange) and after second calibration update (green). This is the only means available to assess the improvement from AN0,AW0.

These results show very little improvement from the calibration updates, suggesting that either the tilt sensor is faulty (in a systematic but non-physical way?) or there's a severe mechanical fault (also predominantly systematic).
