**Summary of Issue:**

Some BoSL boards are unable to communicate with the inserted SIM card. Issue specifically with communication between SIM7000 module and SIM card.

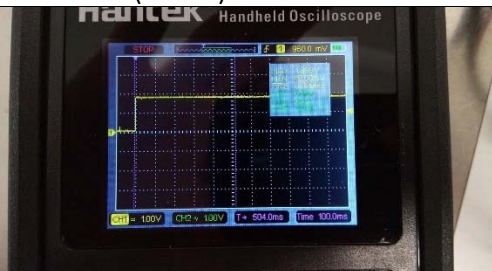
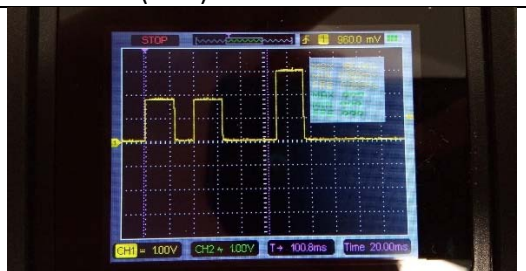
PIN	Waveform (GOOD)	Waveform (BAD)
SIM_VDD

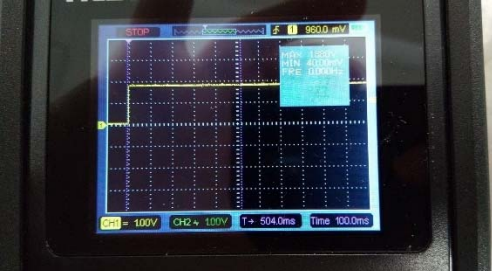
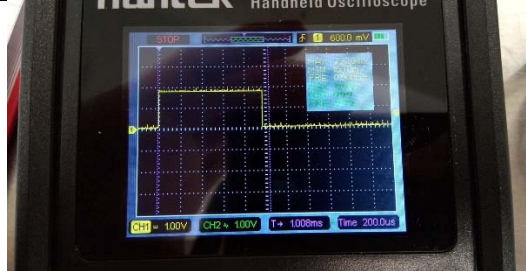
SIM_RST

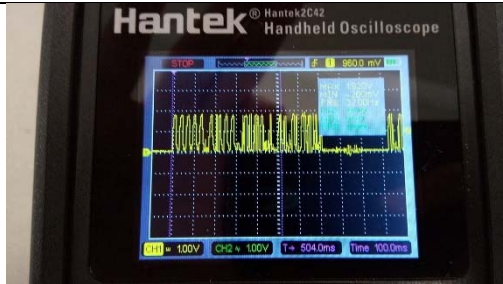
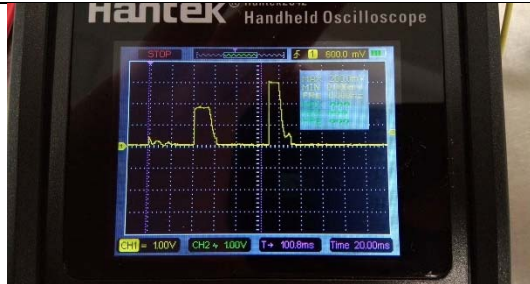
SIM_CLK

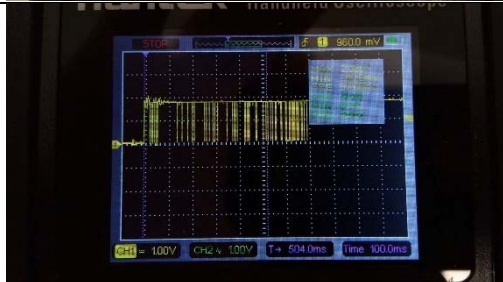
SIM_DATA

No Reading

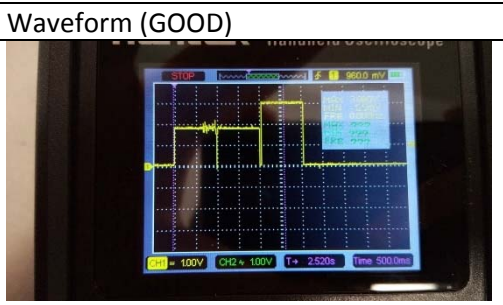
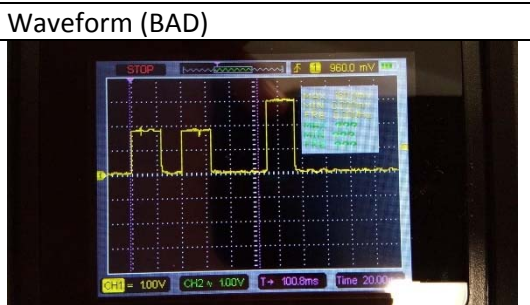
PIN	Waveform (GOOD)	Waveform (BAD)
SIM_VDD

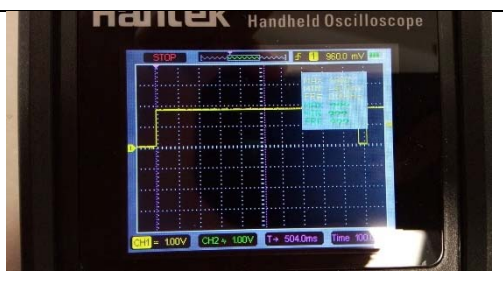
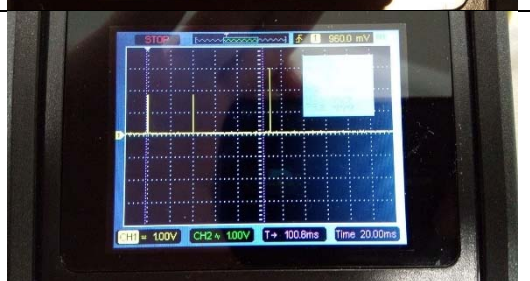
SIM_RST

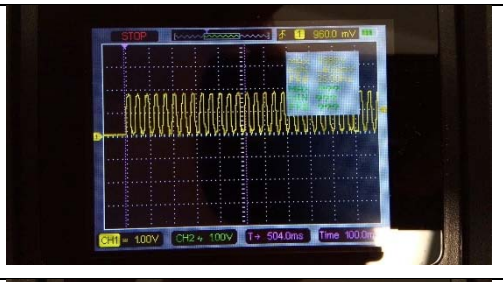
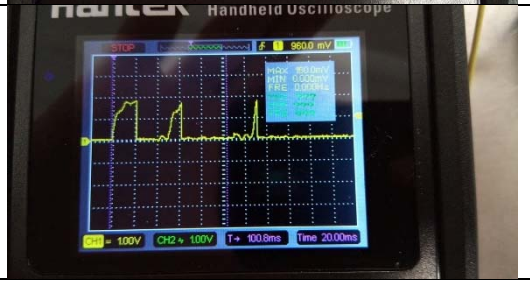
SIM_CLK

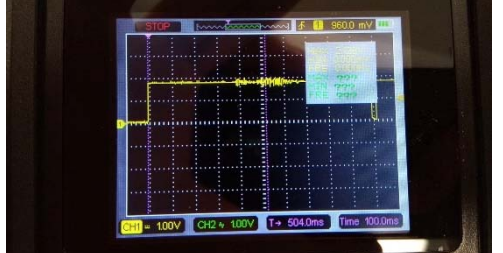
SIM_DATA

No Reading
