Mixed Flowing Gas Test

An Accelerated Corrosion Test

Reliability Engineering | Hugo SF Tsai

2022/05/12

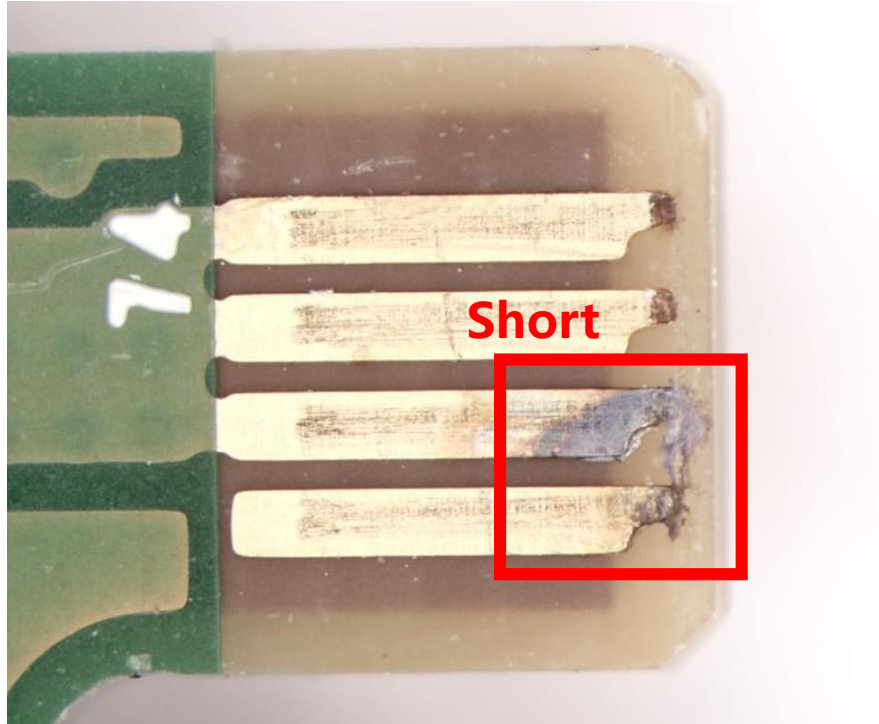
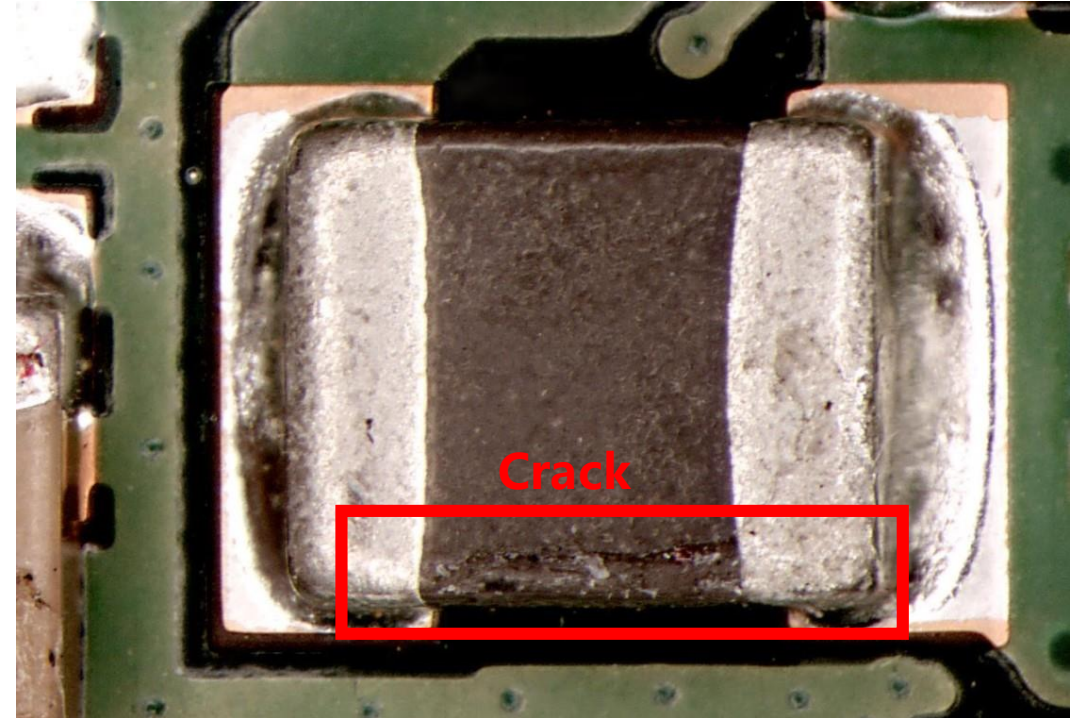
Severe Corrosion Samples

MFG test samples from Microsoft PE4010 m.2 issue (DoE MFG).

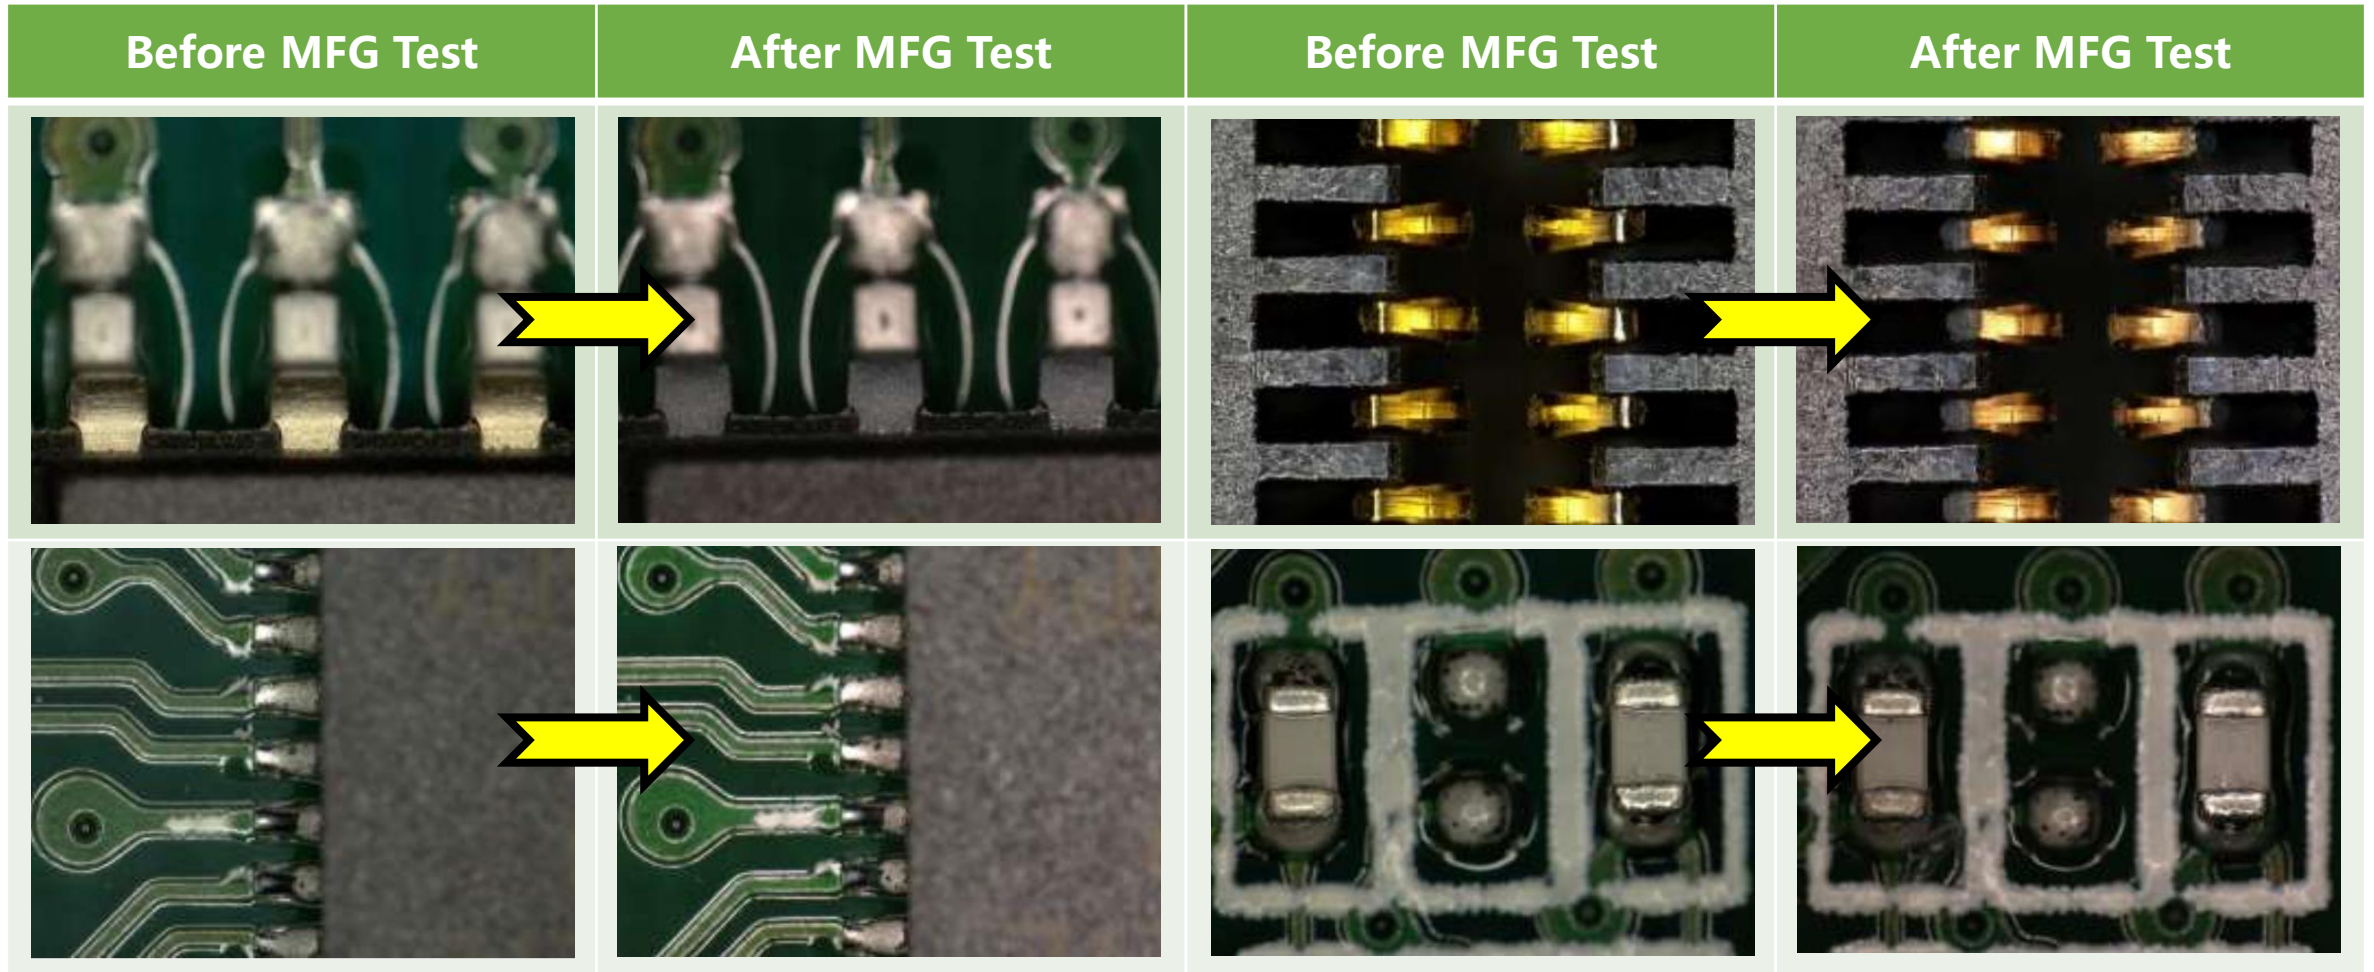
Result (2/3) - Visual Inspection

#	Description
1	The functional test, which determines the final result, shows failed in this test run though the visual inspection seems to show passed.
2	The corrosion thickness growth can be satisfied the ISA 71.04 G3 severity level with 0.64-year warranty and 5.81-year warranty for silver and copper, respectively.
