# RESIDENTIAL PROPERTY INSPECTION REPORT

**Dallas Home**

**4523 Oak Lawn Ave, Dallas, TX**

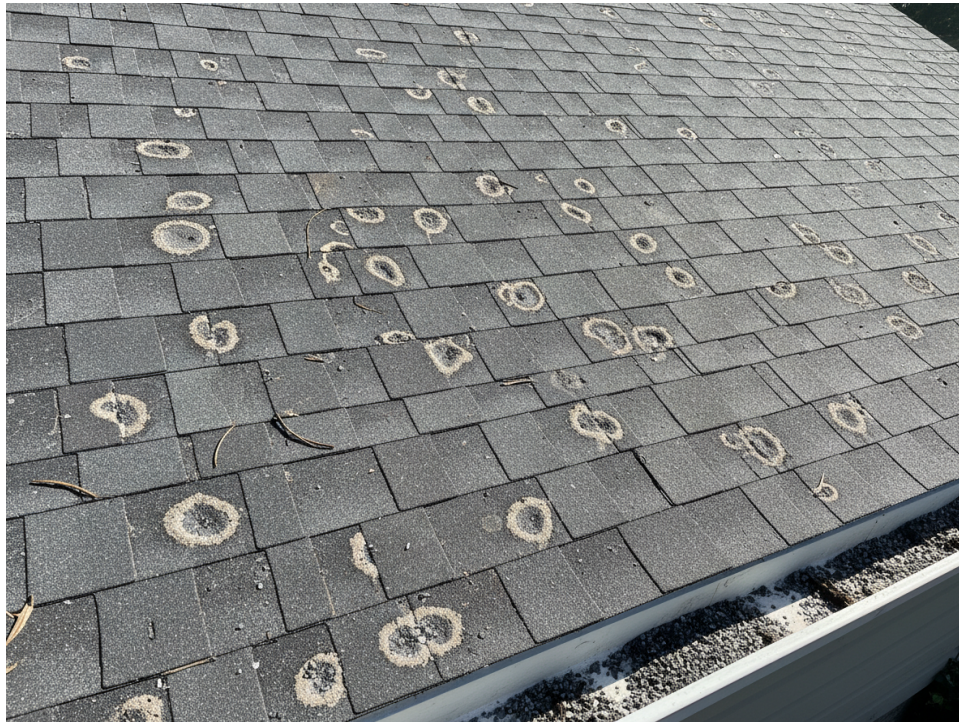
*Photo: ROOF SYSTEM*

Roof shows normal weathering for age. No missing or damaged shingles observed. Flashing appears intact.
