RESIDENTIAL PROPERTY INSPECTION REPORT

San Diego Condo
1523 Garnet Ave, San Diego, CA

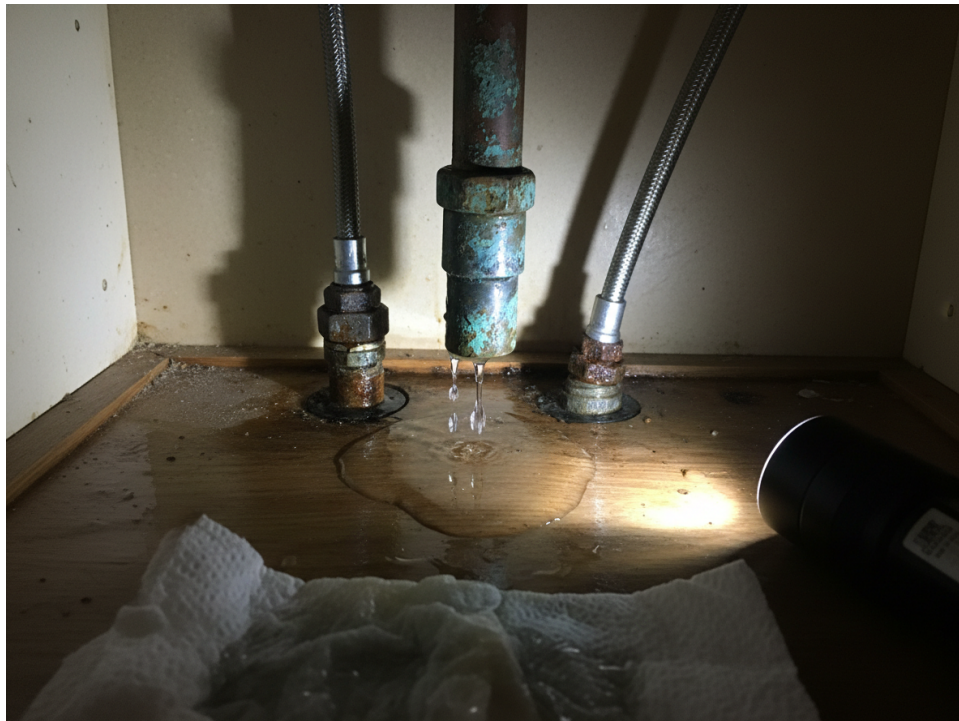
Photo: PLUMBING SYSTEM

Plumbing in excellent condition. No signs of corrosion or leaking at visible connections.
