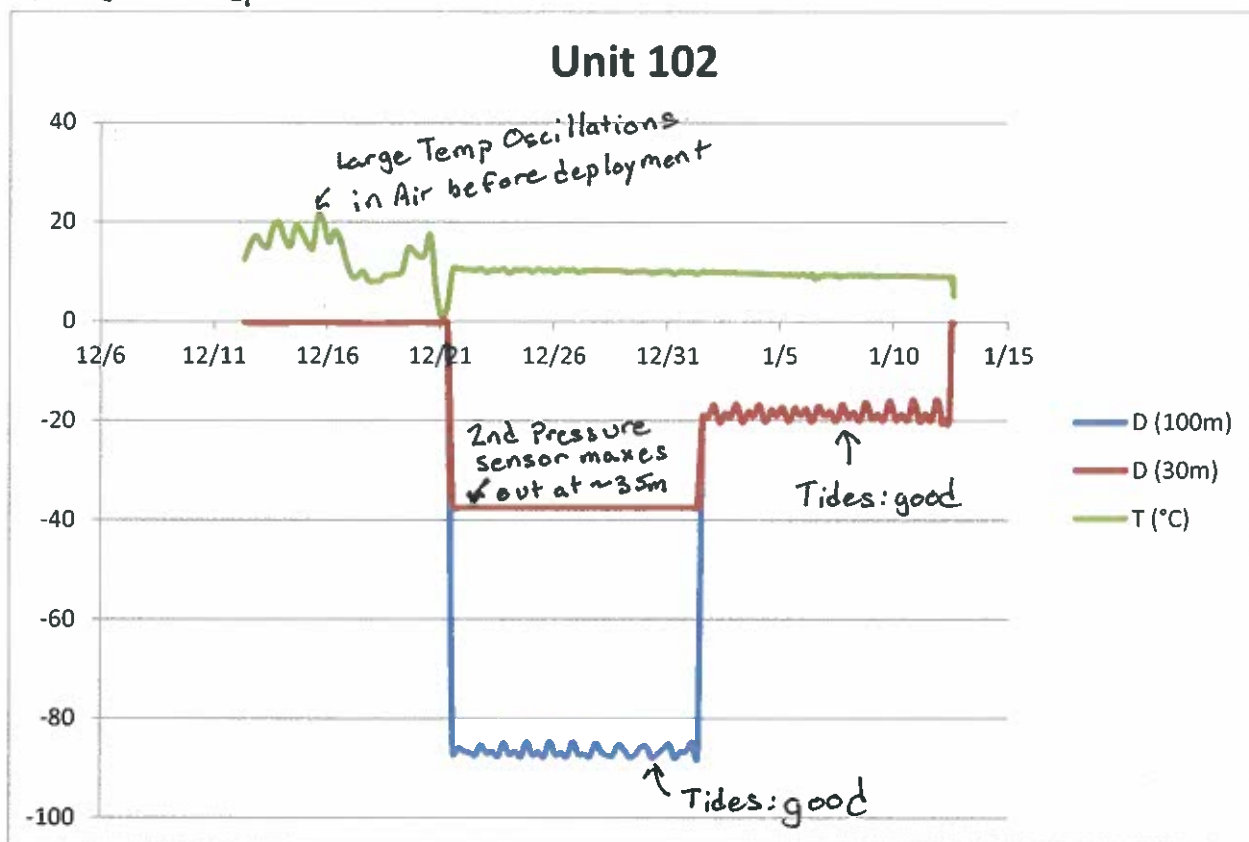
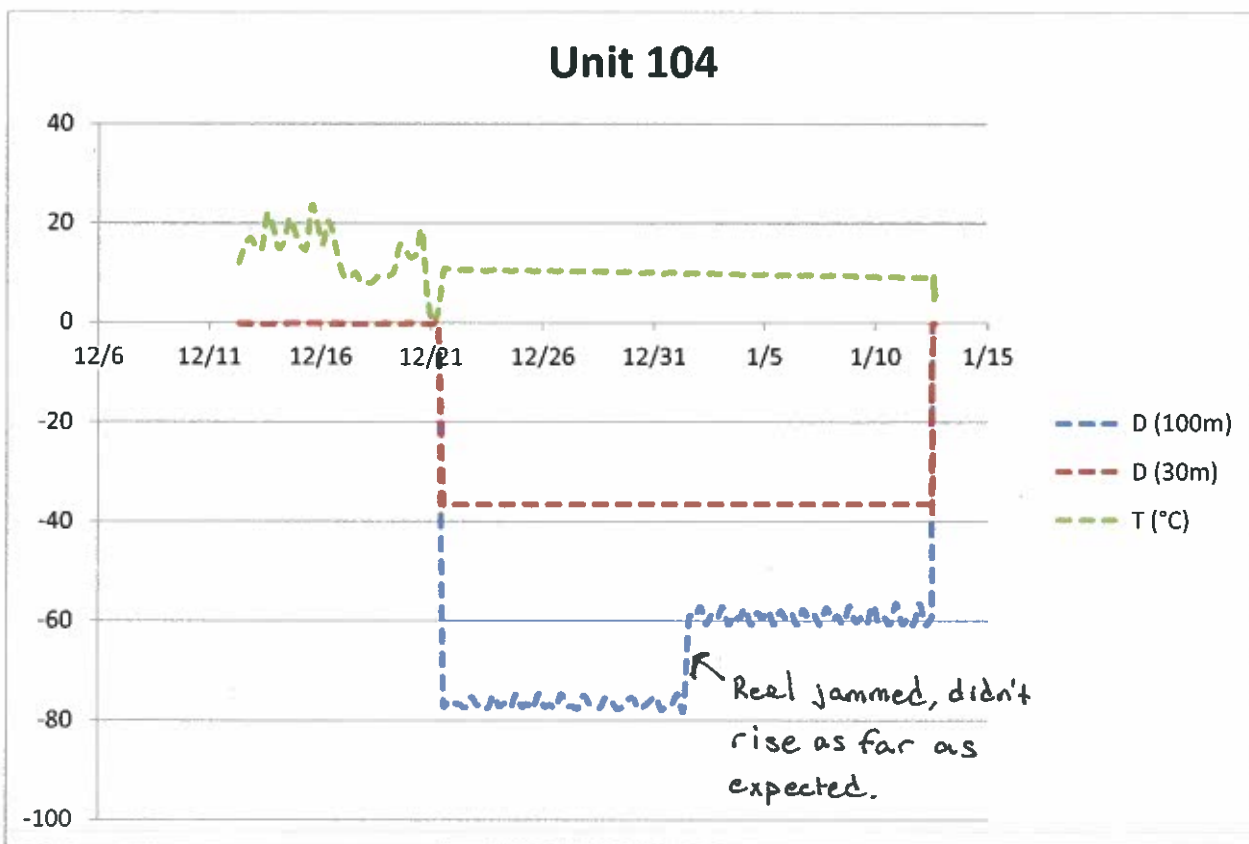
- Temp + Pressure look good
- GPS worked as soon as at surface
- Battery, Programming, Mechanics all Sat.

- Set wrong time on burn wire - no profile
- PAR only occasionally sampled: issue w/ software, hopefully easy fix
- Iridium didn't work on 1st attempt: could be no satellite overhead or not enough freeboard. More testing needed.

- Check PAR sensor sampling
- Re-deploy in Puget Sound for short test to get profile (2-5 days)
- Test Iridium transmissions in water: effects of freeboard and sea-state
