Jesse Hunt IV
36128 Caraway Rd
Denham Springs LA 70706

INSPECTION REPORT INDEX

DATE OF INSPECTION:	24/01/2022
START TIME:	08:30
END TIME:	10:30
CLIENT NAME:	Jesse Hunt IV
CITY & STATE:	Denham Springs, LA 70706

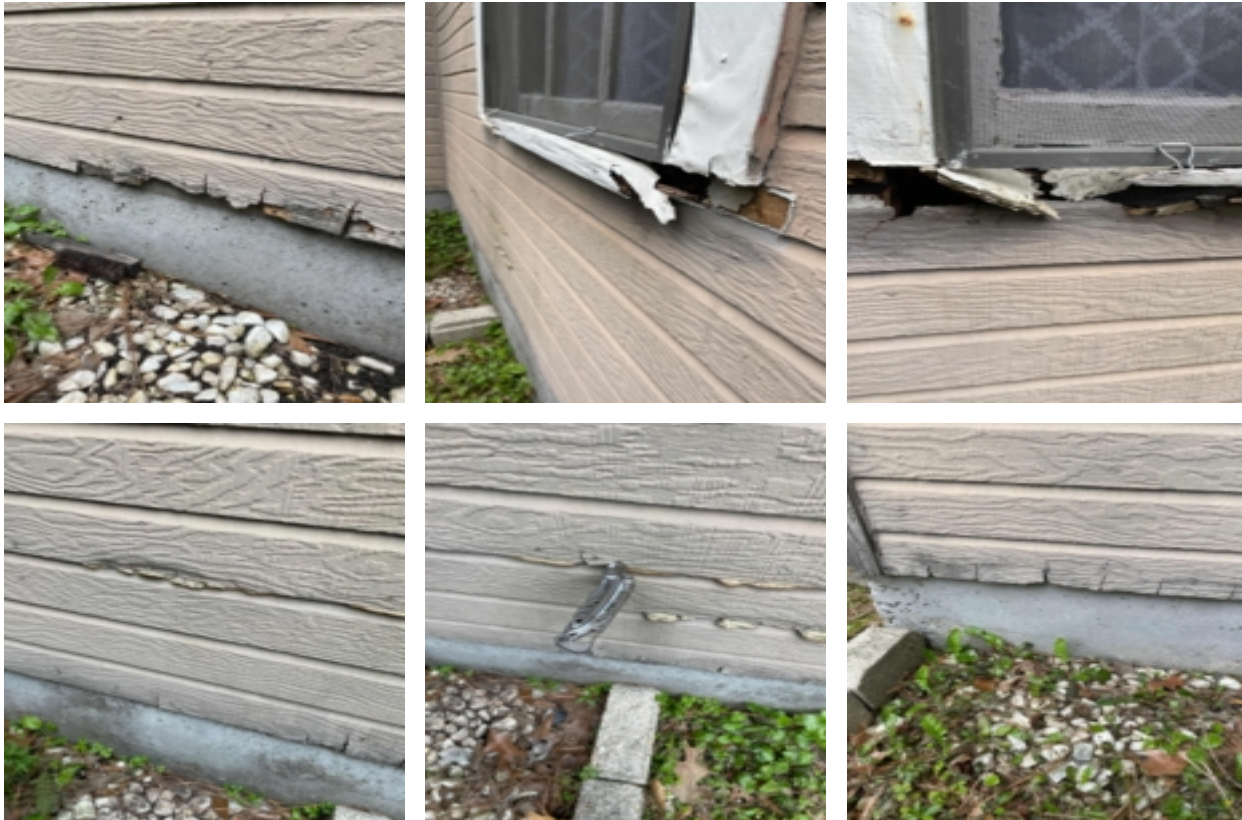
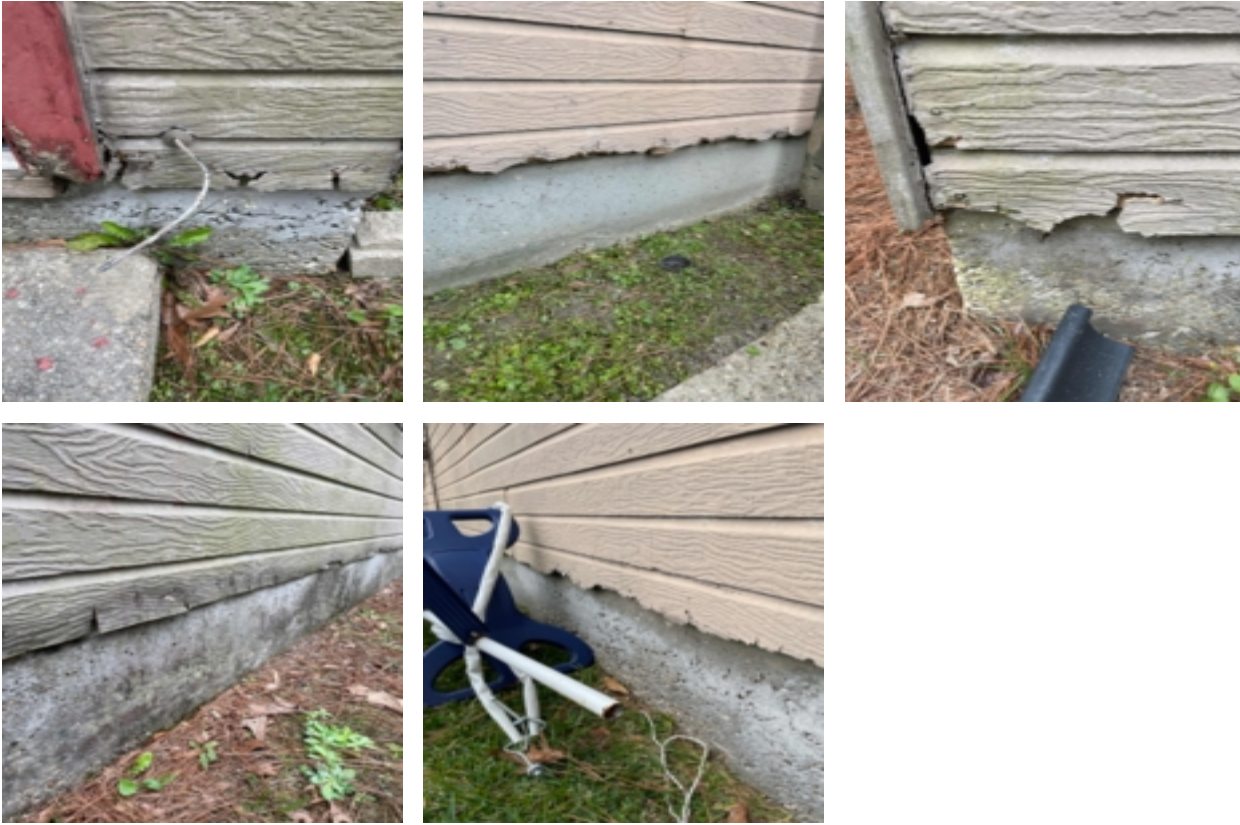
And bottom run of masonite siding is consistently damaged due to moisture around the perimeter of the home. Recommend further evaluation by a licensed contractor and remove/replace all moisture damaged wood.

Large opening in the masonite siding Noted under the front right window. Recommend further evaluation by a licensed contractor and repair/replace.

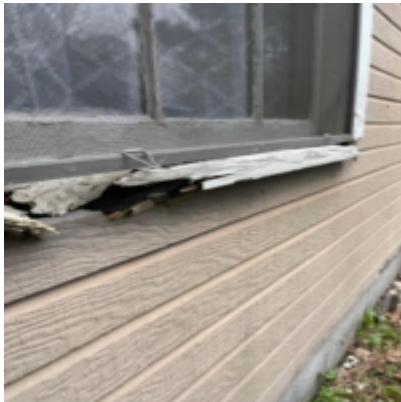
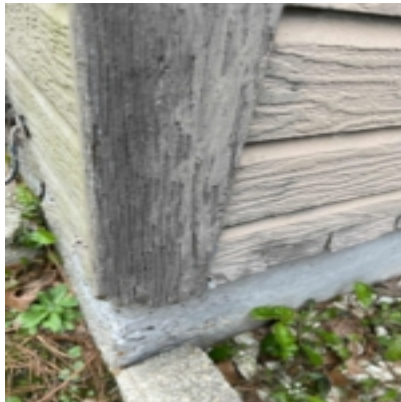
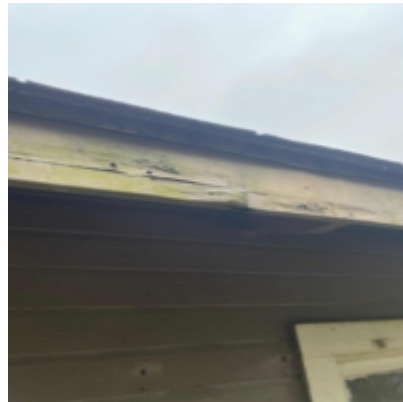
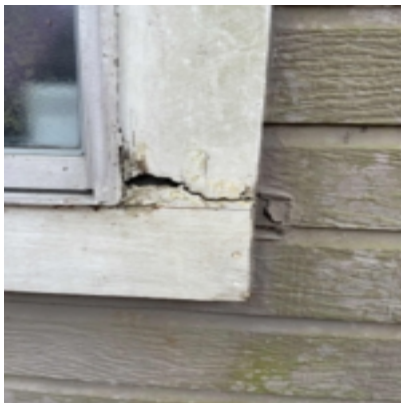
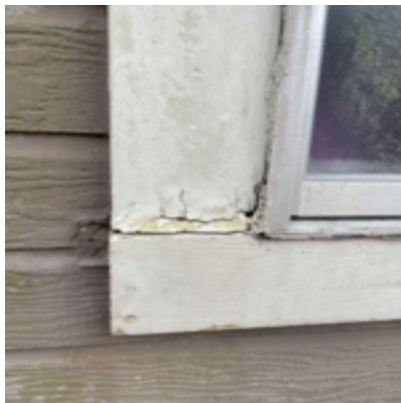
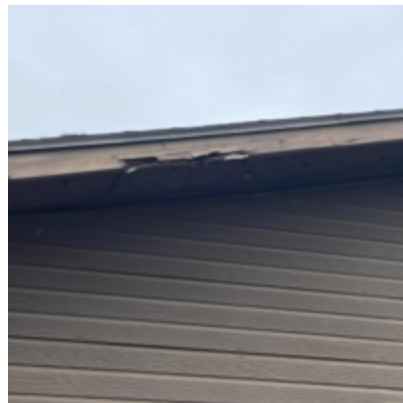
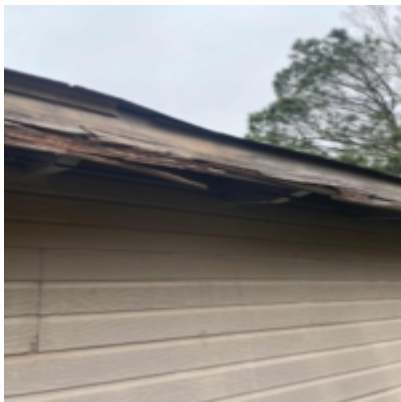
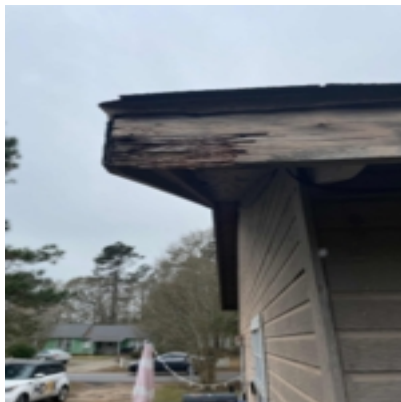
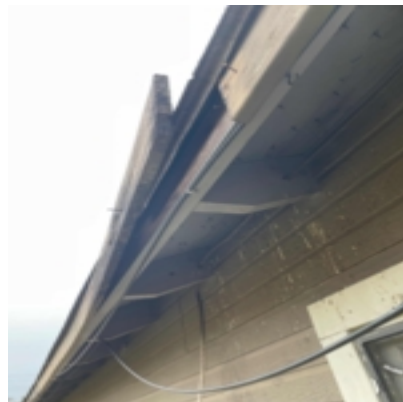
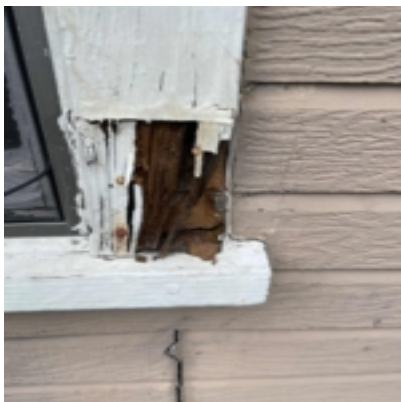
Moisture damage noted at the window trim at the front right window, left side window, right side window, and to rear windows. Recommend repair/replace all moisture damaged wood.

Several Moisture damaged pieces of corner trim Noted around the house.

Damaged fascia board noted on the right end and rear of home. Recommend further evaluation by a licensed contractor and repair/replace.

Recommend remove/replace all moisture damaged wood.

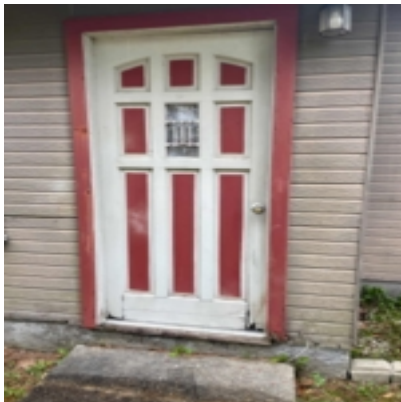
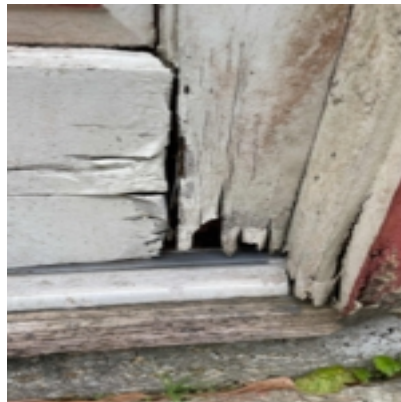
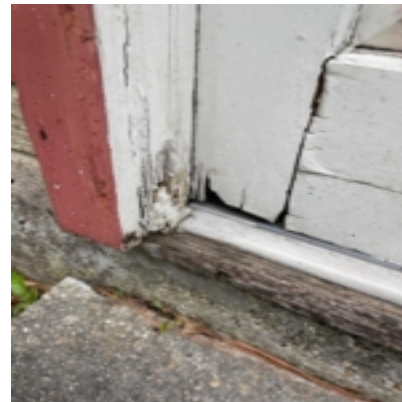
Severe moisture damage noted to the front door. Recommend replacing.

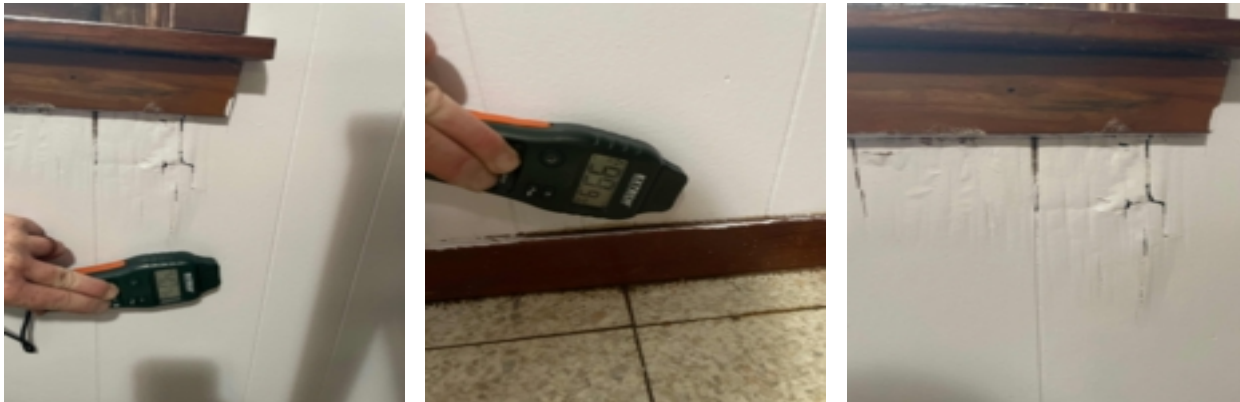
Moisture damage noted to the paneling under the dining room window. Recommend making appropriate repairs to the exterior siding as well as replacing the interior paneling and any other framing that was affected.

Elevated moisture levels noted under the dining area window.

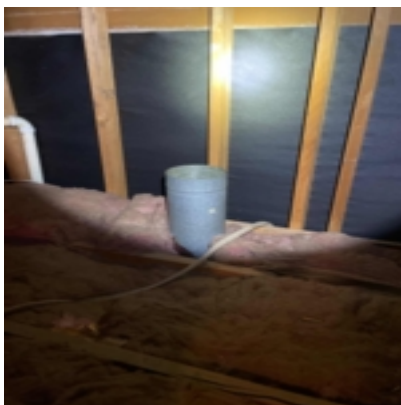
Improper vent connection - unit is venting into the attic. Recommend routing vent to the exterior of the home.

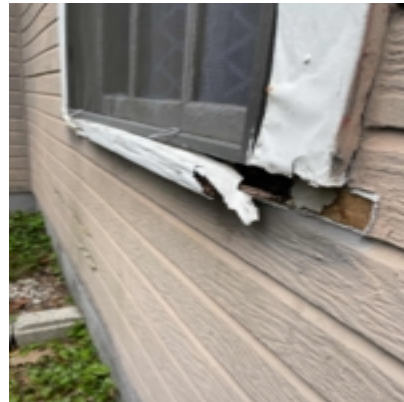
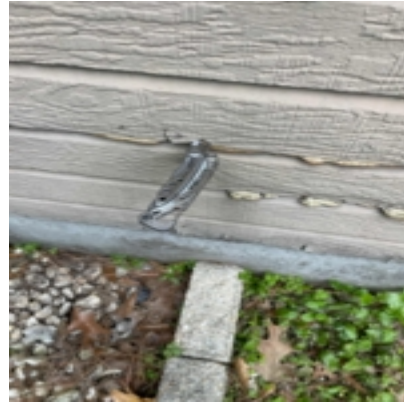
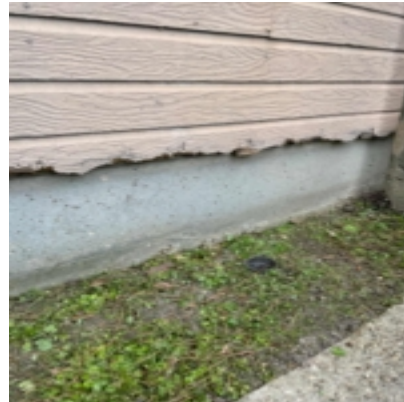
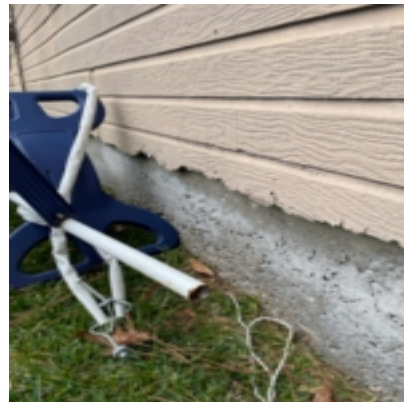
The following concerns were noted at the exterior walls:
And bottom run of masonite siding is consistently damaged due to moisture around the perimeter of the home. Recommend further evaluation by a licensed contractor and remove/replace all moisture damaged wood.
Large opening in the masonite siding Noted under the front right window.
Recommend further evaluation by a licensed contractor and repair/replace.

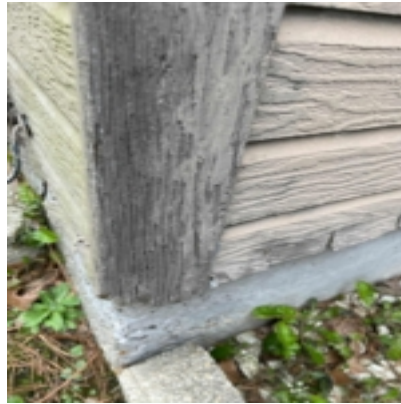
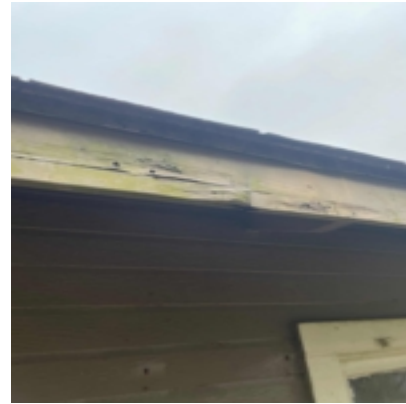
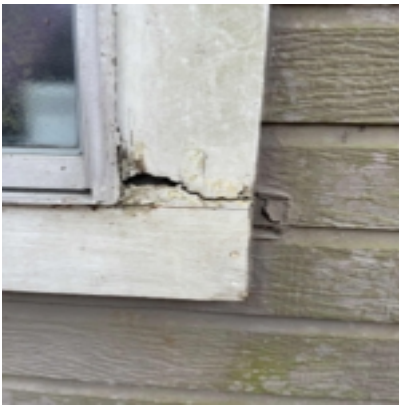
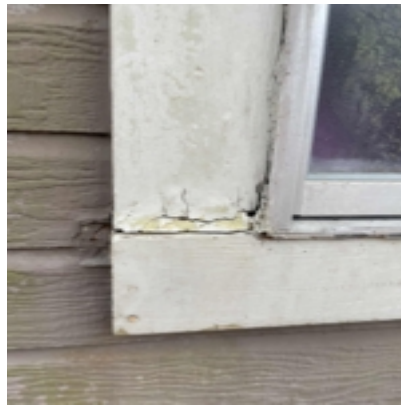
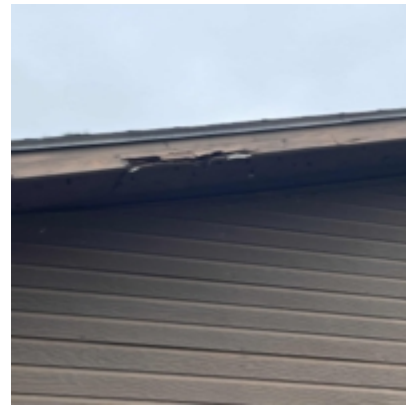
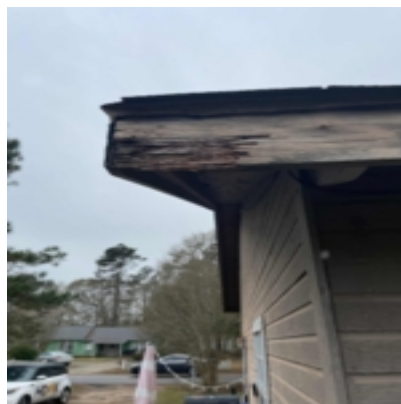
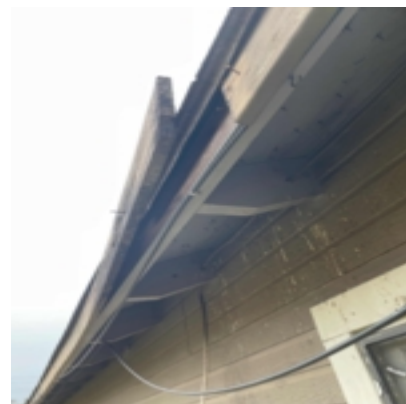
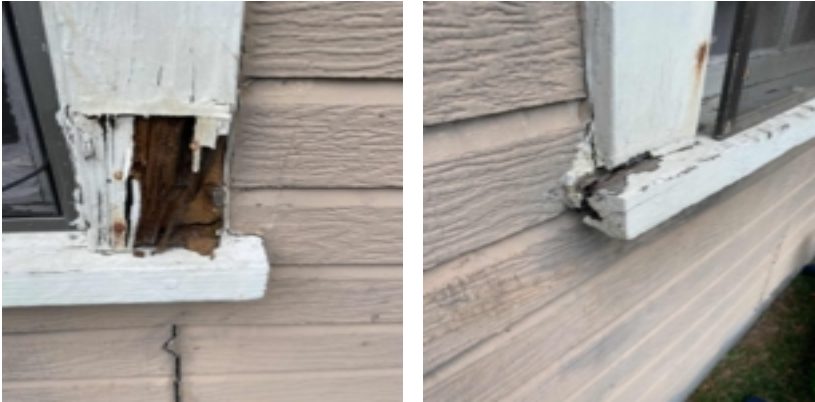
Moisture damage noted at the window trim at the front right window, left side window, right side window, and to rear windows. Recommend repair/replace all moisture damaged wood.

Several Moisture damaged pieces of corner trim Noted around the house. Recommend remove/replace all moisture damaged wood.

Damaged fascia board noted on the right end and rear of home. Recommend further evaluation by a licensed contractor and repair/replace.

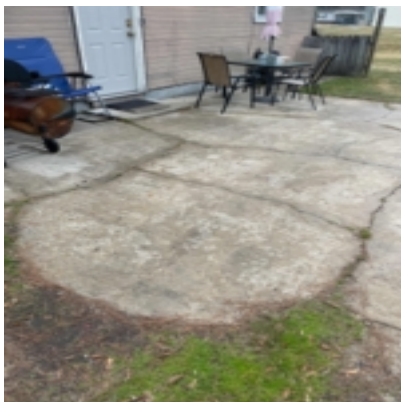
The following concerns were noted at the driveway:
Cracks noted. Some cracking is to be expected as the property settles with age.
Recommend monitoring for any future changes.

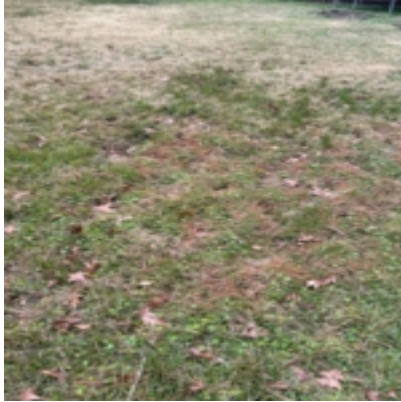
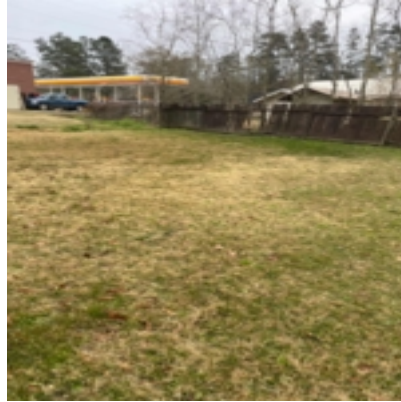
Poor drainage noted in the backyard. Recommend adding fill dirt and grading to help with proper drainage.

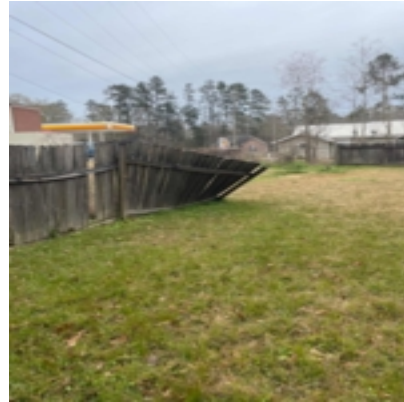
Wood fences in overall poor condition around the perimeter of the yard. Several damaged/leaning/missing sections of fencing noted. Recommend further evaluation by a licensed contractor and repair/replace as needed.

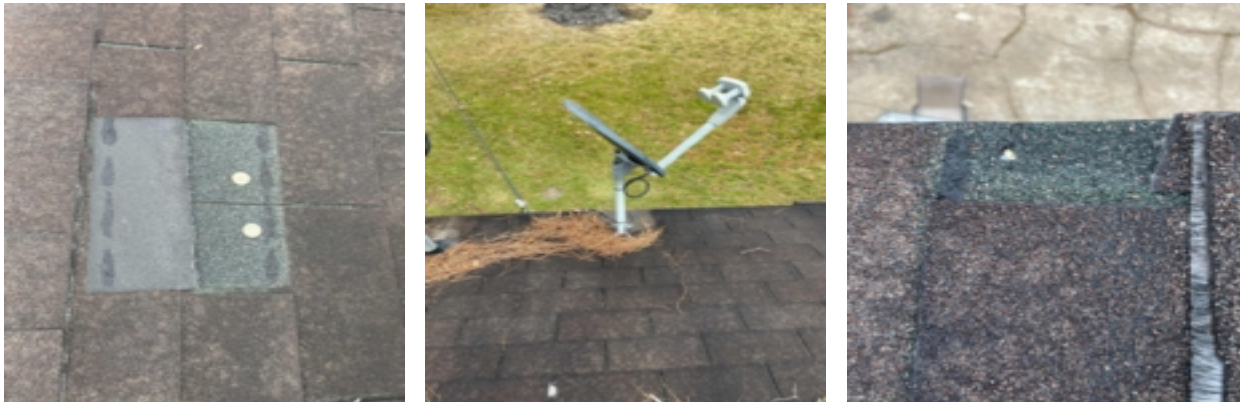
Damaged shingles noted on the rear of roof. Recommend further evaluation by a licensed roofer and repair/replace as needed.

Roof mounted equipment noted. As fasteners inserted through the roof surface increase the possibility for leakage this area must be regularly maintained and inspected.

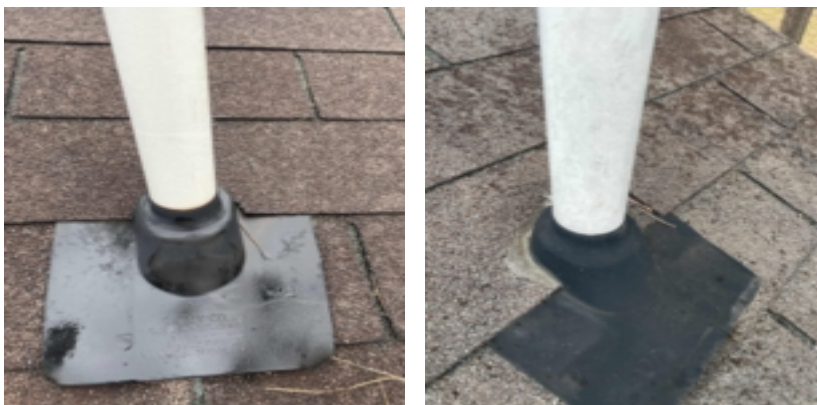
Recommend sealing all plumbing vent pipe/roof jack intersections to help prevent possible moisture intrusion

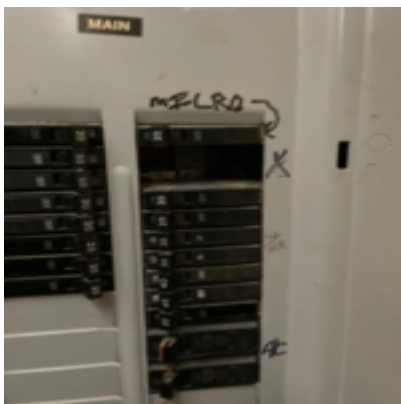
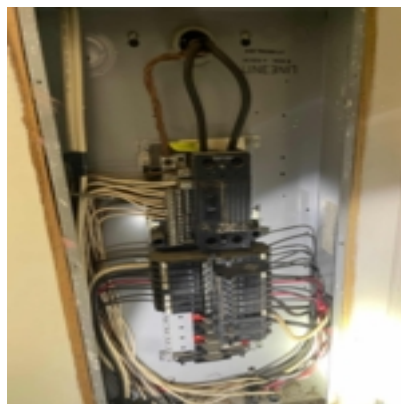
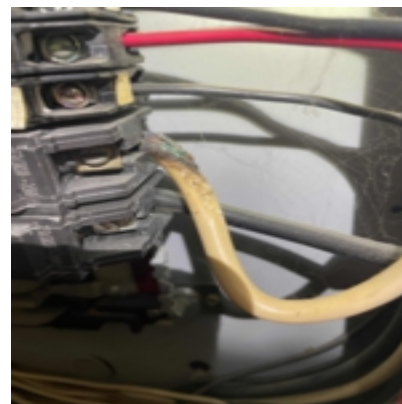
The following concerns were noted at the main electrical panel:
Signs of scorching noted at the 60 amp breaker circuit. Recommend further evaluation by a licensed electrician and repair/replace as needed.
Unused openings in the panel are missing covers, recommend corrections

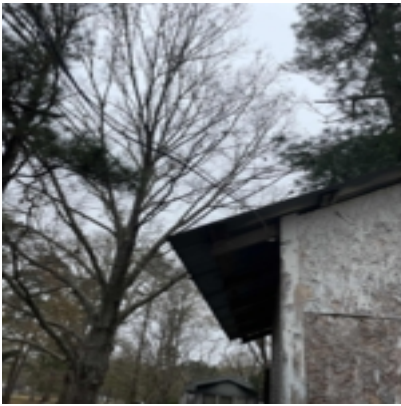
The following concerns were noted at the branch wiring circuits:
Romax sheathing on the wire running from the house to the shed is missing.
Recommend further evaluation by licensed electrician and repair/replace.

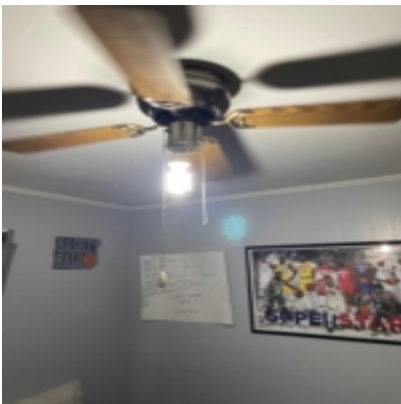
The following concerns were noted at the ceiling fans:
Missing light globe noted at the front right bedroom ceiling fan. Recommend replacing.

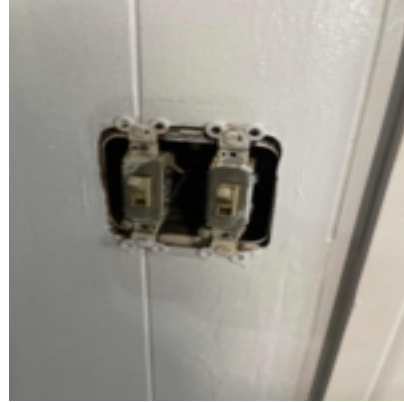
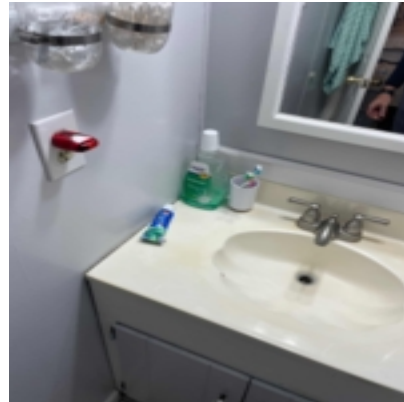
The following concerns were noted with the switches and receptacles:
Ground Fault Circuit Interrupter (GFCI) receptacles are recommended at all locations where you can come in contact with water and electricity at the same time. Consider upgrading to comply with current codes and safety recommendations.

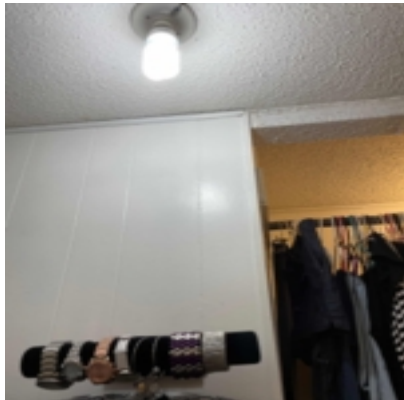
The following concerns were noted with the lights:
The lights are not operational in some areas. It could be due to bad bulbs or bad fixtures. Recommend verifying proper operation of lights before closing.
Exposed light bulbs should have fixture covers for additional safety

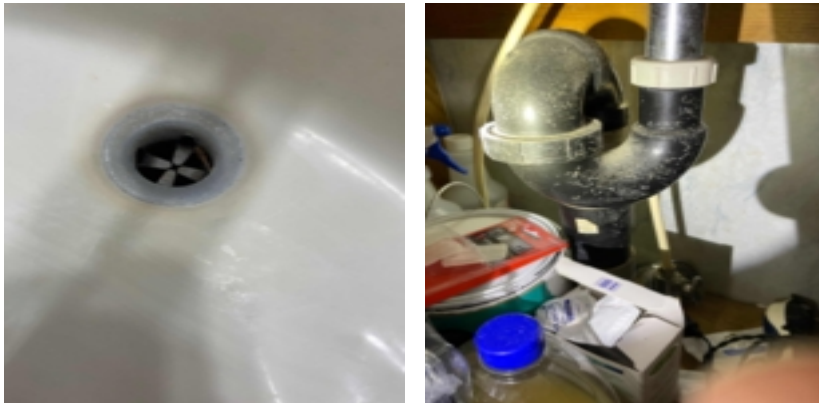
The following concerns were noted at the bathroom sink drain:
Missing/Damage drain stopper noted. Recommend replacing.

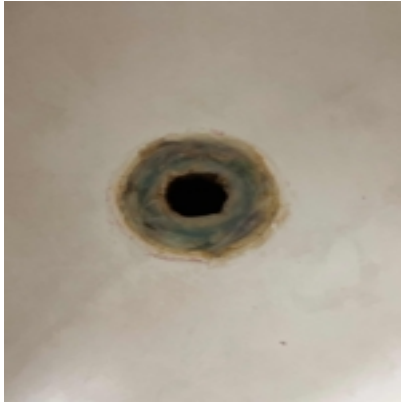
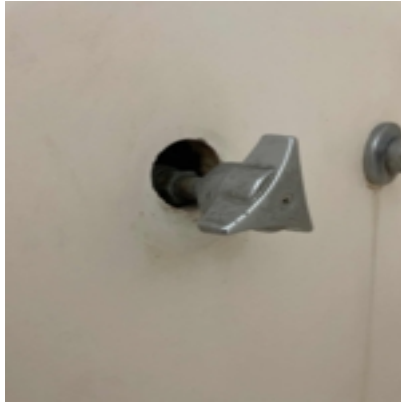
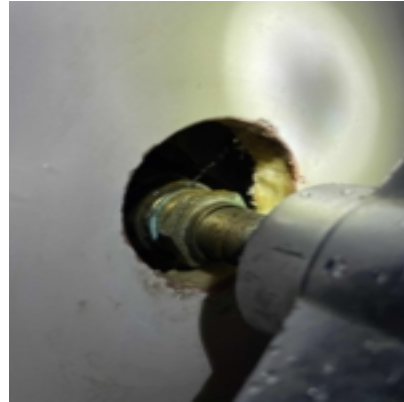
Leak noted at the hot water handler behind the shower wall. Recommend further evaluation by a licensed plumber and repair/replace.

Missing drain grate noted in the shower. Recommend repair.

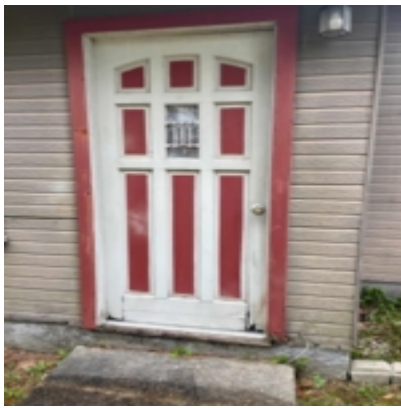
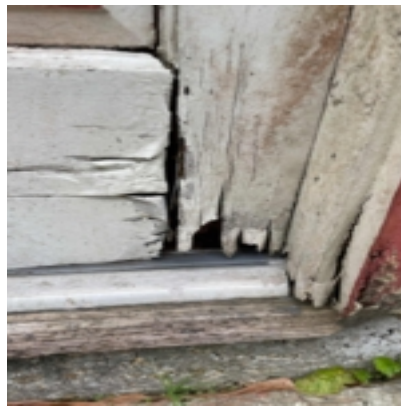
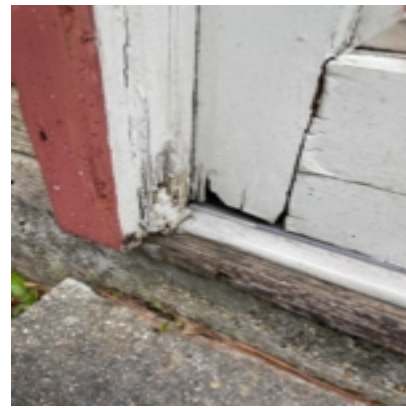
The following concerns were noted at the main entry door:
Severe moisture damage noted to the front door. Recommend replacing.

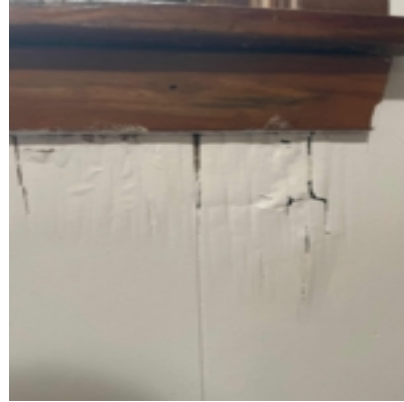
Moisture damage noted to the paneling under the dining room window. Recommend making appropriate repairs to the exterior siding as well as replacing the interior paneling and any other framing that was affected.

Elevated moisture levels noted under the dining area window.

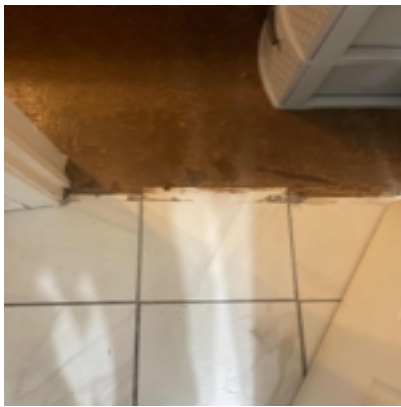
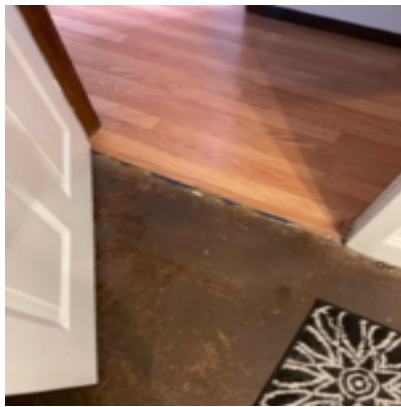
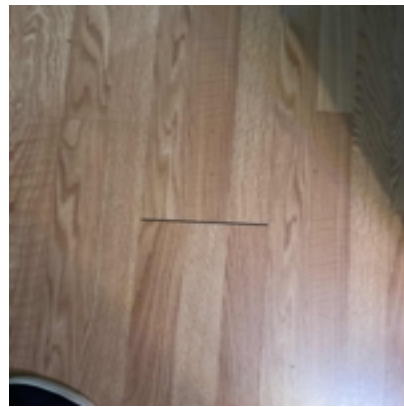
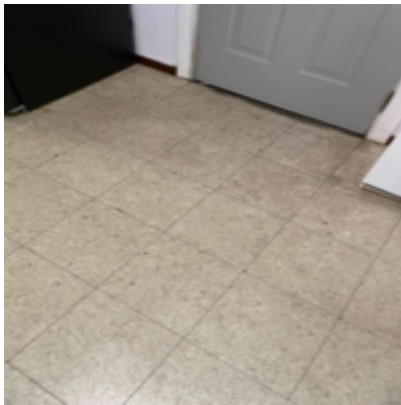
The following concerns were noted with the floors:
Several missing transition strips noted. Recommend repairs.

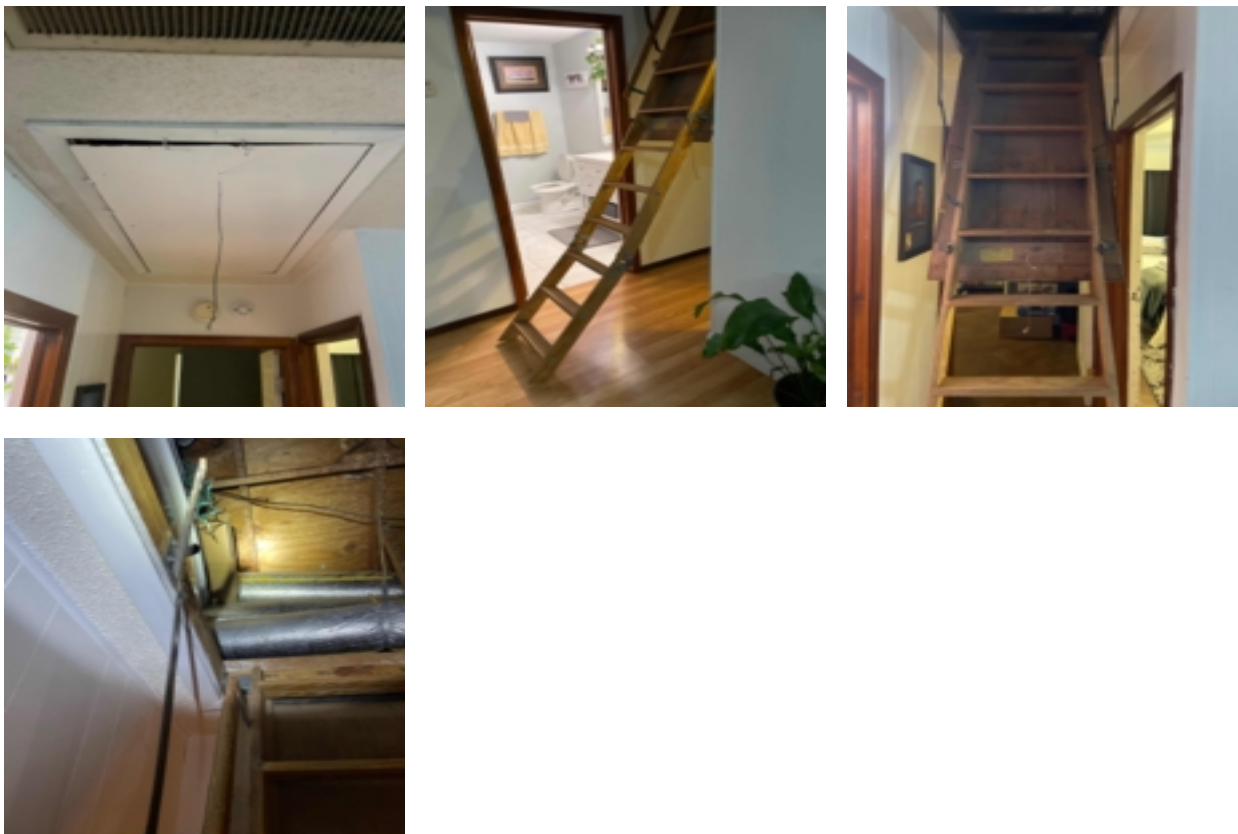
Ladder door does not fully close. Recommend repairing/replacing.

Ladder is in need of trimming to ensure proper opening and operation. Make necessary repairs according to manufacturer's recommendations.

Missing Spring Noted on the left side of attic access stairs. Recommend repairs.

Recommend providing insulation/weatherstripping around attic access door.

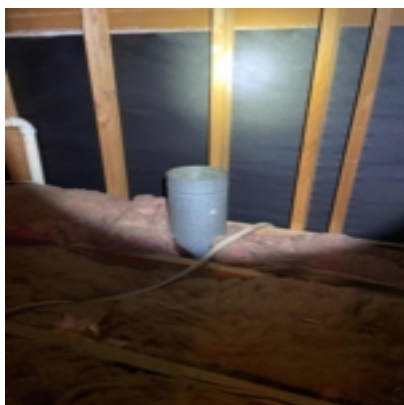
The following concerns were noted with the ventilation:
Improper vent connection - unit is venting into the attic. Recommend routing vent to the exterior of the home.
