# **NATIONAL CONVENTION ON QUALITY AND PRODUCTIVITY 2022**

<b>Name of the Organization</b>	GPV Lanka (Pvt) Ltd	
<b>Plant &amp; Address</b>	Baseline Rd, Daluwakotuwa, Kochchikade.	
<b>Category (tick √ )</b>	<b>Quality Control Circles (QCC)</b>	
	<b>Cross Functional Teams (CFT)</b>	√
<b>Name of the Team</b>	Powertronics	
<b>Name of the Project</b>	Elimination of Soldered Transformer Scrap at Visual Inspection Line	
<b>Date emailed to SLAAQP</b>	15/02/2023

Project Title: - Elimination of Soldered Transformer Scrap at Visual Inspection Line

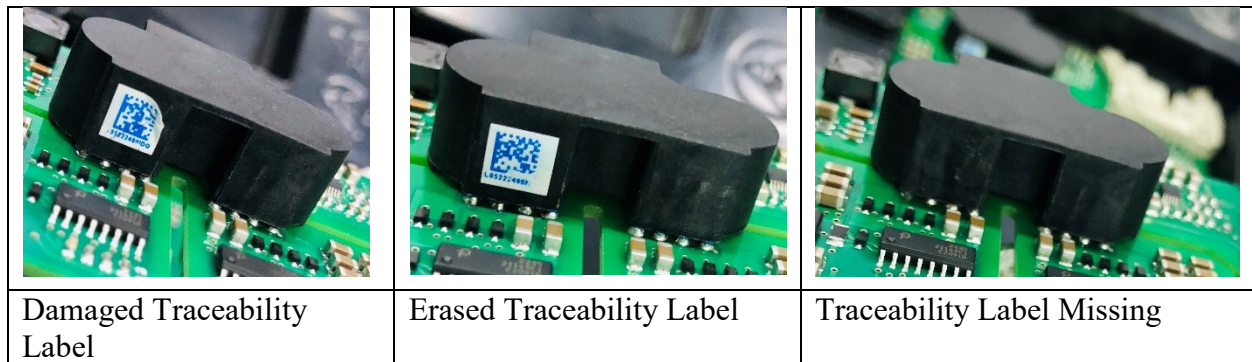
Figure 10: Transformer Traceability issues

The driver serial, which is the traceability marking of the PCBA is pasted in the Visual Inspection line. When comes to the PI visual line, the traceability marking of the transformer should available in order to track the PCBA. If the traceability marking of the transformer not available at the PI visual line, there is no data available to track the PCBA hence it is no use of marking the PCBA with driver serial. Then the current practice is to remove the soldered transformer from the PCBA and re-solder a new transformer with traceability serial. All the transformers without the traceability marking are scrapped at the PI visual line. With the new transformer, the driver serial can be attached.

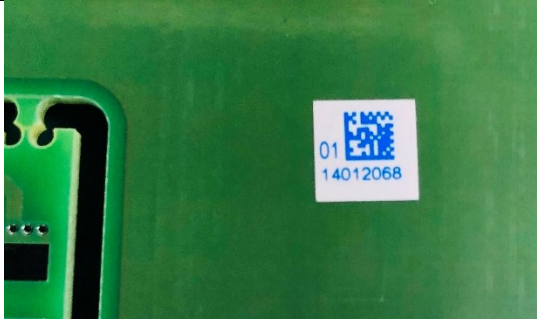
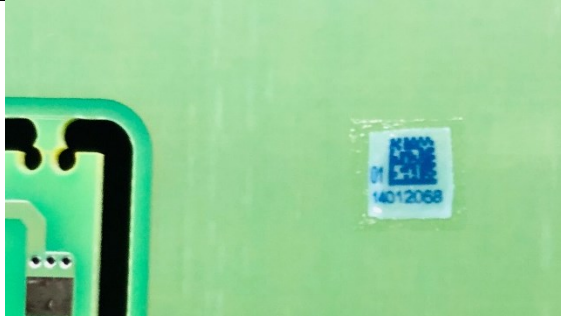
Traceability label on PCB before the Reflow Oven process	Traceability label on PCB after the Reflow Oven process

A sample of 100 PCBA were used as a trail and the traceability was completely damaged at the reflow oven.

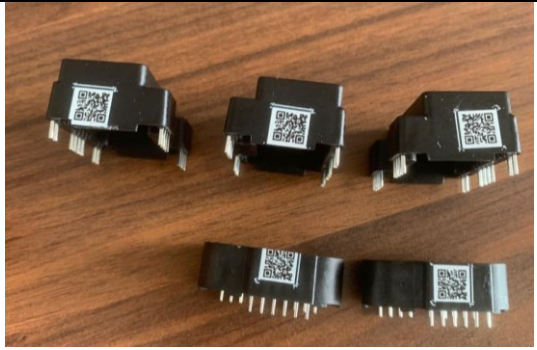
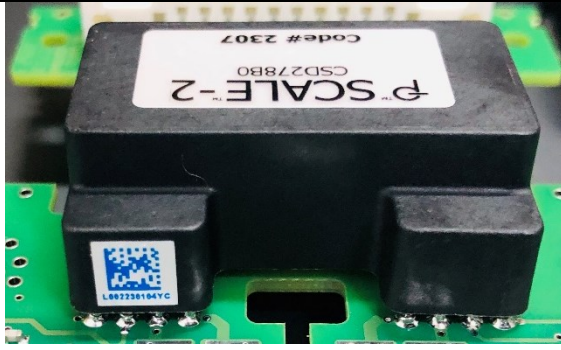
Feasible locations to print on transformers	Customer defined locations to paste traceability label on transformers

Even though the printing is possible, the customer defined locations were not feasible for the printing of the traceability on the transformers.

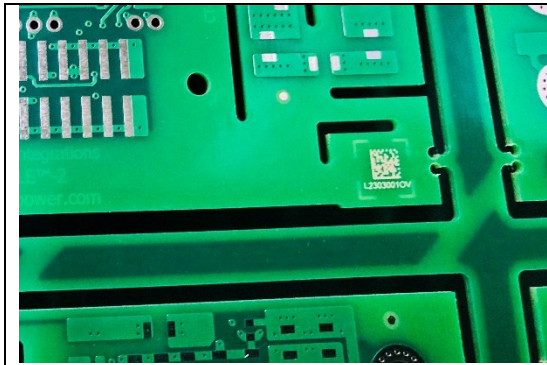
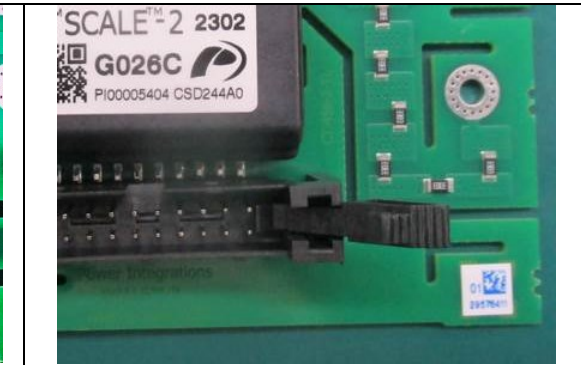
Laser Marked locations on PCB	Customer defined locations to paste traceability label on PCB

A sample of 100 PCBA were used as a trial and the customer approval was gained for the Laser marking on the PCB. After the laser marking was done the Transformers were assembled at THT assembling department.

After the assembly of the Transformers both serials were scanned and recorded with the link between PCB Traceability marking and the transformer traceability label.

Customer approval was taken to reprint the label at PI Line for traceability label damaged, erased or missing transformers without removing the transformers and scrapping.

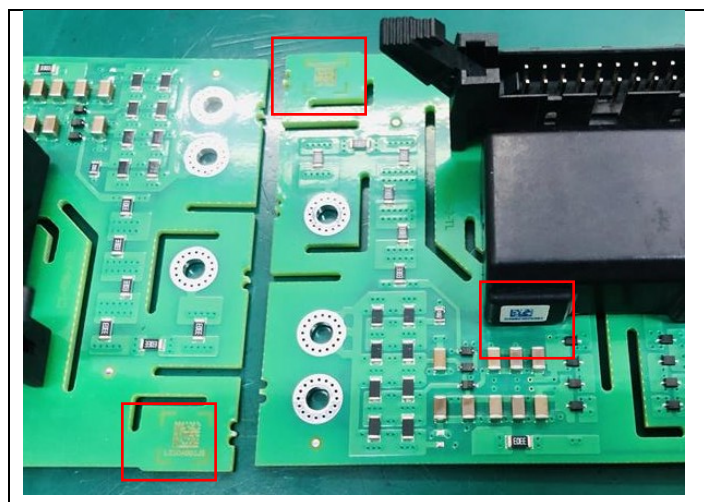
Laser marking on PCBA and Traceability Label on Transformer

With the voting results, the solution was selected as to laser mark on PCB and tally with the transformer. If the transformer traceability is not available at the PI visual and testing line, the label can be reprint and paste by using the PCBA laser mark as a reference.

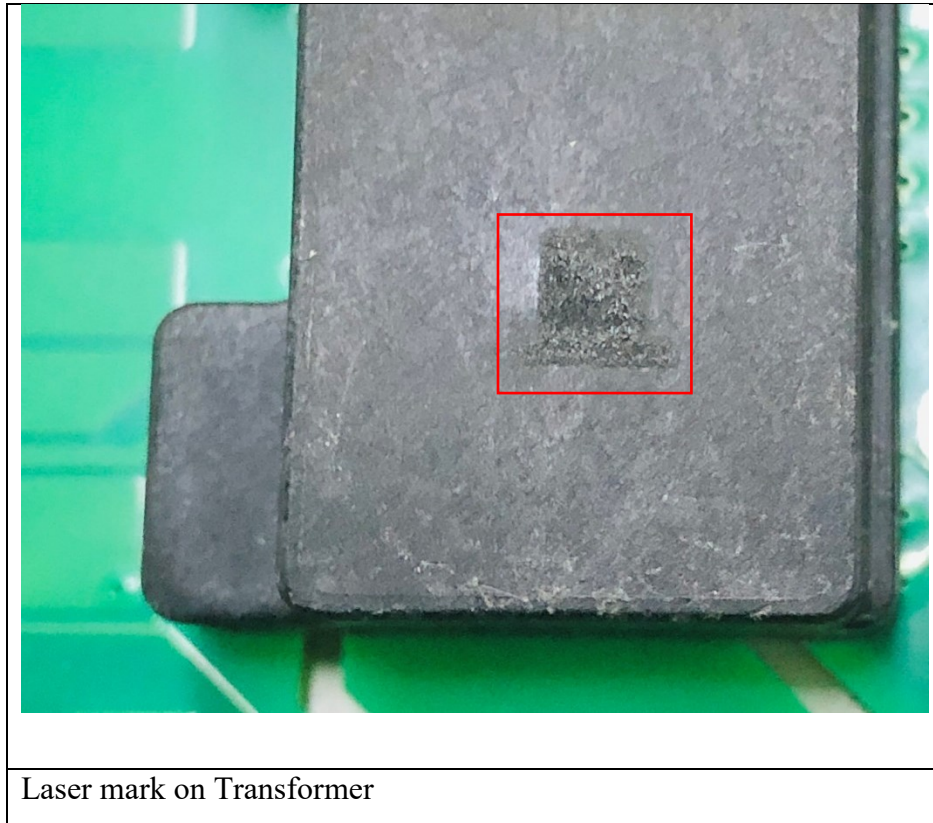
## 5. Laser mark on transformer

A sample was done using different intensities and the laser marking was not readable and the print quality was not at the acceptable level.
