## The Hows, Whys and Fixes for Pegasus "Jitter"

Recent investigations into the reasons and possible cures of Pegasus screen Jitter have revealed that there are at least 4 distinct causes. This report explains the theory behind these causes and suggests some modifications to erradicate the jitter.

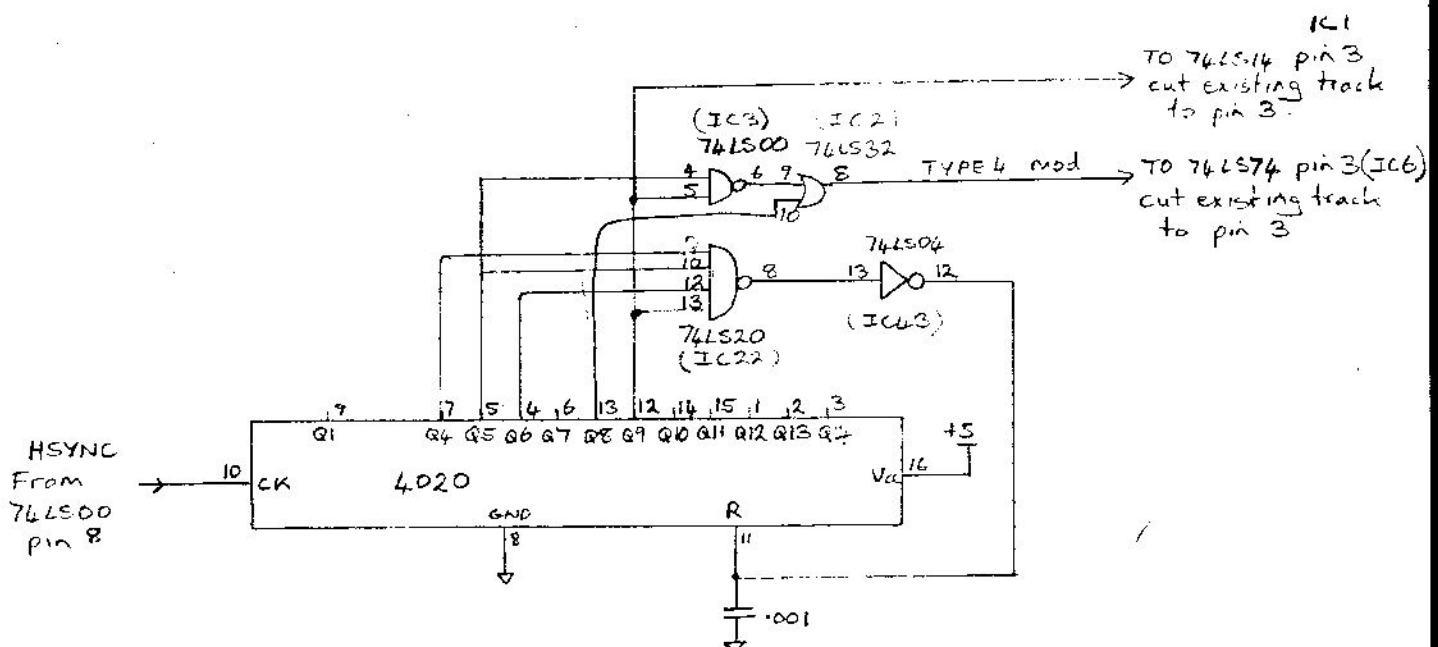
The frame rate for the video is initiated by a signal derived from the mains; Once the frame is started, everything is locked to the processor clock. So while the picture information doesn't jitter with respect to HSYNC and VSYNC, the frames themselves do jitter with respect to each other. In other words the VSYNC signals are not regular. Sometimes they are  $X \times 64 \text{ us}$  (HSYNCS occur every  $64 \text{ us}$ ) apart and sometimes they are  $(X + 1) \times 64 \text{ us}$  apart. Normal TV sets have an oscillator which likes to lock to regular VSYNC pulses. It will infact lock to a frequency with a period somewhere between  $X + 1$  and  $X$  times  $64 \text{ us}$ . Then what you get is a picture sometimes slightly above and sometimes slightly below the true position. The cure is to use some kind of divider to derive your 50Hz from the processor clock, instead of the mains. The following mod uses one IC and some existing gates on the Pegasus board.

The 74LS20 gate has tracks running to it which must be cut.  
 The 74LS04 becomes free from a modification to the dot clock oscillator which was given to us by G. Barbour of Christchurch.  
 This modification stops shimmer on the displayed characters and stabilizes the oscillator frequency.

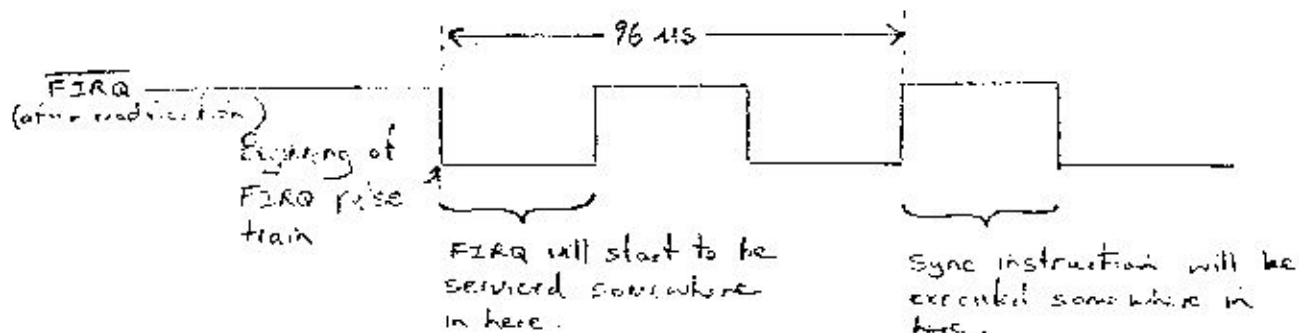
The FIRQ pulses generated by the existing Pegasus hardware are 8  $\mu$ s long. The 6809 chip however only checks the FIRQ pin after each instruction. Since 6809 instructions can take up to 20  $\mu$ s it is clear that it is possible for the chip to miss on FIRQ pulse. If it "sees" the following one then the whole picture will be 64  $\mu$ s too late i.e. one scan line too low on the screen. This causes jitter whenever programs with longish instructions are running.

From this drawing it can be seen that 32  $\mu$ s is the ideal length for the FIRQ pulse (which is active low) because it gives an equal mark space ratio square wave. If the FIRQ pulse were any longer, then the period in which the FIRQ line is high becomes correspondingly shorter and it is then possible for the SYNC instruction to occur while the FIRQ line is low, giving sideways jitter.

If the FIRQ pulse is shorter than 20  $\mu$ s it is possible for them to be missed by the processor. In fact the full 32  $\mu$ s is better because it allows the programmer to mask off FIRQs for two or three instructions if he wishes, without missing an FIRQ.

The cure for Type 2 jitter is to take the FIRQs from the 74LS93 divider, IC7 pin 9. This is a square wave with 32  $\mu$ s each way. This modification also needs a new monitor version 2-3. The delays in this monitor are adjusted so that a) the picture is in the middle of the screen and b) the SYNC instruction is 96  $\mu$ s after FIRQ starts to be serviced. This ensures that the SYNC instruction is not executed while the FIRQ line is low, which would cause terrible sideways jitter.

So 32 us FIRQs are used. The time from the start of servicing of the FIRQ to the SYNC instruction in the monitor is adjusted to be 96 us. Also since the new FIRQs are out of phase with the old ones, the monitor has its delay that positions the picture in the middle of the screen adjusted.

The actual modification is done by cutting the track to the 74LS32 pin 5 and jumping this pin to the 74LS93 pin 9 (IC7) and getting a version 2-3 monitor.

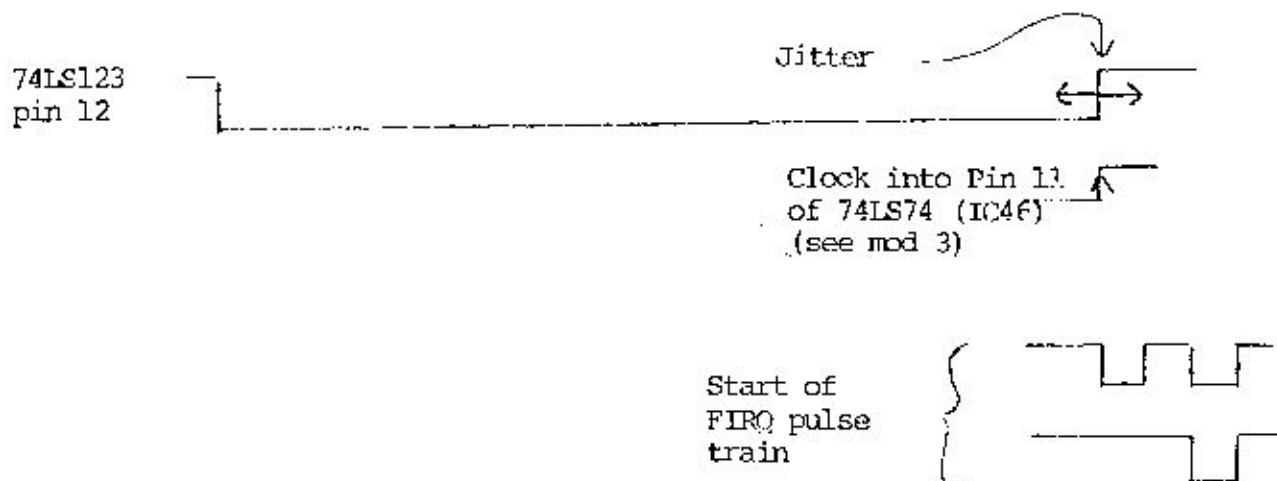
Type 4 jitter is again caused by the 74LS123. Using an oscilloscope it can be seen that a noticeable jitter occurs in the delay pulse whenever the Pegasus is running a program. When the trailing edge of the pulse falls on or near the clocking point explained for type 3 mod then the jitter in the 123 will cause the first FIRQ pulse to appear sometimes latter and sometimes earlier.

The only way to get round this is to bypass the 74LS123 altogether and use some pulses derived from the Type 1 jitter mod. (see the drawing for the 4020 mod). The existing track to 74LS74 IC6 pin 3 must be cut and taken to the spare nand gate as shown. This will give a picture nicely in the middle of the screen. (vertically)
