Elk River Fish Passage

Al Irvine, R.P.Bio.

2020-12-14

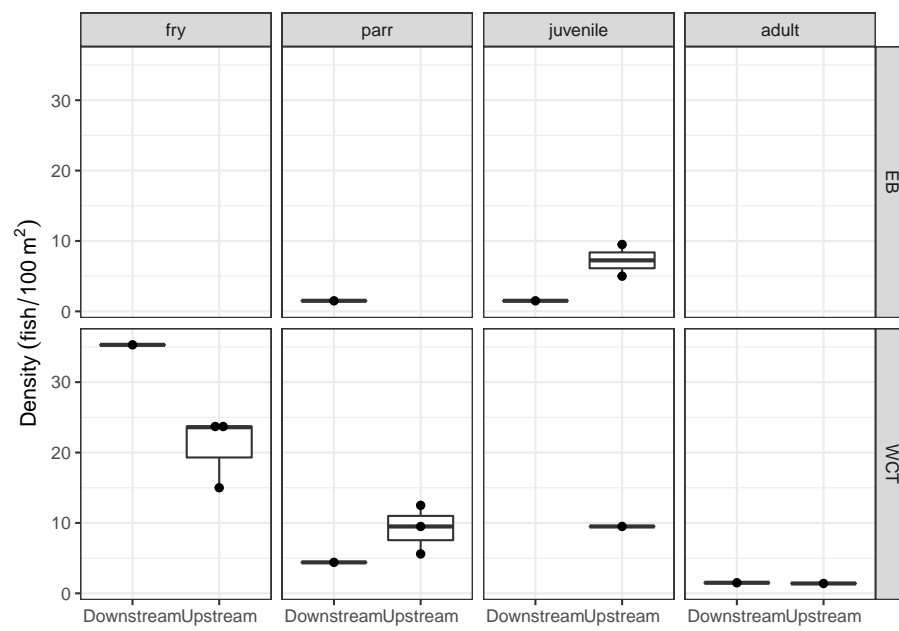
Figure 5.1: Fish densities (fish/100m²) for PSCIS crossing 50155.

There is an estimated N/A km of mainstem habitat upstream of crossing 50155 with habitat in the areas surveyed upstream of the crossing rated as high value for fry and juvenile salmonid rearing. Although it could be partially attributed to the lower gradient habitat downstream and the proximity to the Lizard Creek mainstem, fish sampling results indicated that the crossing is potentially negatively impacting habitat capacity upstream of the crossing as higher densities of westslope cutthroat trout were captured downstream of the crossing than above. It is unclear whether the road is part of the Island Lake Recreational tenure or solely the responsibility of the Ministry of Forests, Lands, Natural Resource Operations & Rural Development. The crossing was ranked as a moderate priority for proceeding to design for an open bottomed replacement structure.
