Appendix - Phase 1 Fish Passage Assessment Data and Photos

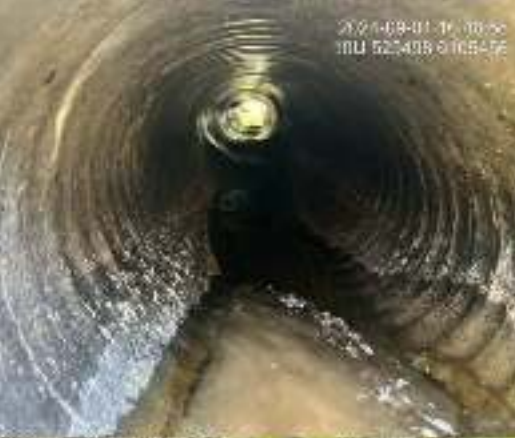
Location and Stream Data	•	Crossing Characteristics	–
Date	2024-09-04	Crossing Sub Type	Round Culvert
PSCIS ID	199663	Diameter (m)	1.2
External ID	16602610	Length (m)	13
Crew	AI LS	Embedded	No
UTM Zone	10	Depth Embedded (m)	–
Easting	515397	Resemble Channel	No
Northing	6094977	Backwatered	No
Stream	Tributary to Colbourne Creek	Percent Backwatered	–
Road	CHCO 11000 FSR	Fill Depth (m)	0.5
Road Tenure	BCTS	Outlet Drop (m)	0.6
Channel Width (m)	2.5	Outlet Pool Depth (m)	0.4
Stream Slope (%)	1	Inlet Drop	No
Beaver Activity	Yes	Slope (%)	3
Habitat Value	Medium	Valley Fill	Deep Fill
Final score	36	Barrier Result	Barrier
Fix type	Replace with New Open Bottom Structure	Fix Span / Diameter	15
Comments: The system has good flow and a significant outlet drop. Upstream substrate consists primarily of fine materials, likely indicating limited habitat complexity for fish.. 18:21:40			
Photos: PSCIS ID 16602610. From top left clockwise: Road/Site Card, Barrel, Outlet, Downstream, Upstream, Inlet.

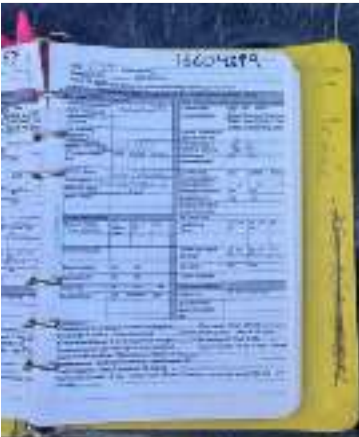
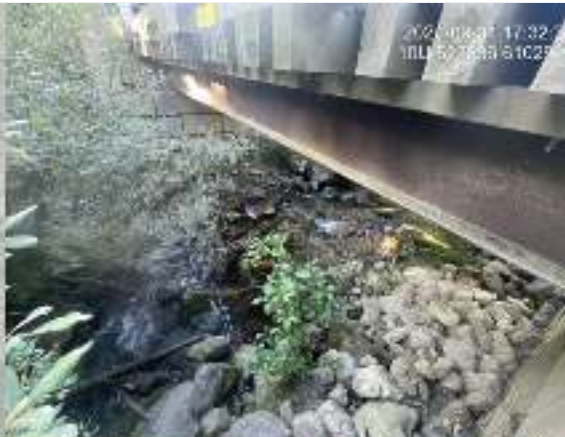
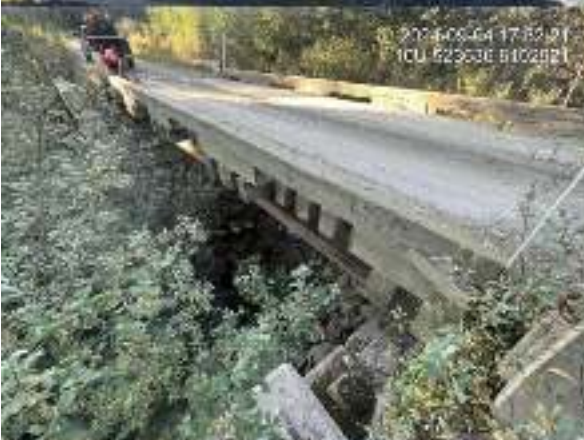
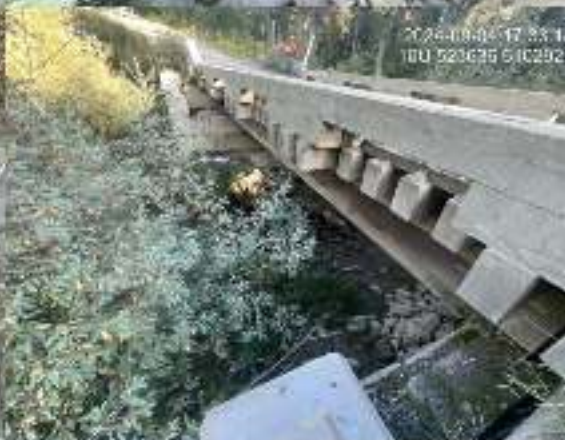
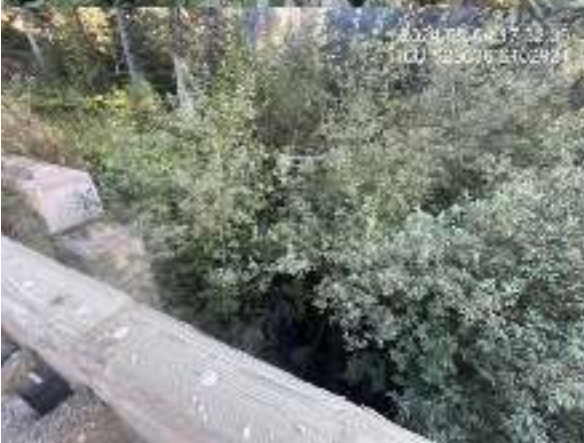
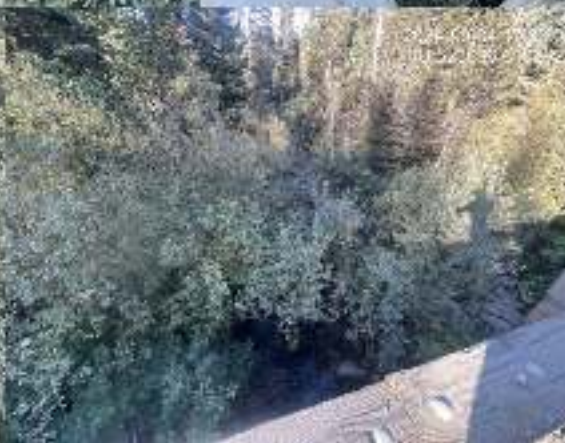
Location and Stream Data	•	Crossing Characteristics	–
Date	2024-09-04	Crossing Sub Type	Bridge
PSCIS ID	199667	Diameter (m)	12
External ID	16602775	Length (m)	5
Crew	AI LS	Embedded	–
UTM Zone	10	Depth Embedded (m)	–
Easting	523637	Resemble Channel	–
Northing	6102924	Backwatered	–
Stream	Tributary to Colbourne Creek	Percent Backwatered	–
Road	Chuchinka-Colbourne FSR	Fill Depth (m)	–
Road Tenure	MoF	Outlet Drop (m)	–
Channel Width (m)	–	Outlet Pool Depth (m)	–
Stream Slope (%)	–	Inlet Drop	–
Beaver Activity	No	Slope (%)	–
Habitat Value	–	Valley Fill	–
Final score	0	Barrier Result	Passable
Fix type	–	Fix Span / Diameter	–
Comments: New bridge in 2024. This is a large stream. . 17:30:20			
Photos: PSCIS ID 16602775. From top left clockwise: Road/Site Card, Barrel, Outlet, Downstream, Upstream, Inlet.
