Appendix - Phase 1 Fish Passage Assessment Data and Photos

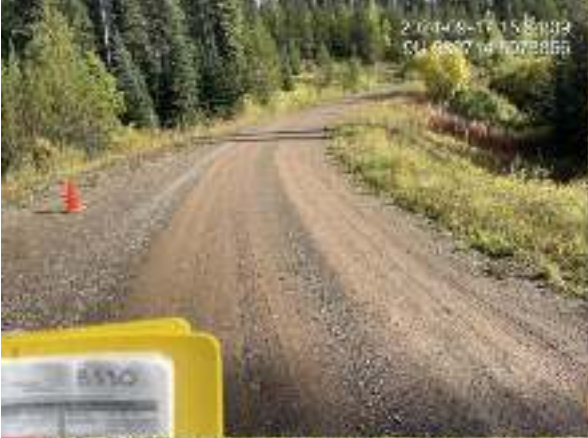
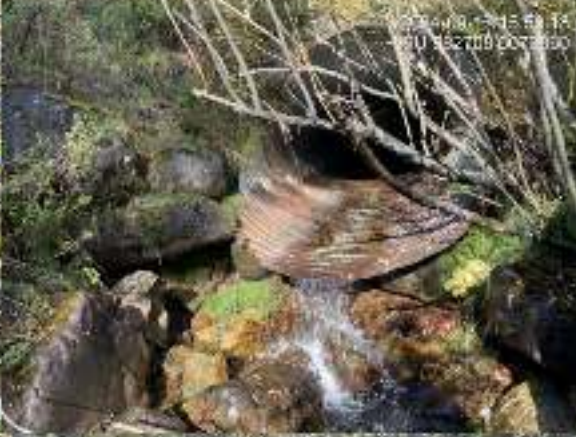
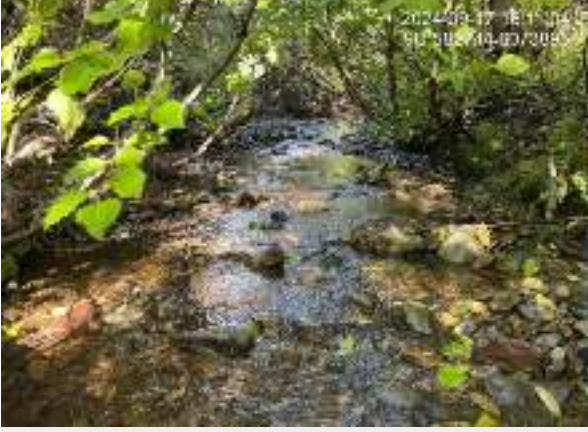
| Location and Stream Data | • | Crossing Characteristics | – |
|--|--|---|---|
| Photos: PSCIS ID 8530. From top left clockwise: Road/Site Card, Barrel, Outlet, Downstream, Upstream, Inlet. | | | |

| Location and Stream Data | • | Crossing Characteristics | – |
|--|--|---|---|
| Comments: The stream has good quality habitat with abundant overhanging vegetation and boulders providing cover, pools for overwintering fish, and gravel suitable for spawning. Rainbow trout, cutthroat trout, and Dolly Varden were captured during sampling. Very large culvert with a significant amount of road fill (9m). There was an engineering site survey conducted in 2024 but the design plans were put on hold due to high replacement costs and uncertainty around if salmon could access the crossing due to potential barriers downstream. DFO was involved and reported that coho were spawning downstream of the crossing in October 2024. | | | |

| Location and Stream Data | • | Crossing Characteristics | – |
|--|--|---|---|
| Fix type | Replace with New Open Bottom Structure | Fix Span / Diameter | 33 |

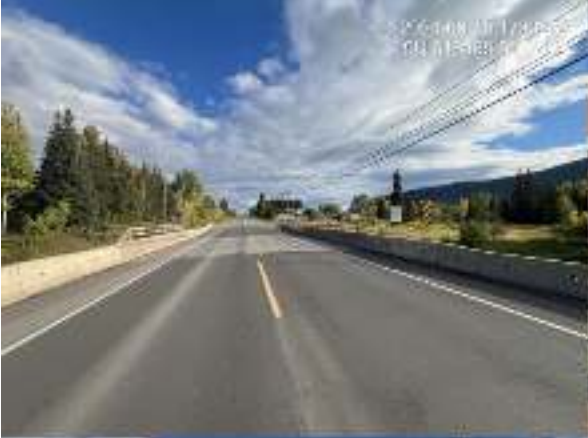
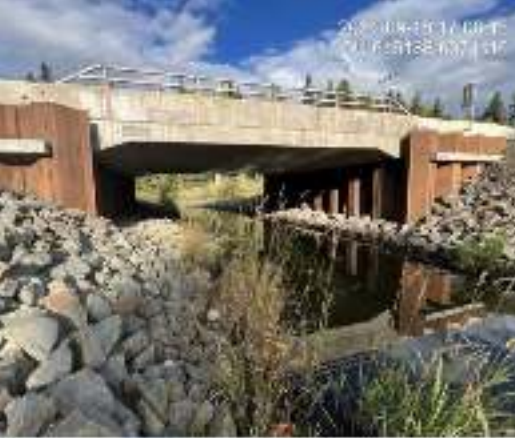
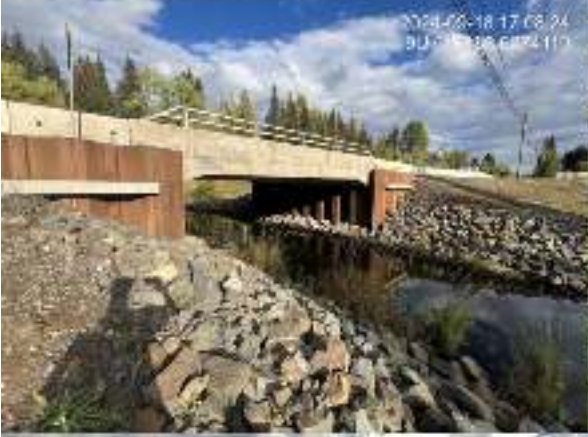
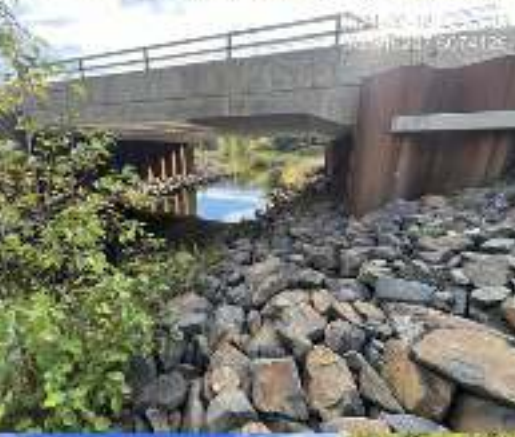
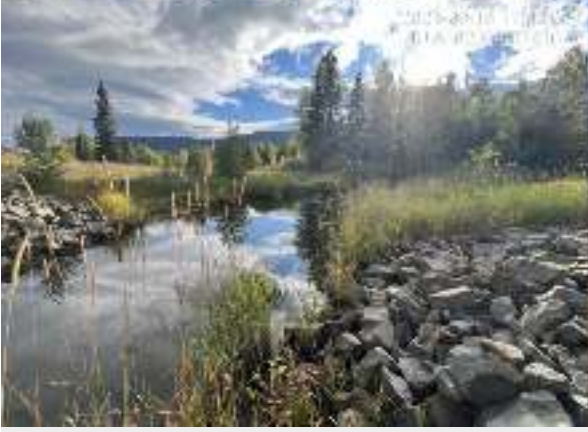
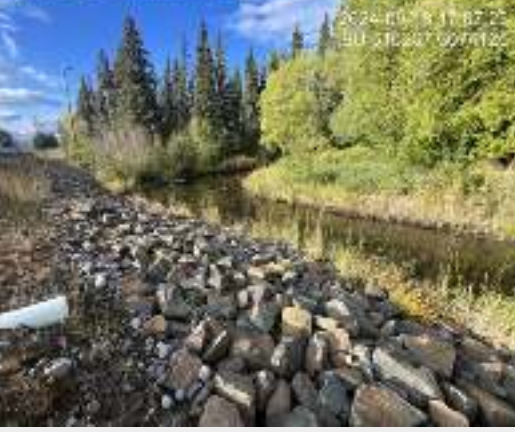
| Location and Stream Data | • | Crossing Characteristics | – |
|---|---|---|---|
| Photos: PSCIS ID 58235. From top left clockwise: Road/Site Card, Barrel, Outlet, Downstream, Upstream, Inlet. | | | |

| Location and Stream Data | • | Crossing Characteristics | – |
|---|---|---|---|
| Comments: New, well built, bridge. | | | |

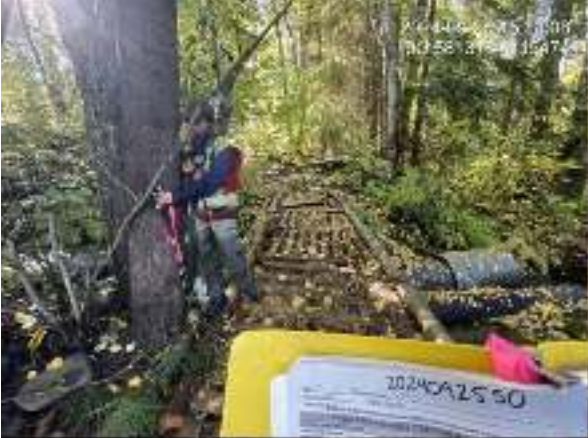
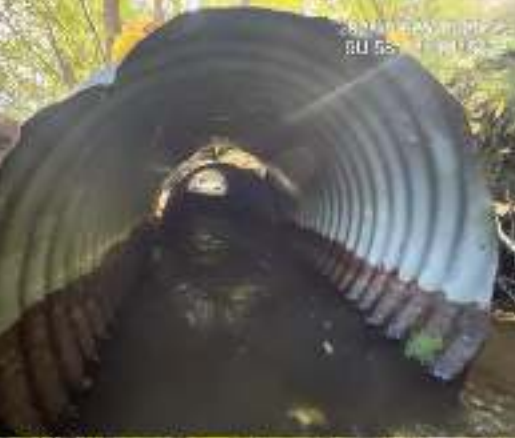
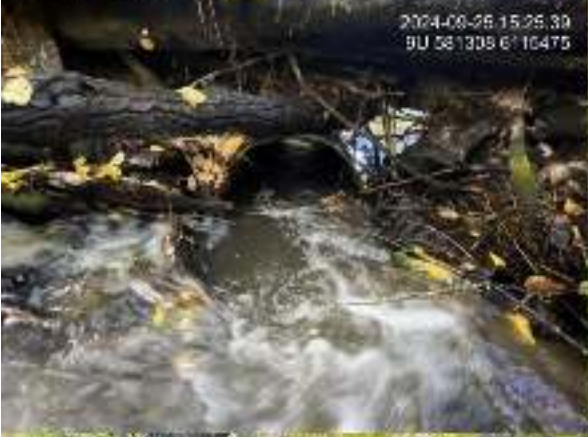
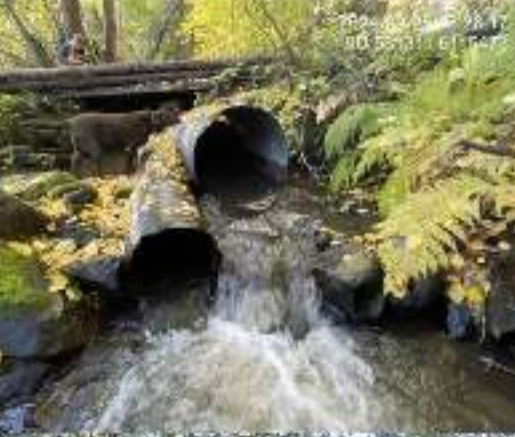
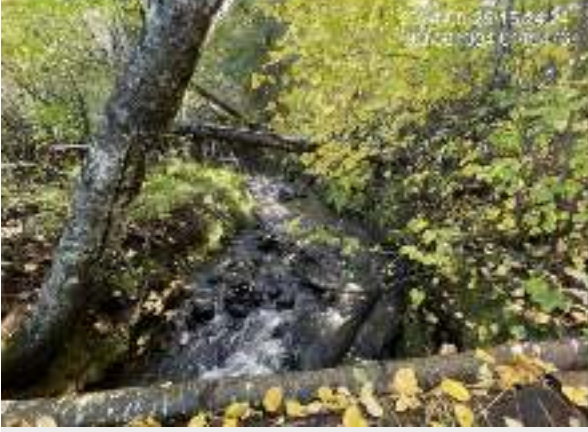
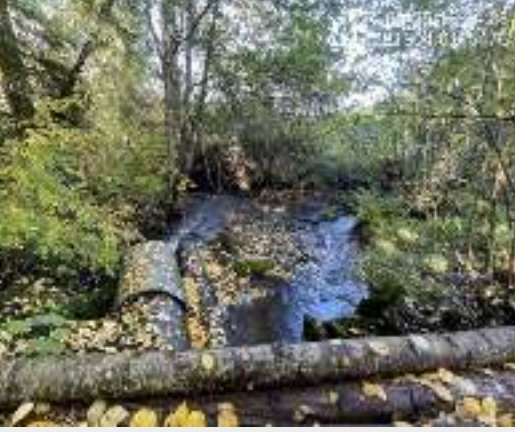
Photos: PSCIS ID 2024092550. From top left clockwise: Road/Site Card, Barrel, Outlet, Downstream, Upstream, Inlet.

Comments: The landowner has constructed a bridge over the stream with two culverts, measuring 0.47 m and 0.9 m in diameter. Some flow passes through the culverts while some bypasses them, though it is unclear if fish can navigate the bypassing flow. The bridge appears to provide access to adjacent agricultural fields. High-quality habitat with numerous pools and abundant gravel is present, but strong currents in the culverts due to significant flow likely inhibit fish passage.

| Location and Stream Data | . | Crossing Characteristics | – |
|---|--|---|---|
| Fix type | Replace with New Open Bottom Structure | Fix Span / Diameter | 15 |

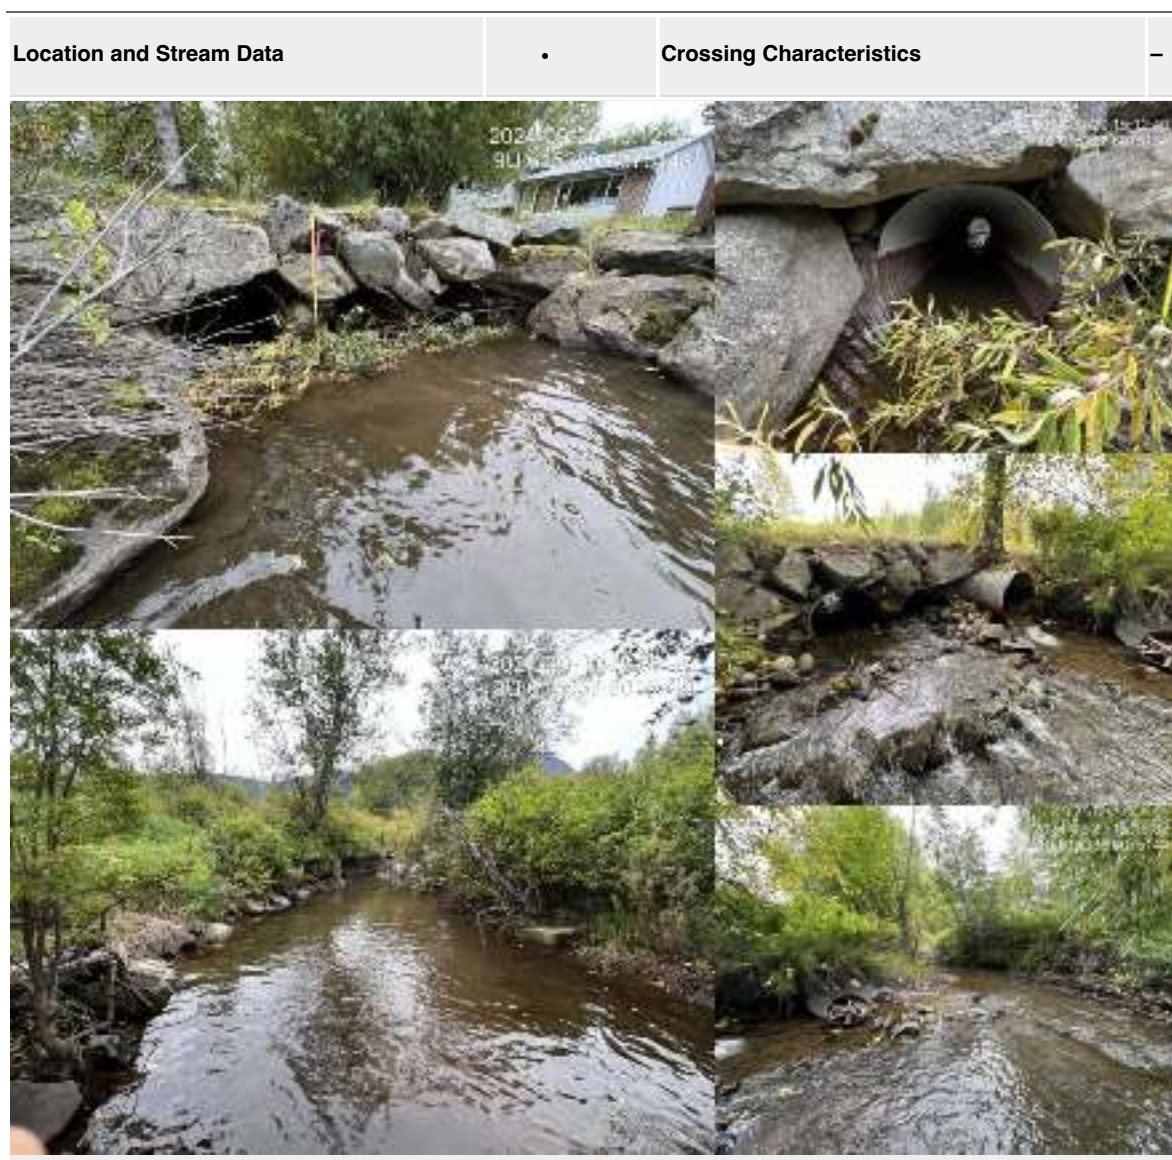
| Location and Stream Data | . | Crossing Characteristics | – |
|--|--|---|---|
| Comments: Three 0.95 m pipes run under a private driveway. The pipe lengths and gradients are estimated, with two pipes appearing fully embedded and one slightly elevated by approximately 30 cm. The stream is channelized with large boulders throughout the property. Beaver activity is evident, with debris at the inlet and three dams ranging from 0.4 to 1 m high within 150 m upstream. The landowner reported previous blockages caused by beavers, requiring the inlet to be cleared and significant amounts of accumulated material to be dredged out. Photos: PSCIS ID 2024092003. From top left clockwise: Road/Site Card, Barrel, Outlet, Downstream, Upstream, Inlet. | | | |

| Location and Stream Data | . | Crossing Characteristics | – |
|--|--|---|---|
| Fix type | Replace with New Open Bottom Structure | Fix Span / Diameter | 15 |

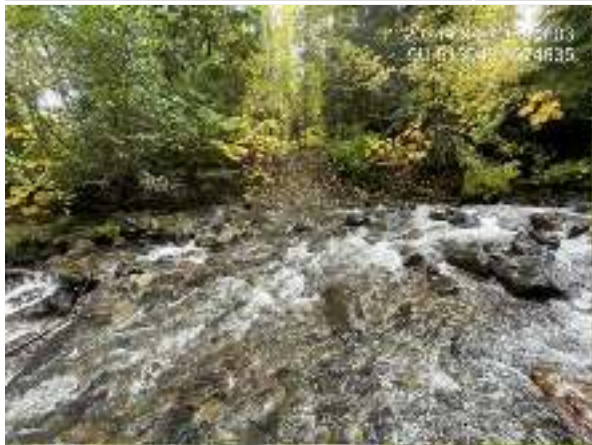
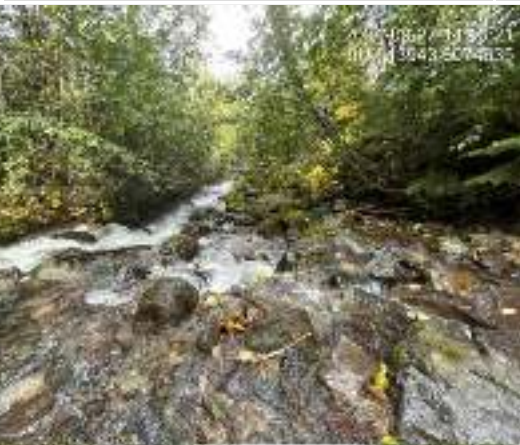
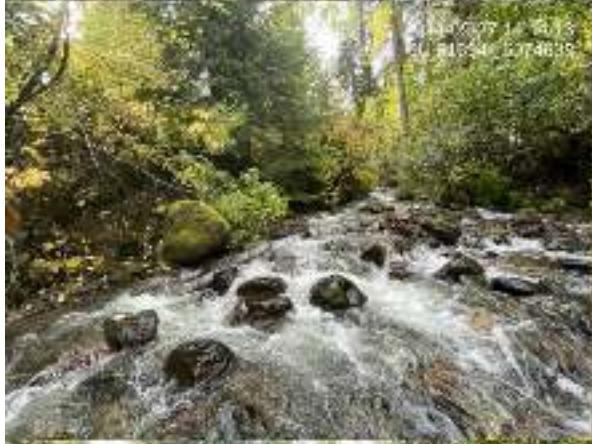
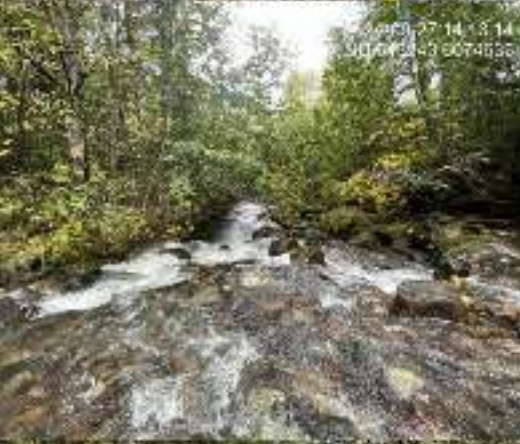
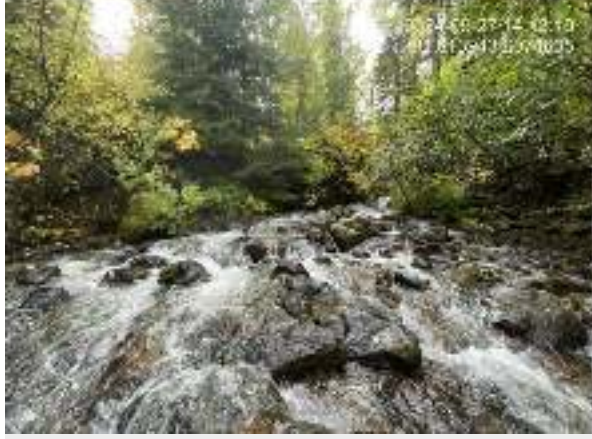
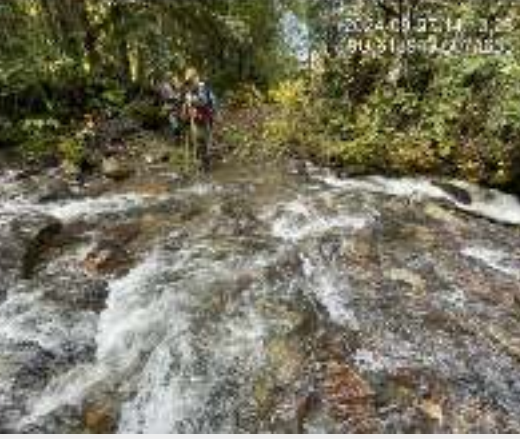
| Location and Stream Data | • | Crossing Characteristics | – |
|--|---|---|---|
| Photos: PSCIS ID 2024092751. From top left clockwise: Road/Site Card, Barrel, Outlet, Downstream, Upstream, Inlet. | | | |

| Location and Stream Data | • | Crossing Characteristics | – |
|--|---|---|---|
| Comments: Ford across transmission line road which parallels the transmission lines. Fully passable. | | | |
