Assessing the Instability of Dong Nai River in Bien Hoa District Using Bank Erosion Hazard Index (BEHI) and Remote Sensing and GIS

To cite this article: L M Nguyet *et al* 2019 *IOP Conf. Ser.: Earth Environ. Sci.* **272** 022219

L M Nguyet¹, D Q Minh², P T H Lan¹

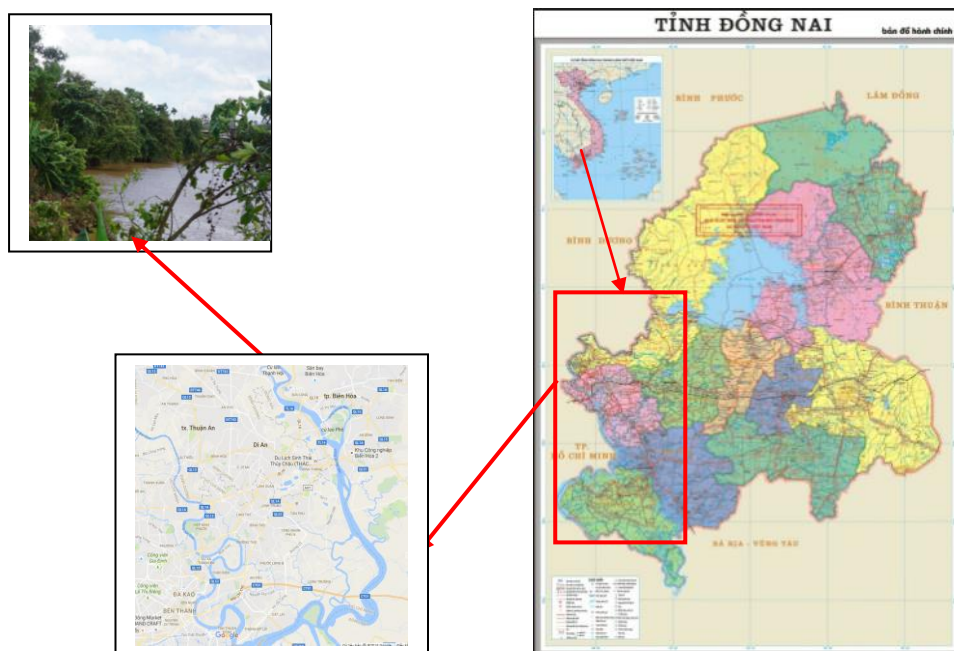
Figure 1. Location of bank erosion in Bien Hoa – Dong Nai.

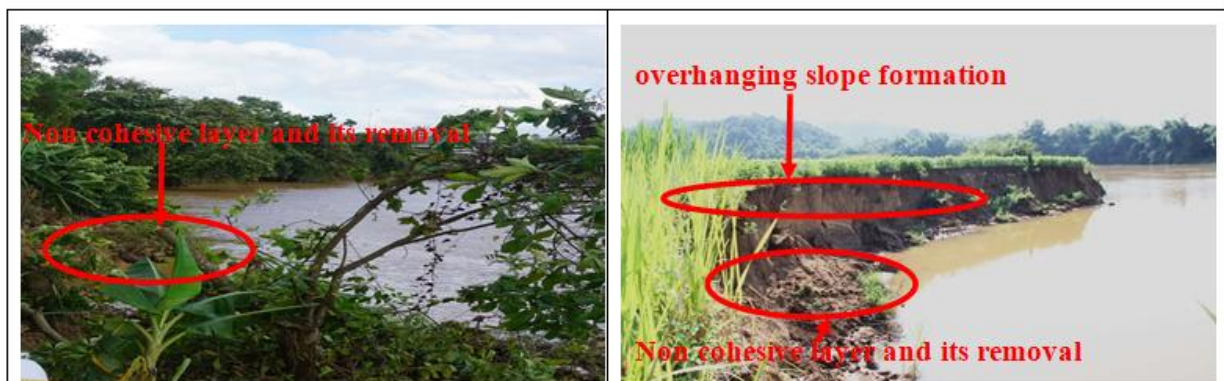
Under cutting or loss of underlying support is the primary cause of bank erosion at Dong Nai River. As a result of hydraulic action, the soil particles of underlying layer is detached and carried far away by stream flow which results in overhanging layer at the top. This overhanging layer with time collapse and execute rapid bank erosion.

Figure 2. Cohesive and non-cohesive layers at Dong Nai River.

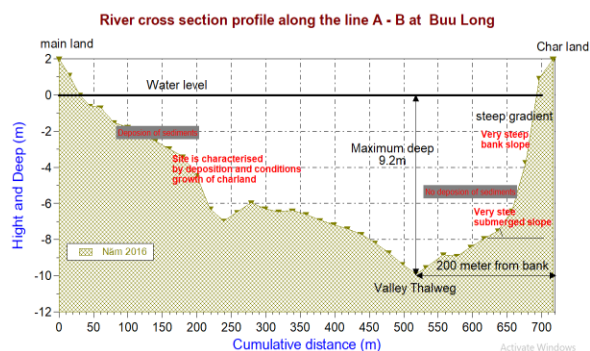
Field survey took place at the location of Hoa An bridge at about 500m to the upstream of Dong Nai River (location MC1). A river cross profile was done along the left bank of Dong Nai River at Buu Long. The near bank river bed profile depicts that the depth is close to the river bank which plays a significant role to increase the velocity of water.

Figure 4. River cross profile between mainland and char land at Buu Long.

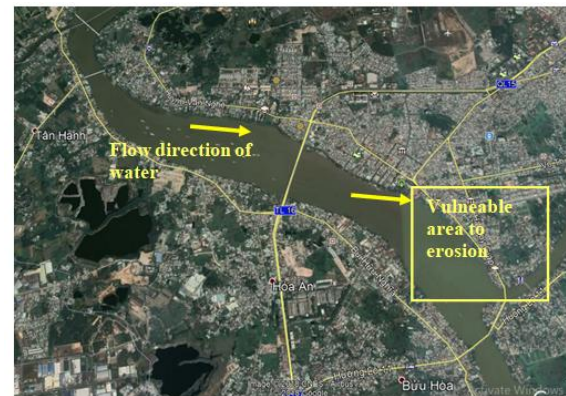
Figure 5: Vulnerable sites of bank erosion at Buu Long - Bien Hoa.
