Errata

TMS320F2806x Real-Time MCUs Silicon Errata Silicon Revisions B, A, 0

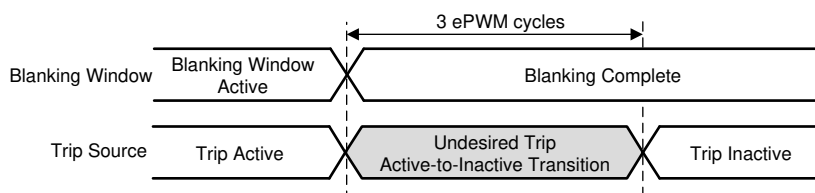
Figure 3-4. Undesired Trip Event and Blanking Window Expiration

Details The blanking window is typically used to mask any PWM trip events during transitions which would be false trips to the system. If an ePWM trip event remains active for less than three ePWM clocks after the end of the blanking window cycles, there can be an undesired glitch at the ePWM output.

Figure 3-4 illustrates the time period which could result in an undesired ePWM output.
