MSA DUE DILIGENCE MINE VISIT REPORT

COMPANY: [REDACTED]

Date visit: May 6th, 2014

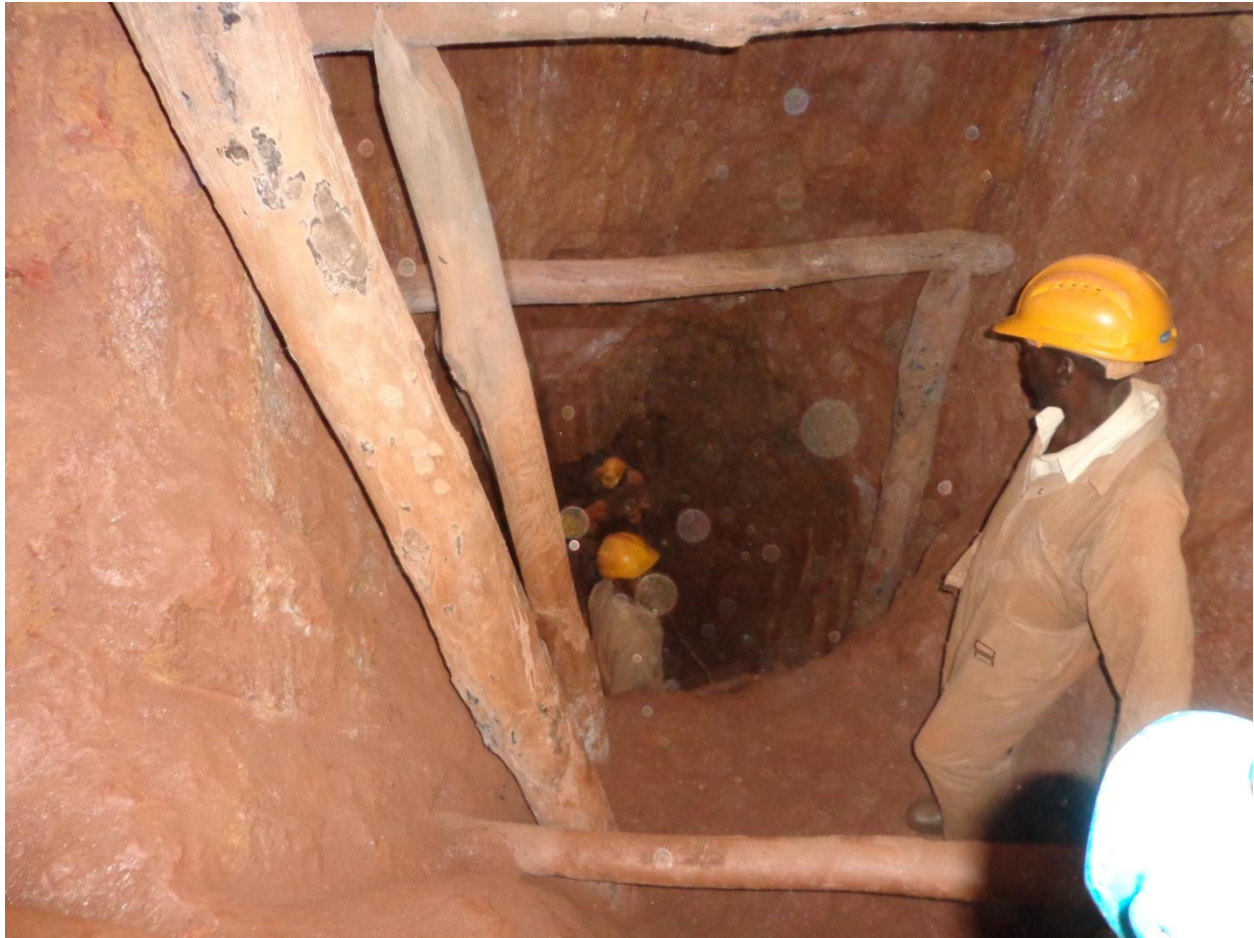
The main tunnel is safely timber supported.

Photo showing tin mine shaft at [REDACTED] Bugesera District.

MSA team recommends exploration of tin in colluviums by pitting and trenching and put inclined drifts along the four mineralized veins identified in the main tunnel.

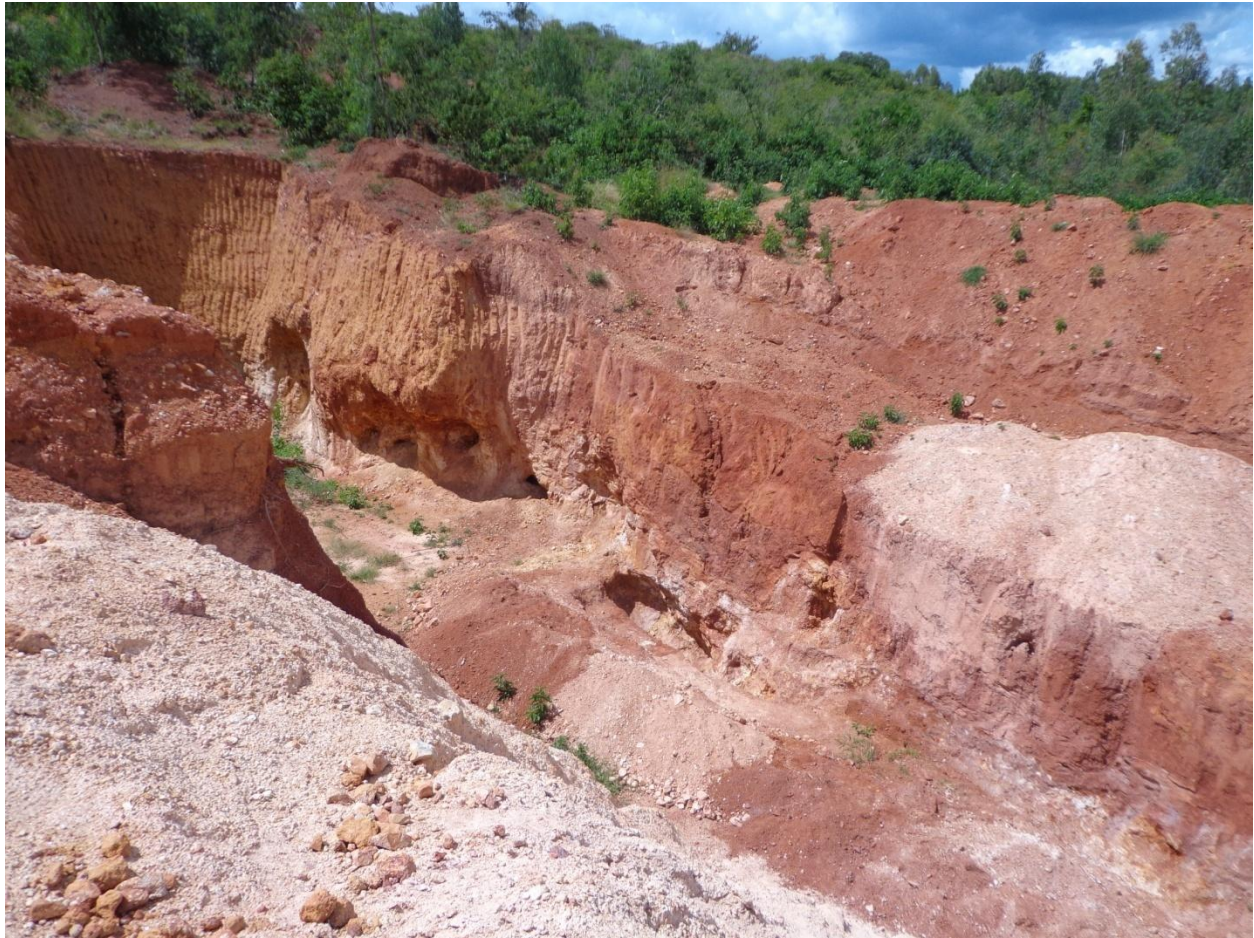
Photo showing open pit mining operations at [REDACTED] Tantalum site, [REDACTED] Bugesera District.

MSA team advise the company to reopen the pit on the tin and tantalum bearing pegmatite by benching a small section and checking the tantalum potentials of the two pegmatite veins; the company has already his own excavator on the site and a bulldozer.
