## MSA DUE DILIGENCE MINE VISIT REPORT

**COMPANY:** [REDACTED]

**Date visit:** April 9<sup>th</sup>, 2014

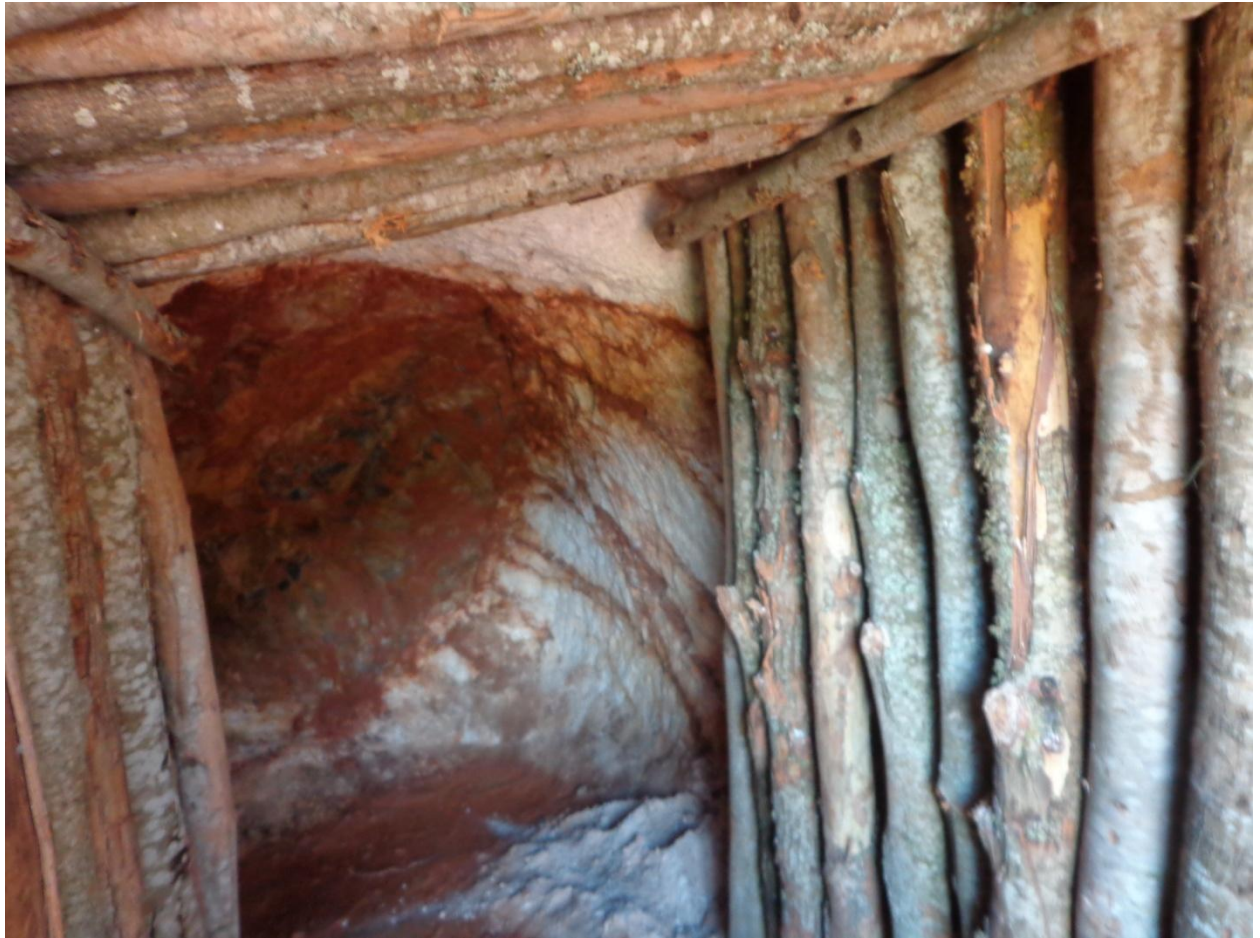
Tunnels are wood supported and safe.

Photo showing tunnel at [REDACTED], [REDACTED], mine site, Muhanga District

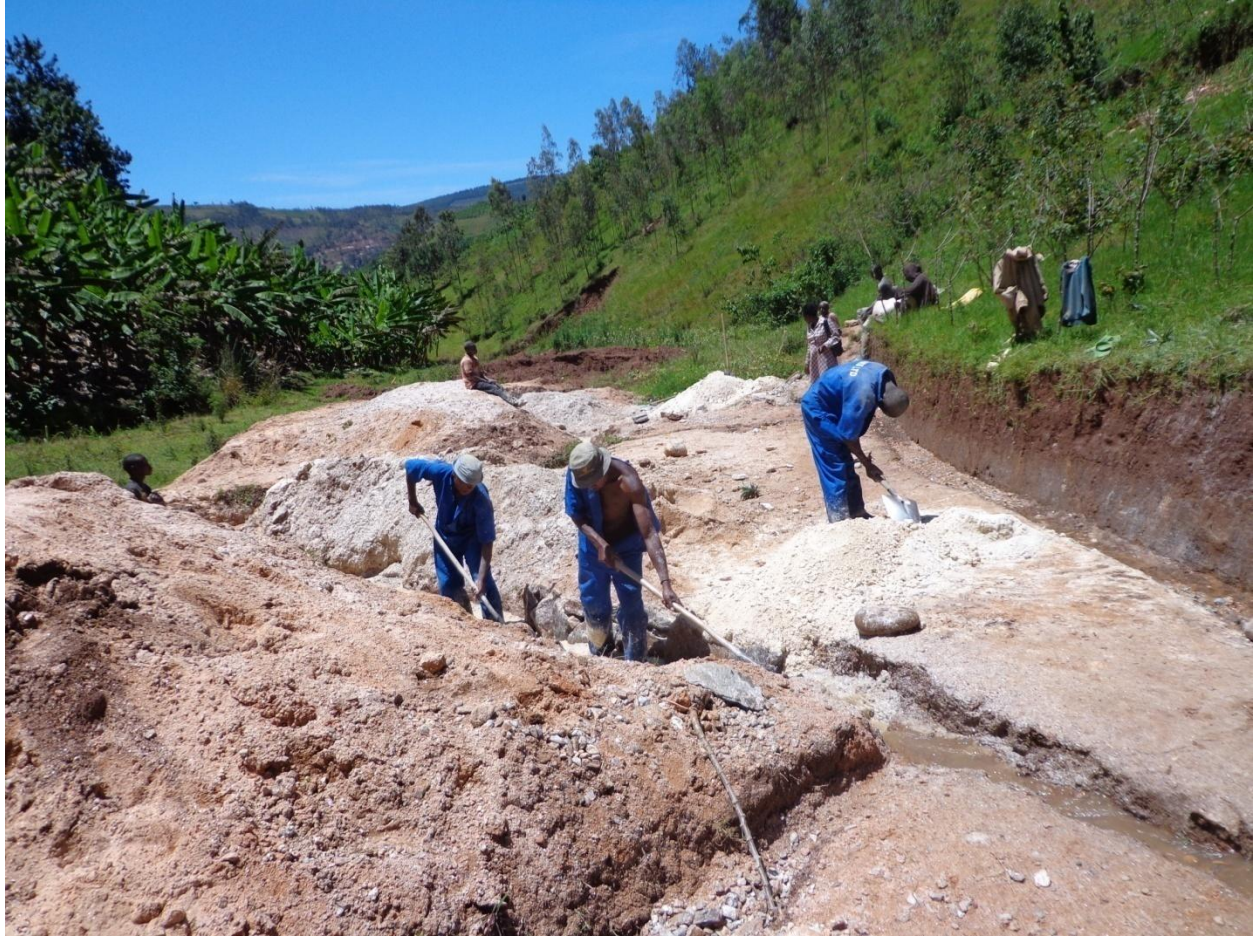
Photo showing minerals washing by ground sluice at [REDACTED] mine site, Muhanga District
